WalkBoston

Walkability Assessment Report Galvin Middle School, Wakefield June 11, 2012

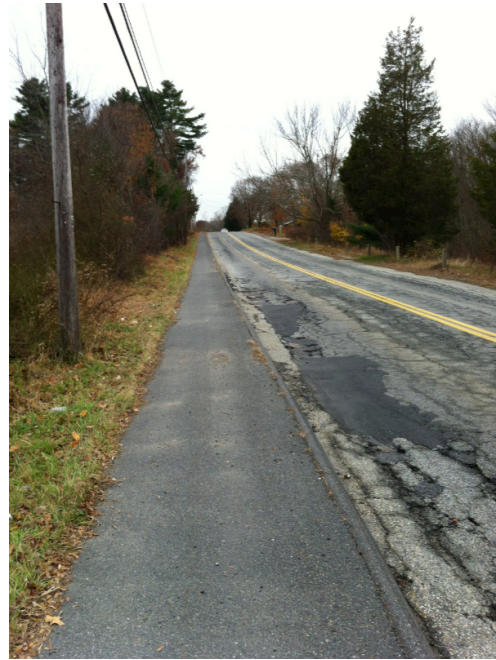
THE NARROW SIDEWALK ALONG LINCOLN STREET IS UNCOMFORTABLY CLOSE TO THE VEHICULAR TRAVEL LANE.

- Short-term/small-investment: Reduce the effective width of the travel lanes, which are approximately 12 feet wide, by painting a white line at least 1 foot in from the curb, thus visually reducing the travel lanes to 11 feet (or less). This is nothing new: there is a hardly-visible, faded white line that once existed on this stretch of Lincoln Street. There currently exists a more recently painted white line on a small section of Lincoln Street near the campus.
- Long-term/large-investment: Rebuild a wider sidewalk between Dacey Field and the campus, with the walk zone separated from the roadway with a grass buffer. This buffer not only discourages walking close to the travel lanes; it would also keep plowed snow from being piled on the walk zone. According to the National Center for Safe Routes to Schools:

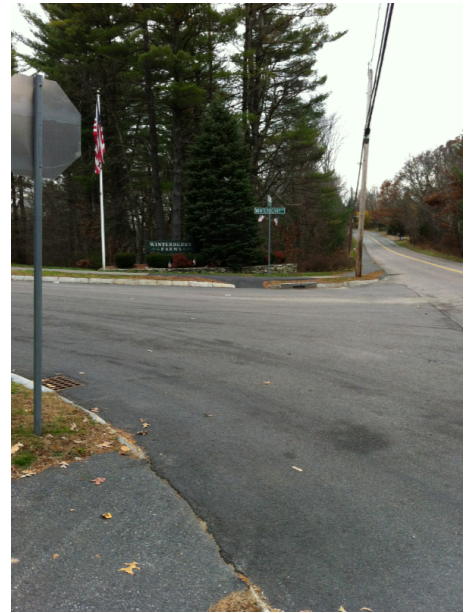
The intersection of Winterberry Drive (a residential street) and Lincoln Street, has turning radii much in excess of what is needed on a residential two-lane street with limited local traffic.

WINTERBERRY DRIVE IS VERY WIDE, WHICH ALLOWS FAST TURNING MOVEMENTS.

- Short-term/small-investment: Add a crosswalk and “Children Crossing” signage at this intersection to indicate to motorists that children use this route to get to and

from school. Also, “narrow” the width of Winterberry Drive by painting white lines a few feet in from each curb

- Medium-term/moderate-investment: Install planters or barrels at the corners to create a narrower turning radius on both sides of Winterberry Drive.
- Long-term/large-investment: Re-engineer the intersection with narrower turning radii.

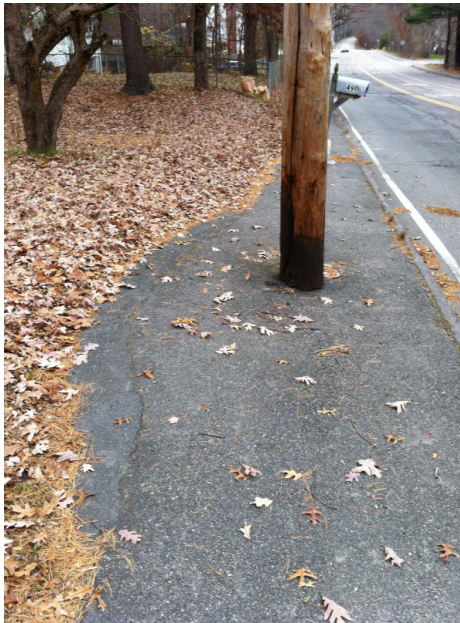
Utility poles and mailboxes narrow the effective width of the sidewalk on Lincoln Street between the campus’ main entrance and the pedestrian entrance. These obstacles create potentially hazardous conditions, especially for those who use wheelchairs or other mobility aids. According to the US Department of Transportation’s Bicycle and Pedestrian Information Center:

- Short-term/small-investment: The Town of Franklin should work with residents whose mailboxes block the sidewalks to devise an alternative mailbox mounting technique that keeps the walk zone clear and eliminates the need for large weighted devices.
- Short-term/small-investment: Expand the sidewalk with asphalt around utility poles. This appears to have been done at one point along Lincoln Street (pictured).

EXPAND THE SIDEWALK WITH ASPHALT AROUND UTILITY POLES.

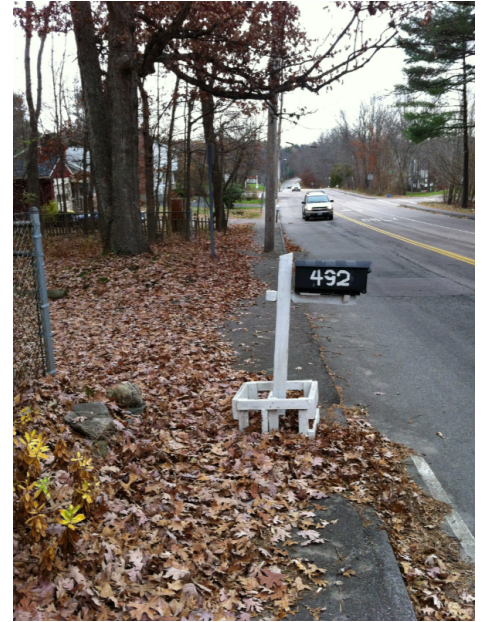
Furthermore, mounting mailboxes in large wood-framed boxes (pictured) or large buckets filled with stones violates Chapter 125-4 of the Town of Franklin Code

MAILBOXES SHOULD NOT OBSTRUCT THE SIDEWALK. THE TOWN SHOULD WORK WITH RESIDENTS TO FIND ANOTHER WAY TO MOUNT MAILBOXES THAT ALLOWS FOR SAFE PEDESTRIAN PASSAGE.
