Lenox Town Center Walk Audit

Lenox, MA

July 28, 2016

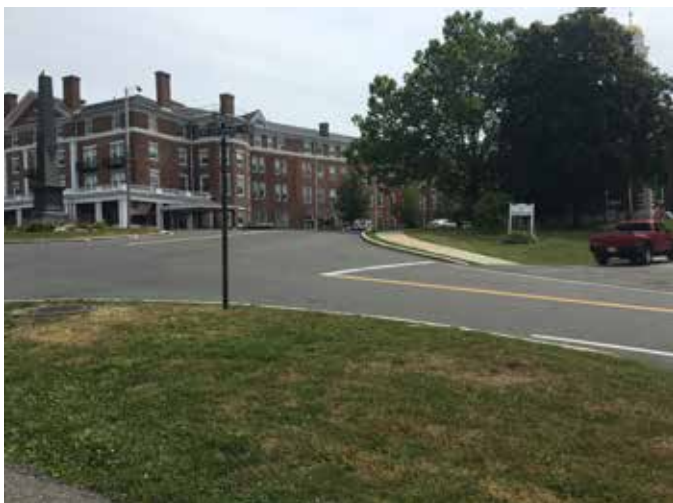
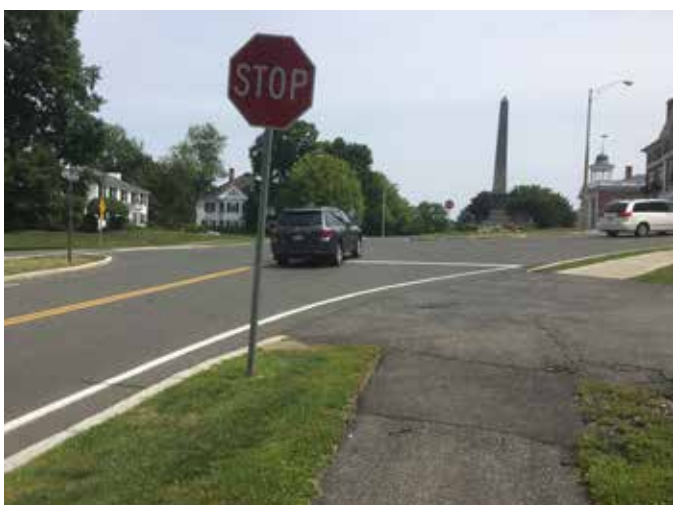
There is no crosswalk across Old Stockbridge Road at the intersection of Rt 183/7A.

The Walker Street/West Street/Main Street/Old Stockbridge Road intersection (183/7A) in front of town hall and the Curtis House sees high volumes of vehicular and pedestrian traffic. People walking do not have a complete marked route across the intersection from any direction and must walk a significant distance out of their way to use crosswalks. There are only two crosswalks at the intersection – one across West Street and one located just east of the intersection between the Curtis House and Town Hall. There is a third crosswalk across Main Street connecting the Library and the Summer White House Inn. It is unreasonable to expect people to walk to the Library and back to West Street to cross this intersection.

The intersection is not signalized, but the northbound Old Stockbridge Road approach and the Main Street southbound approach are controlled with stop signs. Drivers familiar with the intersection move quickly through it, while visitors hesitate as they determine who has the right of way. The Paterson –Egleston

Monument sits in the center of the junction of 7A and Route 183. When approaching the intersection from the south on Old Stockbridge Road, people must go up a considerable hill which compromises sight lines and pedestrian visibility.

Views of Old Stockbridge Road approach where a crosswalk is needed. The sightlines, grade, and existing driveway make it more difficult to mark a safe crossing.

- Explore the following short-term options for installing a marked crosswalk across Old Stockbridge Road
 - » Mark a crosswalk and install accessible ramps and sidewalk connections between the municipal parking lots on the east side of Old Stockbridge connecting to the sidewalk on the west side just south of the residential driveway
 - » Relocate and/or close the municipal and private residence driveways on Old Stockbridge Road just south of the West Street intersection to make room for a marked crosswalk and accessible ramp
 - » Install roadside crosswalk signs to make the crossing more visible
- Review location of stop sign and stop line where Old Stockbridge meets West Street
- Move existing crosswalk sign closer to edge of the road; consider installing advance crosswalk signs

- Tighten curb radius where Walker Street meets Old Stockbridge Road on the west side of town hall
 - » Install curb ramps and a crosswalk at the Walker St/Old Stockbridge Rd intersection
 - » Install roadside crosswalk signs to make crossing more visible
- Rethink location of angled parking in front of the Curtis House
 - » Redesign to accommodate marked crosswalk between Adams Community Bank and the Curtis House – could include curb bump-out or complete curb realignment to mirror curve and convert to parallel parking
 - » Remove parking entirely to maximize pedestrian visibility

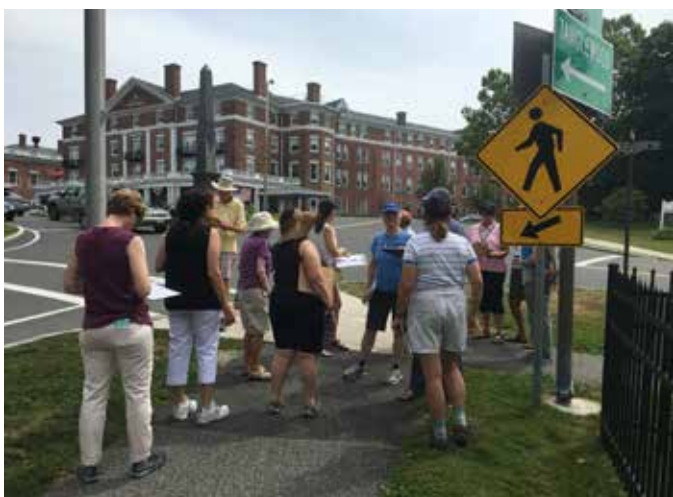
View of the West Street approach with the only marked crosswalk in the Rt 138/7A intersection

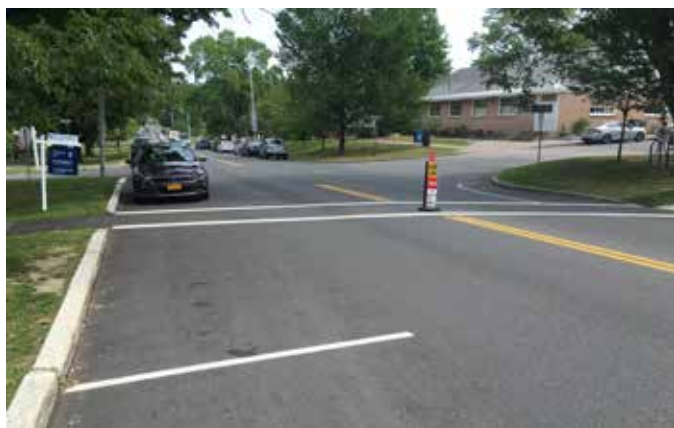
Despite the bylaws, walk audit participants observed multiple locations where parking is striped within the restricted distance. Cars parked in these spaces limit the visibility of people wishing to cross the street and the visibility of drivers required to yield to people crossing. The biggest safety concern is the zone before the crosswalk when people crossing are looking back at oncoming traffic.

Parking too close to the crosswalk on Main Street just south of the intersection with Housatonic Street

- Remove parking space striping from the following Lenox town center locations:
 - » Two mid-block crosswalks on Walker Street between Church Street and Main Street intersection
 - » Three mid-block crosswalks on Main Street between West Street and Cliffwood Street
- Evaluate crosswalks on 7A north of the town center for parking encroachment issues that block visibility
- Install no parking signs near crosswalks and at intersections
- Paint diagonal white lines in no parking zones adjacent to crosswalks and intersections
- Work with the Lenox Police Department to enforce no parking ordinances

- Install curb bump-outs at locations where painted lines do not deter parking

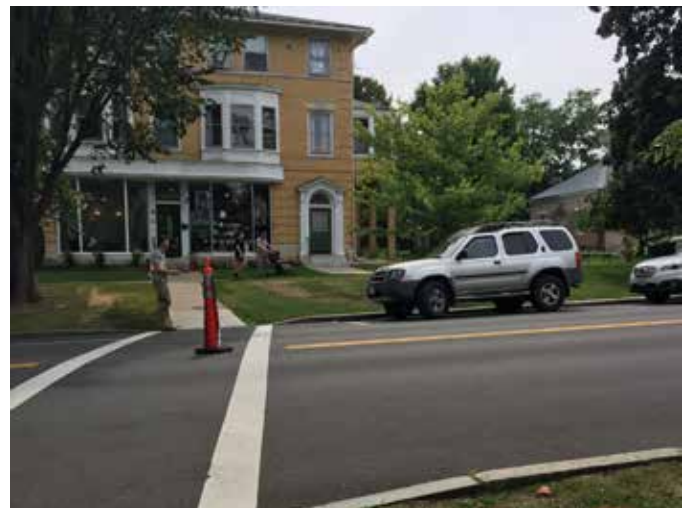
Cars parked within 20' of a crosswalk block pedestrian visibility and increase potential for conflicts.

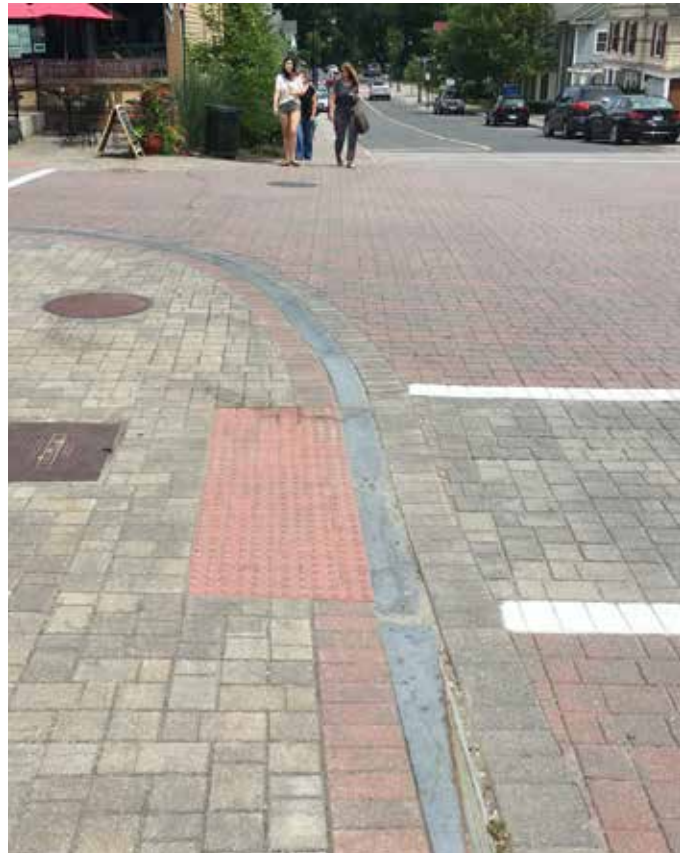
At the intersection of Housatonic and Church Streets, white lines have been painted to highlight crosswalks, but many walkers don't use them.

If the paving treatments on the travel ways had been limited to the raised intersections, such as at Housatonic Street/Church Street, and the raised crosswalks, such as at Housatonic and Main Street, the paving patterns may have been effective, rather than confusing.

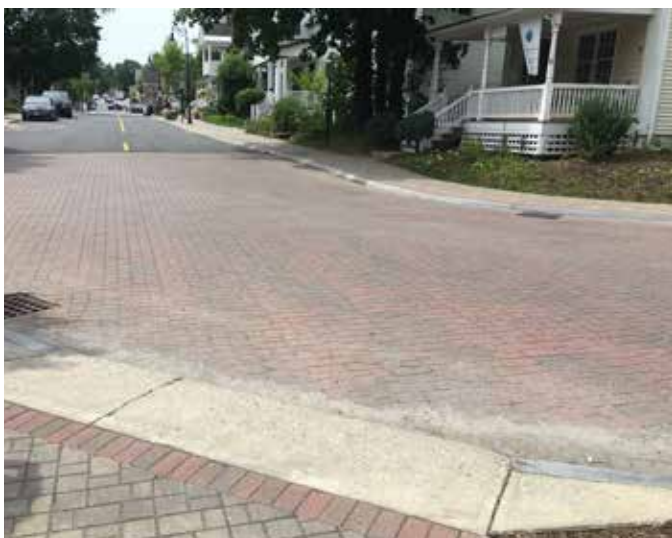
In some cases, pavers indicate a pedestrian zone while in others they are used in vehicular travel lanes. For example, as Franklin Street curves to meet Church Street, the travel way is paved with the same concrete pavers as those used on the adjacent sidewalks (except for a slight change in color). This area should not be a pedestrian priority zone, however the similar paving pattern could indicate pedestrian use. Furthermore, the lack of a painted yellow centerline in this area facilitates drivers' tendencies to flatten out the curve and consequently drive into the lane of oncoming traffic.

The meaning of the use of pavers on the curve connecting Franklin Street and Church Street is unclear.

- Continue to use paint to clarify pedestrian zones and vehicular travel ways
- Continue ongoing maintenance of concrete pavers on travel ways, sidewalks and crosswalks to limit tripping hazards
- Establish Town crosswalk design standards that include guidelines for raised crossings, raised intersections, mid-block crossings, and crossings at intersections

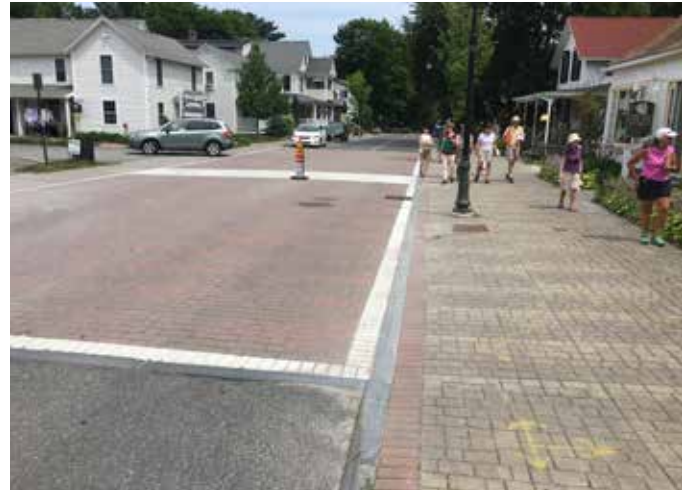
The flush curbs in the middle of Church Street, combined with the paving patterns, create confusion around who has the right of way. The long length of the flush curb could be a pedestrian plaza or a shared street. With parking permitted adjacent to the flush curb, the space's purpose is murky at best.

Ambiguous use of paving materials and flush curbs on Church Street

- Install temporary curbing along eastern edge of Church Street flush curb to differentiate sidewalk from travel way in front of children's clothing and toy store
- Consider temporary curbing at the Franklin Street/Main Street intersection to delineate sidewalk

- Establish town-wide guidance on use of flush curbs to provide developers, designers and transportation engineers with information on where flush curbs are appropriate
- Redesign and replace flush curbs with straight curbs in conflict locations – may not occur until roads are reconstructed, or at a minimum resurfaced

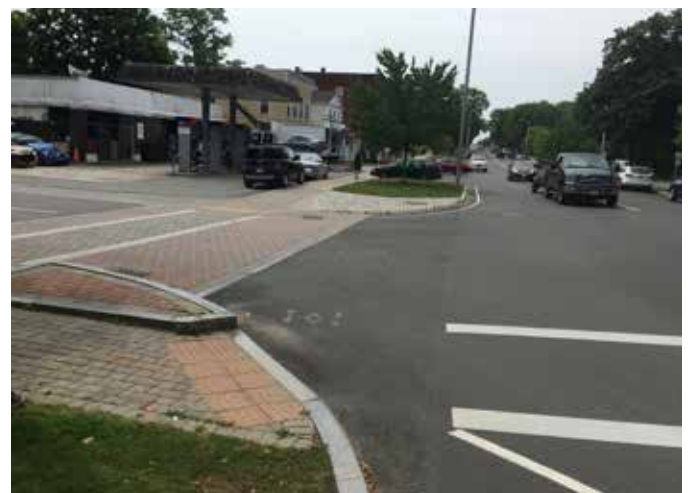
At the Franklin and Main intersection, the flush curb along the southern edge of the sidewalk creates an elongated curb cut for the Sunoco Gas Station giving people walking along that edge little separation from the driveway or the street. The lack of differentiation at the southeast corner forces people into the street before the crosswalk begins and allows drivers to cut the corner.

View of Franklin/Main Street intersection looking south down Main Street

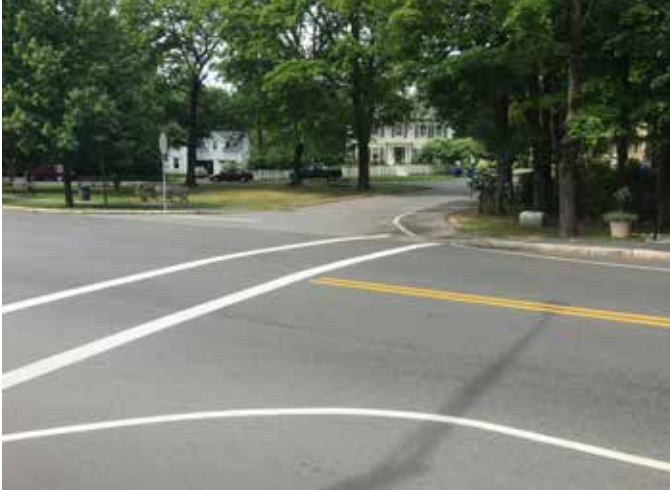
Long crosswalk across Main Street at the Main/Franklin/Cliffwood intersection

Walk audit participants reported that the crosswalk across Main Street at the intersection of Main and Franklin Streets, in particular, was “long” and “dangerous.” Curb bump-outs would shorten the crossing distance and narrow the travel lane at this important intersection as you enter the retail district of the town center.

- Paint a ladder crosswalk across Main Street at the Main St/Franklin St intersection

- Install curb bump-outs at the Main St/Franklin St intersection
- Explore other options for slowing fast-moving traffic on Route 7A including narrowing lanes

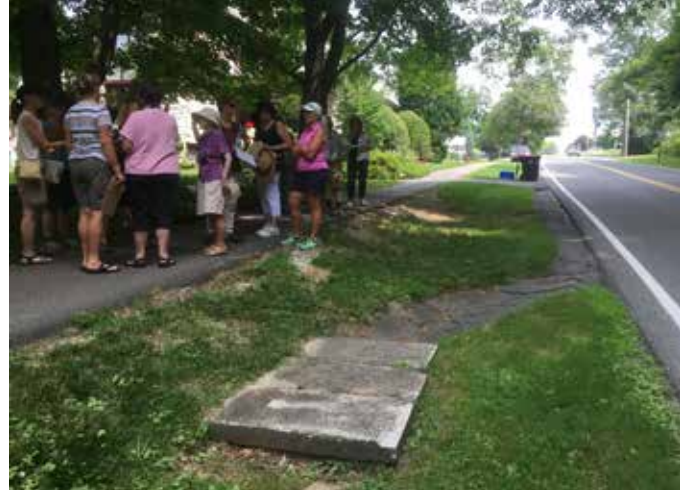
Asphalt sidewalks leading to the town center are in vary in quality and all are relatively narrow

The asphalt sidewalks along the west side of Old Stockbridge Road are showing signs of age. Tree roots and freeze/thaw processes have begun to break up the sidewalks, and cross-slopes have increased with time. The sidewalks are relatively narrow given the high volumes of pedestrians (particularly in the summer and fall tourist seasons). Maintenance of these sidewalks is critical to promote walking to the town center for people living and visiting destinations within walking distance of the center.

- Identify priority sidewalks leading to the town center in need of repair/replacement. Priority sidewalks include those connecting schools, senior housing, transit stops, parks, and local landmarks to the town center. Old Stockbridge Road is a priority sidewalk.
- Coordinate with the Department of Public Works resurfacing/reconstruction programs

- Establish sidewalk prioritization plan and annual sidewalk replacement/repair budget to systematically replace aging sidewalks leading to town center

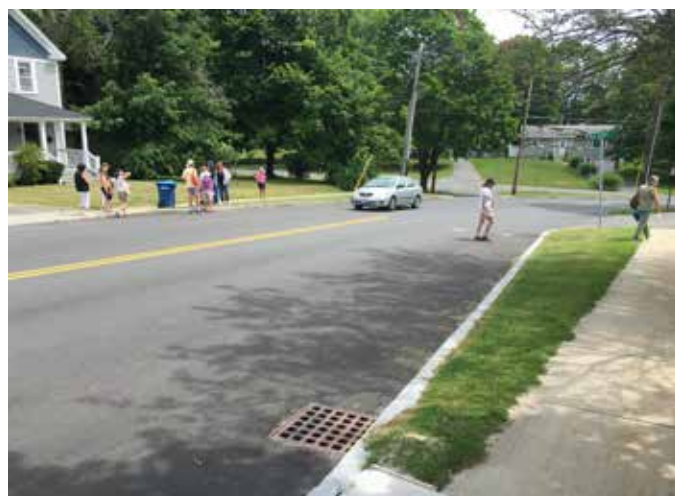
Ore Bed Park is a destination for many children and staff in the childcare, camp and pre-school programs at the Community Center. Housatonic Street separates the Community Center from the park. There is no sidewalk along Old Center Street and no crosswalk across Housatonic Street. The sight lines are challenging as Housatonic Street curves to meet Church Street at the town center. Participants reported that drivers speed along this stretch of road. Staff members at the Community Center described a crossing strategy involving multiple caregivers and children holding hands in a line.

There is no safe place to cross between Ore Bed Park and the Community Center for many children who use both facilities.

- Evaluate feasibility and safety implications of installing a crosswalk between Ore Bed Park and Old Center Street
- Monitor and/or enforce traffic speed limits on Housatonic Street to encourage slower driving

- Consider installing a sidewalk, pedestrian warning signs, and/or pavement markings to bring awareness that people may be walking

- Study the possibility of reconstructing the intersection of Housatonic Street, Ore Bed Road, and Old Center Street with the goal of improving safety

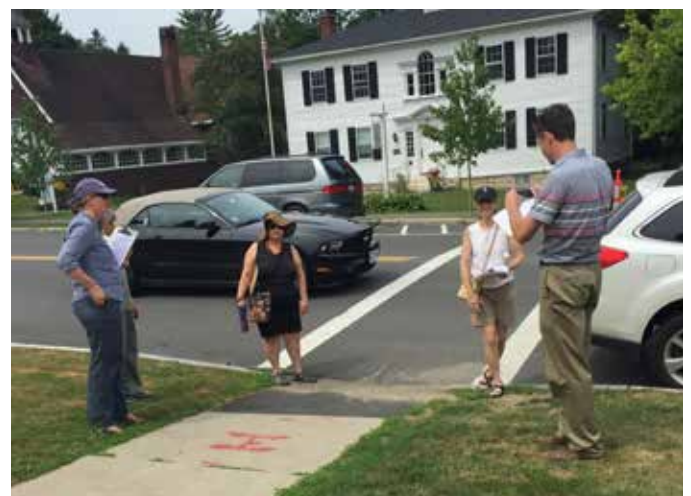
- Crosswalk in front of community center is missing curb ramps and tactile warning panels
- All crosswalks on Main Street between Walker Street and Cliffwood Street are missing tactile warning panels.
- Crosswalk across Main Street nearest to Cliffwood Street needs new curb ramp
- ADA parking space in front of fire hydrant has no ramps at Franklin and Main Street intersection

Crosswalks on Main Street need tactile warning strips and ADA-compliant curb ramps

- Advise the dental office to move their sign so that it does not encroach upon the sidewalk
- Determine if high priority locations are already on the Department of Public Works schedule for road reconstruction/repaving and ensure that ADA improvements are included in the projects

- Develop an ADA compliance plan for the Town of Lenox that prioritizes areas with the highest volumes of pedestrians (if one does not already exist)
- Secure funding for ADA compliance projects in the Town of Lenox. Two potential sources are the MassDOT Complete Streets funding program and the Safe Routes to School Infrastructure Program (if the location is near a school or on a primary student walking route)

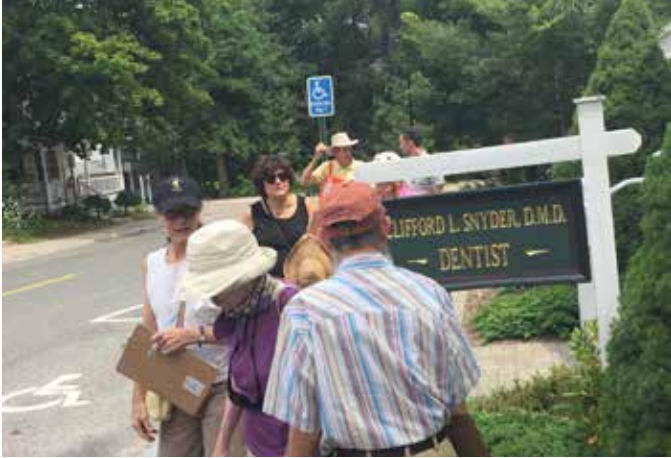
Sign should be moved so it no longer blocks the sidewalk along Church Street

While affecting all sidewalk users, but disabled ones most significantly given its proximity to handicapped parking, the wooden sign for Dr. Snyder's dental office overhangs into the sidewalk. Several walk audit participants admitted to bumping into the sign repeatedly because it is an unexpected obstruction in the sidewalk.
