South End Neighborhood Evening Walk Assessment Springfield, MA

November 16, 2016

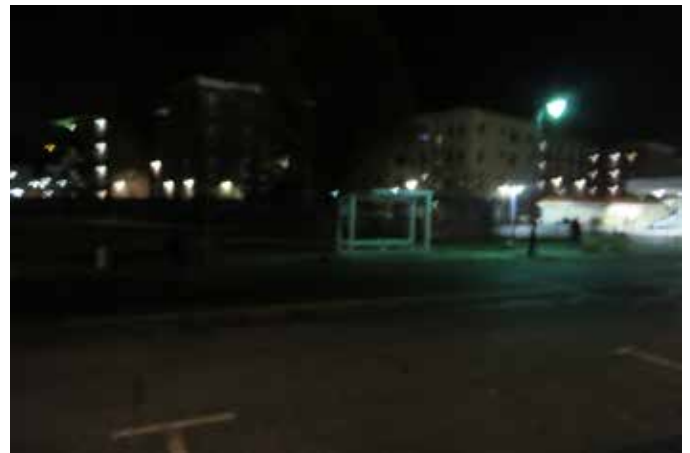
The locations of the streetlight poles installed along Main Street do not provide adequate light at the Main Street crosswalks. The lights are often located in front of or behind the crosswalk, rather than on the crosswalk making it difficult for drivers to see people in the crosswalks. Bus stops, such as the bus shelter at the intersection of Main Street and Adams Street, are also poorly lit. In addition, the light bulbs in the streetlight fixtures seem to have different levels of brightness that are not coordinated with land uses or traffic patterns.

Low light levels along Main Street

In addition to the city's lights, the lighting in parking lots and on buildings along the Main Street corridor does not provide adequate light for people walking at night. Many buildings and parking lots along Main Street have light fixtures, but many were not turned on. Furthermore, many store windows are dark either because the store is closed or vacant. Some store windows are covered; other windows are small. Many of the store doorways are recessed and dark, and are potential places for people to hide.

- Use reflective paint on roadways to increase visibility of pavement markings in low light conditions
- Survey the location of light poles and crosswalks within the Main Street corridor. Determine if light fixtures can be adjusted or light poles moved to better light marked crosswalks. Determine if light levels or brightness can be increased using different bulbs, or consider moving crosswalks to locations that have better lighting.
- Discuss lighting strategies and/or incentives for businesses and building owners to keep lights on at night, improve transparency of store front windows, and light dark spaces and parking lots

- Consider hiring a lighting consultant to study current lighting conditions along Main Street and propose strategies to improve lighting with a goal of crime prevention and pedestrian safety
- Implement a lighting design that ensures pedestrian walkways and crosswalks are well lit with uniform light levels

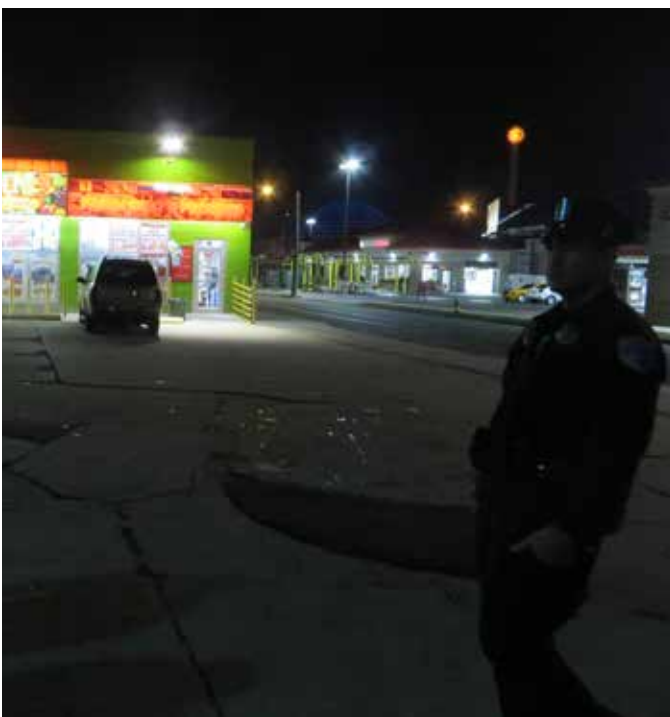
Dark parking lot in front of a well-lit building on Main Street

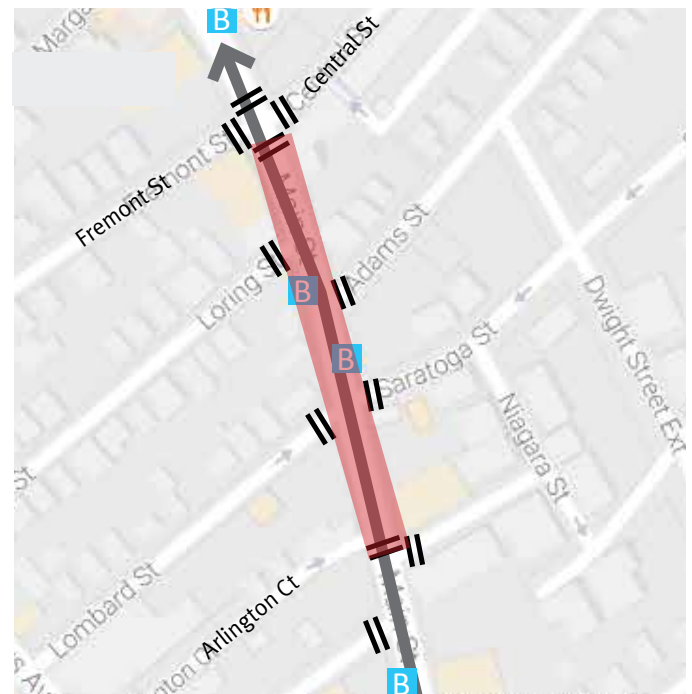
Crosswalks on the streets that intersect Main Street are well marked with an inlaid thermoplastic pattern, as are those that cross Main Street. However, there are long stretches of Main Street without crosswalks with relatively high numbers of people crossing without a crosswalk (particularly between Central/Fremont Streets and Arlington Court). These high crossing locations include bus stops and businesses. While it is not prudent to mark crosswalks across Main Street at all intersections, additional crosswalks may provide safer ways for people to cross Main Street.

There are no marked crosswalks on Main Street between Central/Fremont Streets and Arlington Court

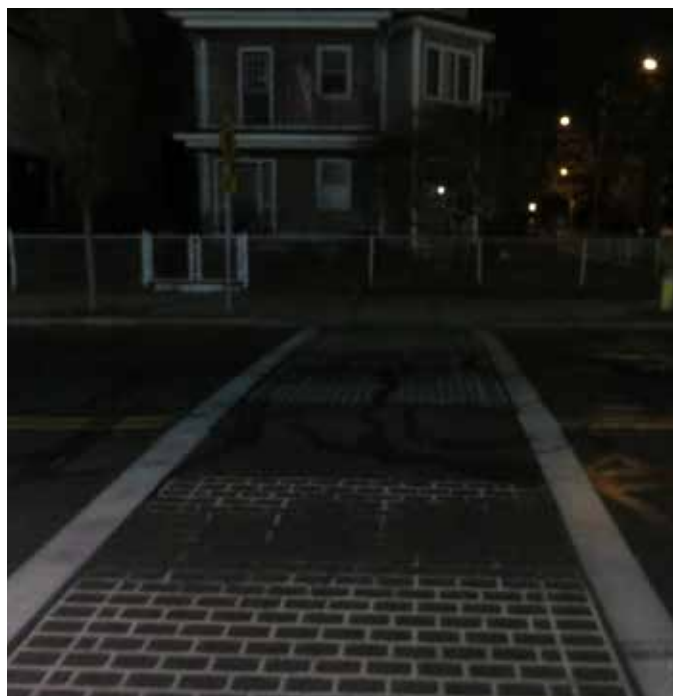
Walk audit participants described the crosswalk just north of Columbus Square as treacherous. It is located at the base of a hill after a blind curve in the road for northbound drivers. High traffic speeds and compromised sight lines make pedestrians difficult to see despite the well-marked crosswalk and crosswalk signs. Additional safety measures, such as advance crosswalk signage or a Rectangular Rapid Flashing Beacons (RRFB), may be warranted at this crossing. Curb extensions were planned in the most recent Main Street redesign to reduce crossing distances and slow traffic, but walk audit participants stated that residents opposed them over snow clearance issues.

Crosswalk across Main Street near the Acushnet Avenue intersection

- Post advance crosswalk signage along Main Street at crosswalk near Acushnet Avenue and Main Street intersection (*see MUTCD Section 2B.11 Yield Here to Pedestrians signs*)
- Study vehicular traffic patterns and pedestrian crossing patterns on Main Street to determine if additional crosswalks are warranted and safe. Consider proximity to bus stops when selecting new crosswalk locations, such as between Adams and Saratoga Streets and Gardner Street
- Paint diagonal lines near crosswalks and post No Parking signs to discourage people from parking within 20 feet of the crosswalk

- Reconsider adding curb extensions to shorten crossing distances. Snow removal and storage can be managed with curb extensions in place
- Install a Rectangular Rapid Flashing Beacon (RRFB) at the mid-block crosswalk near the Acushnet Avenue/Main Street intersection (or at the Main St/Locust St intersection, but not at both)
- Implement a lighting design that ensures pedestrian walkways and crosswalks are well lit with uniform light levels

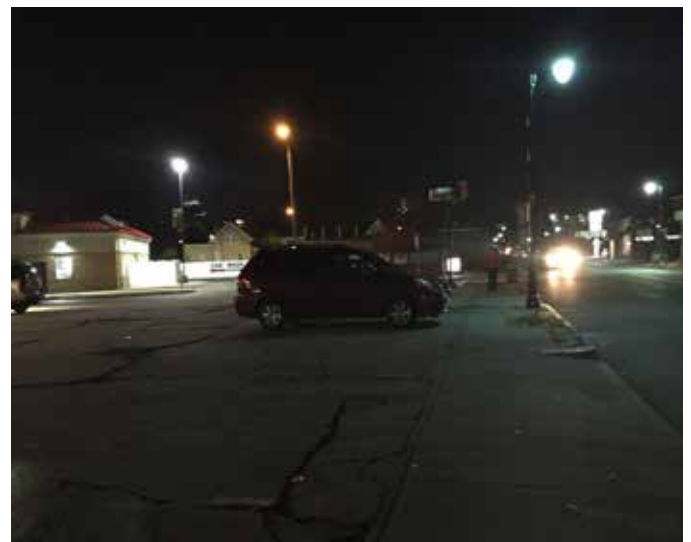
Parking lots are a prominent land use along the Main Street corridor (see map on p.9). Some parking lots use walls, fences or vegetation to separate the sidewalk from the parking area (e.g., car wash parking lot at Gardner Street), but most have no separation. Furthermore, the wide driveways reaching these lots interrupt the sidewalk, forcing people walking to constantly look for cars turning in front of them. This compromises the quality and safety of the walking environment. The majority of the parking lots were empty, which may have been a function of the time of the walk audit. In general, parking lots do not enhance a neighborhood’s walkability.

Parking lots line the edges of Main Street in the South End

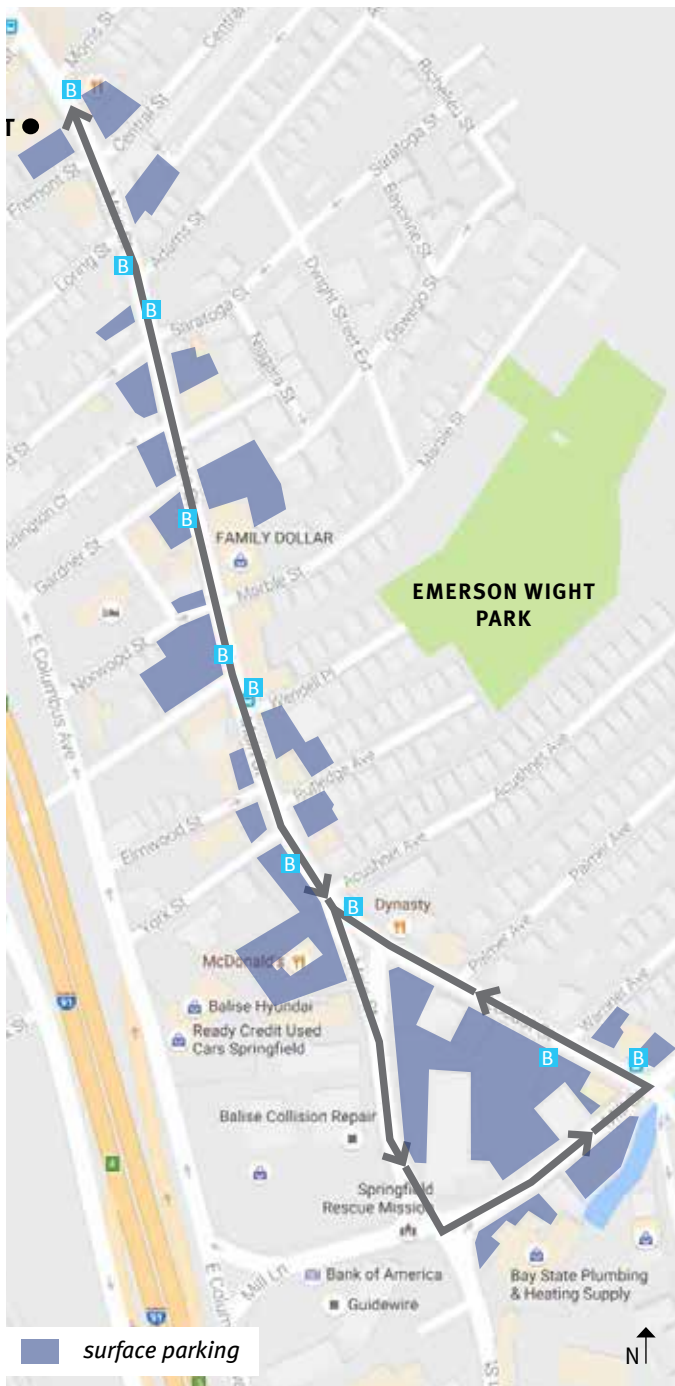
Surface parking is a primary land use along Main Street

- Organize programs to redefine and revamp spaces along the corridor, such as Arlington Court (i.e., place-making programs). Possible activities include: mural painting, sidewalk art, pop-up parks, parklets, or outdoor events that encourage people to use the spaces in a positive manner.
- Develop concept plan for neighborhood park on vacant land at Main Street and Adams Street
- Work with existing business owners to better define the edges of parking areas to improve the safety and quality of the walking environment

- Consider amending zoning codes and/or site plan design review guidelines to limit the number of driveways and modify parking ratios for businesses along the Main Street corridor

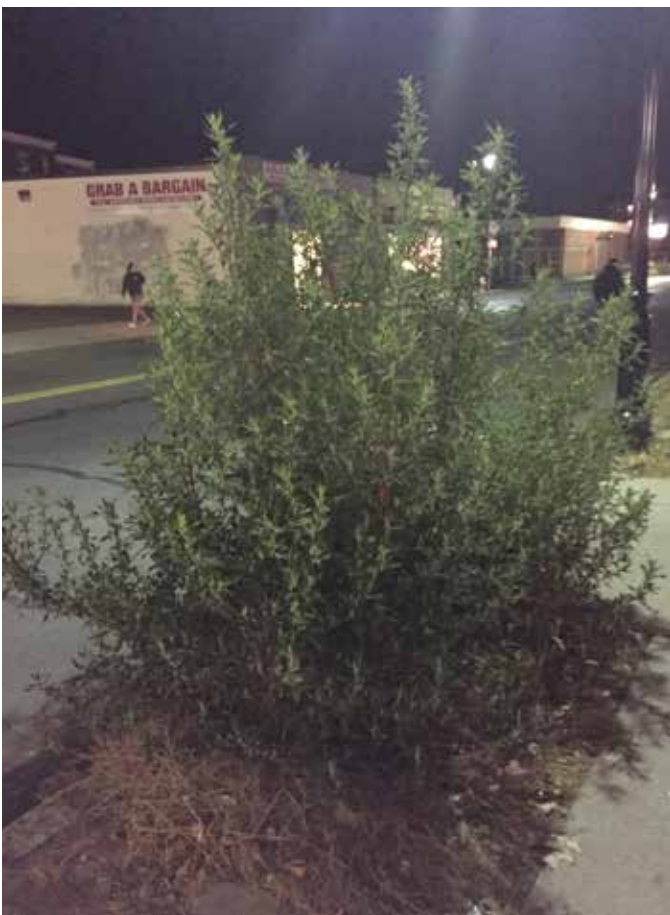
Much of the Main Street corridor streetscape is in need of basic maintenance activities. Weeds and vegetation have overgrown planting areas. Trees have been cut down, but the stumps remain. According to walk audit participants, trash barrels are typically full and litter is often on the streets. A crew from the Sheriff's department had been working on Main Street earlier on the day of the walk audit so the street looked better than usual. Both trash pick up and trimming vegetation are relatively inexpensive operations.

Weeds remain in the planting beds from the summer months

- Work with the City of Springfield to determine responsibility for maintaining streetscape; increase trash removal service
- Work with business owners and property owners on dedicating time and resources to maintaining storefronts, sidewalks and plantings

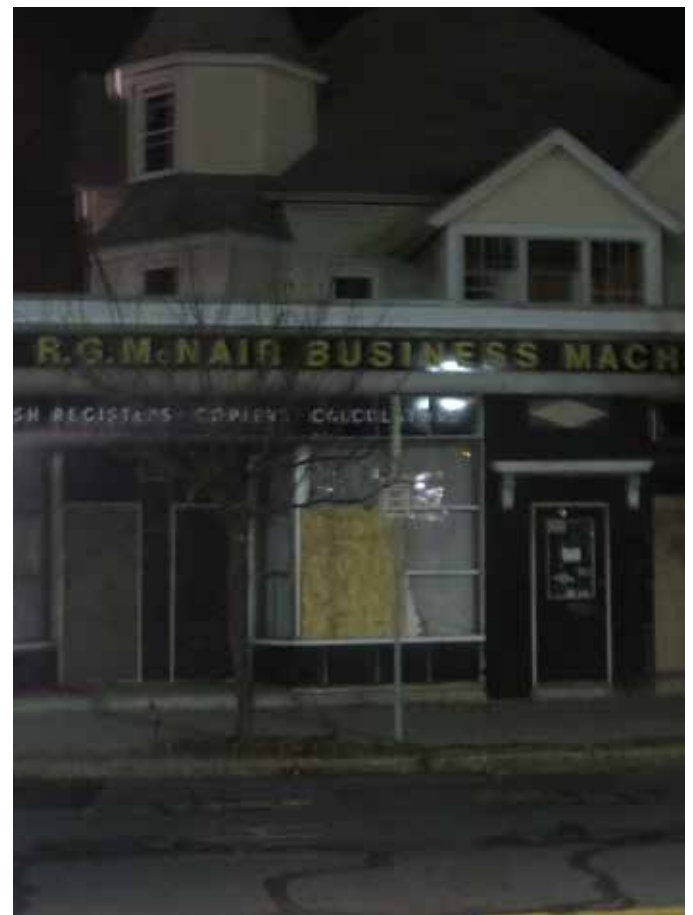
Facade improvement programs can help to maintain a building's appearance while in transition

- Apply for façade improvement grants or other programs that provide small business owners with funding to reinvest in their property

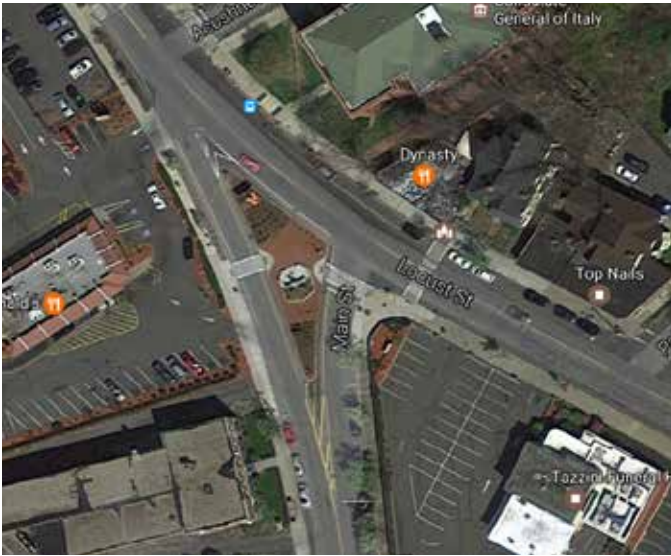
Main Street/Locust Street intersection

The Main Street and Locust Street intersection at the southern end of the study area forms a triangular pedestrian plaza with a statue of Columbus, several flagpoles, and attractive landscaping elements. High visibility crosswalks with ADA-compliant curb ramps and detectable warning panels lead to the pedestrian island across the two Main Street travel lanes and across Locust Street. However, these positive aspects of a walkable environment are undermined by high traffic speeds.

The most dangerous crossing is across Locust Street, where the sightlines, lighting, and parking patterns at the crosswalk make it difficult to see people walking in the crosswalk or waiting to cross the street. People driving northbound on Locust Street pick up speed as they drive downhill to Locust Street’s intersection with Main Street. Cars are parked directly adjacent to the crosswalk on the northeast side of the street blocking pedestrian visibility. The cobra-head style streetlight shines a bright light at the intersection of Palmer Avenue and Locust Street, leaving the crosswalk in darkness.

The sidewalk on the east side of Main Street south of the Main St/Locust St intersection ends within 100 feet of the intersection and is missing until Main Street’s intersection with Mill Street. There is a complete sidewalk on the west side of Main Street, but no crosswalk to reach the west side.

- Paint fog lines on Locust Street to narrow vehicular travel lanes and calm traffic.
- Install “No Parking” signs and paint diagonal lines within 20’ of the crosswalk to discourage parking adjacent to the crosswalk
- Add additional flex posts south of the triangular plaza on Main Street to block illegal U-turn movements. (Flex posts were installed here at one time)
- Consider moving the crosswalk across Locust Street north to intersect with the pedestrian triangle. Relocation would eliminate potential conflicts between drivers turning right onto Locust Street from Main Street; however, the crosswalk may be less visible on the curve of Main Street
- Add pavement markings, brick roadway patterns and/or planters to cue drivers to slow down, to beautify the walking environment, and to visually connect the triangular plaza with the broader streetscape

- Complete the sidewalk on the east side of Main Street between the Main St/Locust St intersection and the Main St/Mill St intersection
- Relocate street light pole or add second light pole to make pedestrians and crosswalks more visible at night
- Install a Rectangular Rapid Flashing Beacon (RRFB) at the Main St/Locust St intersection (or at the mid-block crosswalk near the Acushnet Avenue/Main Street intersection, but not at both)
- Study the possibility of raising the crosswalk across Locust Street to calm traffic and enhance pedestrian visibility

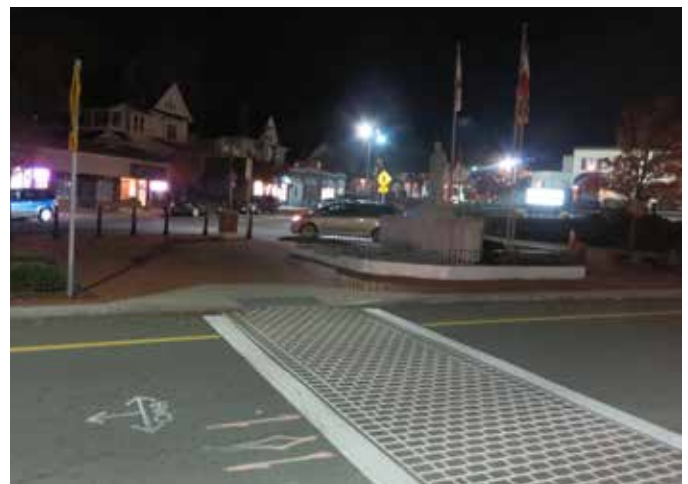
View of the crosswalk across Main Street leading to pedestrian plaza

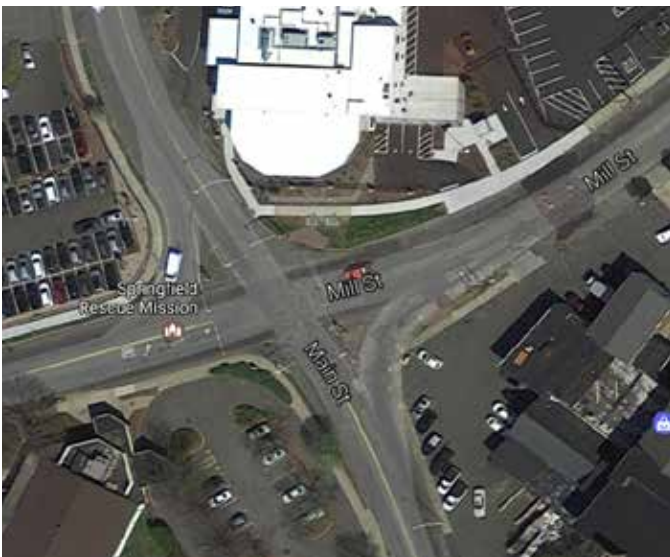
The Main Street/Mill Street intersection is very wide (including one slip lane on each side of the intersection for traffic turning right from Main Street onto Mill Street) and is surrounded by industrial uses and parking lots. The sidewalk network is complete, but interrupted by long curb cuts on the southeast edge of Main Street and the southeast edge of Mill Street. There are no marked crosswalks or pedestrian signals across any of the approaches. The lack of pedestrian infrastructure makes this intersection uncomfortable and potentially dangerous for people walking.

- Paint fog lines on Main Street and Mill Street to narrow vehicular travel lanes and calm traffic
- Add high visibility, ladder crosswalks, and ADA-compliant curb ramps and detectable warning strips across all four sides of the intersection
- Install countdown pedestrian signals in conjunction with crosswalks and ensure that the signal phasing and timing prioritizes pedestrians

- Study the traffic volumes on Main Street and Mill Street to determine if the intersection can be reduced in size, including the removal of the right-turn slip lanes
- Consider installing curb bump-outs/extensions to reduce crossing distances and slow traffic
- Enhance street lighting to make pedestrians and new crosswalks more visible at night

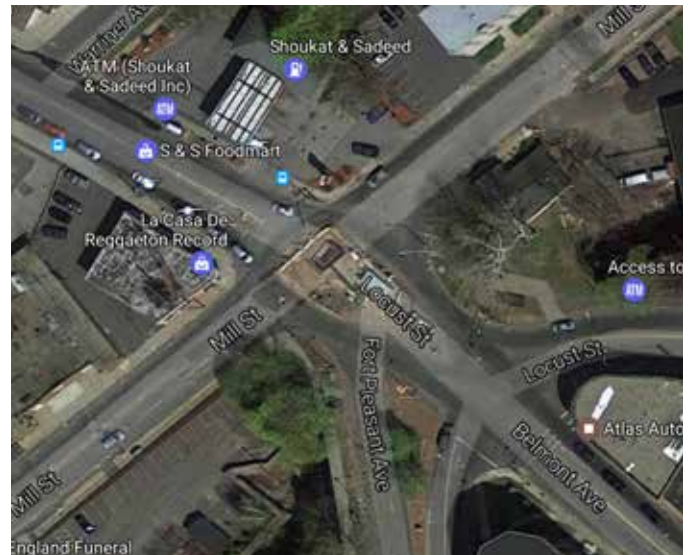
Mill Street/Locust Street intersection
(construction shown in this aerial view has been completed)

The Mill Street/Locust Street intersection presents significant challenges for pedestrians. The Mill Street/Locust Street intersection, with Belmont Avenue and Fort Pleasant Avenue merging nearby, is part of an important corridor connecting the Main Street commercial district, the surrounding residential

neighborhoods, and Forest Park. Planters were located along the street edges, but were removed. High traffic volumes and speeds, confusing traffic patterns generated by the haphazard convergence of six roadway segments, long crossing distances, and a lack of crosswalks and pedestrian signals all create hazards for pedestrians at this location.

There are three crosswalks at the intersection, two cross Mill Street and one is marked on the north side of Locust Street. Additional crosswalks cross Belmont Avenue and Locust Street east of the major intersection, but there is no crosswalk on Fort Pleasant Avenue. All of the marked crosswalks consist of only two parallel lines.

- Repaint crosswalks as high visibility, ladder crosswalks and construct ADA-compliant curb ramps and detectable warning panels on all approaches of the intersection
- Install pedestrian countdown signals in conjunction with crosswalks and ensure that the signal phasing and timing prioritizes pedestrians
- Consider painting fog lines to narrow travel lanes on all approaches
- Study traffic volumes and turning movements to determine the need for right turn lanes on the northern approach of Locust Street and both Mill Street approaches. If traffic volumes and turning movements do not justify the need for right turn lanes, consider installing curb bump-outs to shorten crossing distances

- Study feasibility of reconstructing the intersection to include a round-about complete with bicycle and pedestrian facilities, or a realignment of the Fort Pleasant Avenue, Belmont Avenue and Locust Street approaches

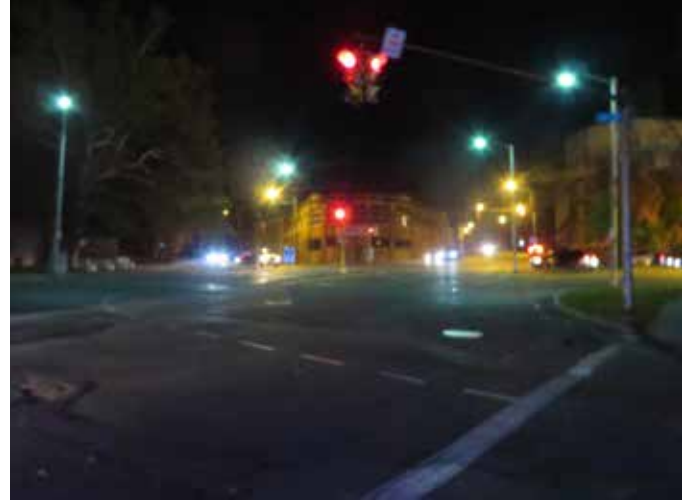
View of the Mill St/Locust St intersection looking southeast up Belmont Ave and Locust Street.
