The Point Walk Assessment Salem, MA

June 6, 2018

Walk Assessment Overview

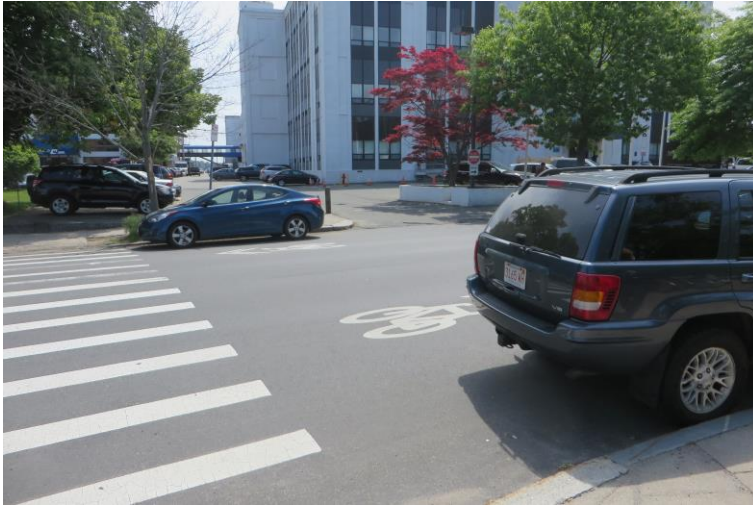
- **Use daylighting and bumpouts/curb extensions at crosswalks to improve visibility between pedestrians and drivers, reduce long pedestrian crossing distances, and calm traffic.** Vehicles throughout the Point often park right next to crosswalks, even though state law prohibits parking within 20 feet of a crosswalk. This creates safety hazards as drivers and pedestrians often cannot see each other around the parked vehicles. Posting of “No Parking” signs within 20 feet of crosswalks, combined with enforcement of these parking restrictions, can help “daylight”

Vehicles park right next to crosswalks throughout the Point, preventing pedestrians and drivers from seeing each other.

the crosswalks and improve visibility. Another daylighting solution is to physically restrict parking using paint, plastic flex posts and/or planters in the short term at low cost.

Bumpouts/curb extensions at crosswalks can also make pedestrians more visible to drivers. Like daylighting, bumpouts can be implemented in the short term at low cost using paint and plastic flex posts. Bumpouts can also reduce long crossing distances for pedestrians and narrow wide turning radii for motor vehicles, thus creating safer crossings and calming fast-moving traffic. This is especially important along Congress Street, which is a wide street with high volumes of traffic and parked vehicles.

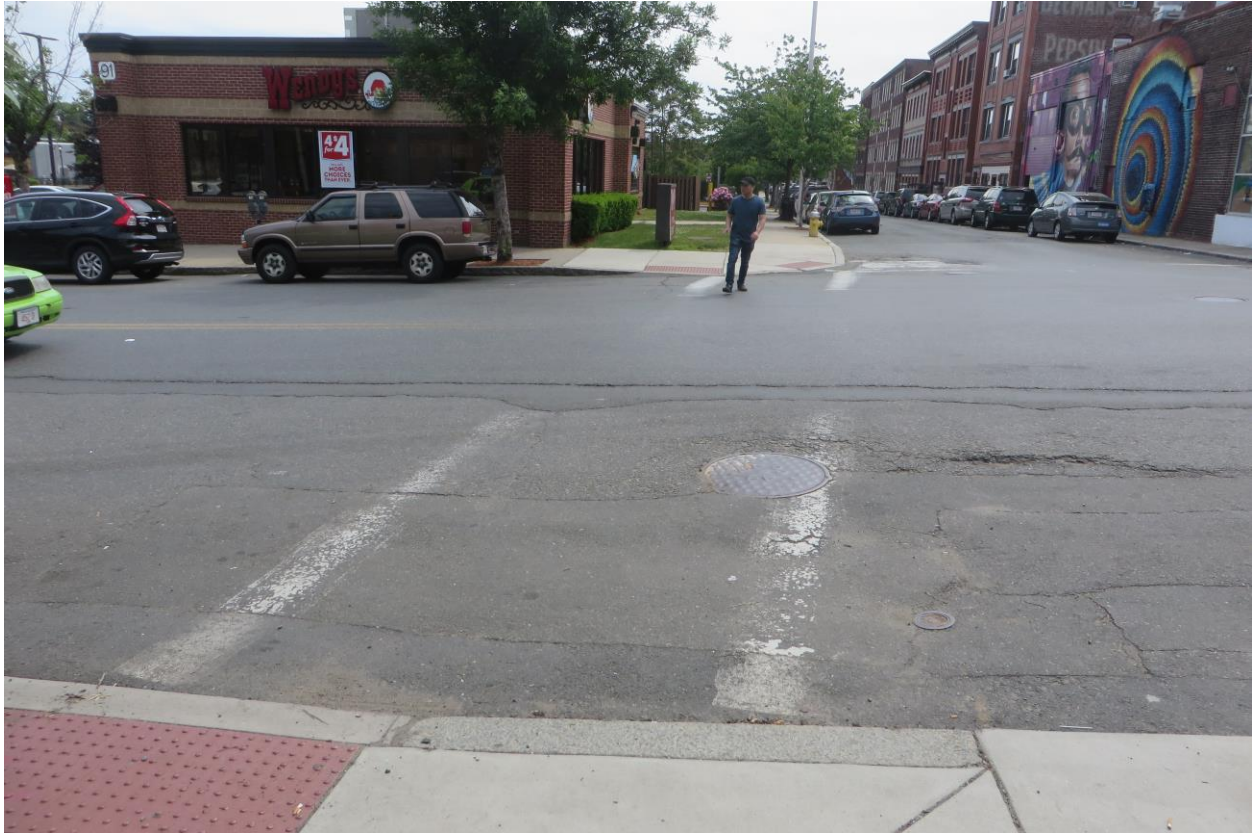
Lafayette Street at Peabody Street

Crosswalks at Lafayette Street and Peabody Street are largely faded and lack a highly visible ladder design.

The crosswalks at Lafayette Street and Peabody Street are largely faded and there is no crosswalk across Lafayette Street to and from the south side of Peabody Street. Walk audit participants suggested that upgrading crosswalks at this location would improve pedestrian safety and support potential placemaking efforts to activate and enliven the alley next to the North Shore Community Development Corporation's office on Washington Street. Walk audit participants also noted the lack of pedestrian access and connectivity to the Harborwalk between the Wendy's and Beverly Bank, even though this is a common desire line for people walking. **Strategies to improve walking safety and connectivity include the following:**

- **Restripe and upgrade crosswalks from two parallel lines to more highly visible ladder designs.**
- **Consider adding a crosswalk with highly visible ladder design across Lafayette Street at the south side of Peabody Street.**
- **Work with Wendy's and Beverly Bank to explore strategies for a marked pedestrian path and wayfinding to connect people to the Harborwalk.**

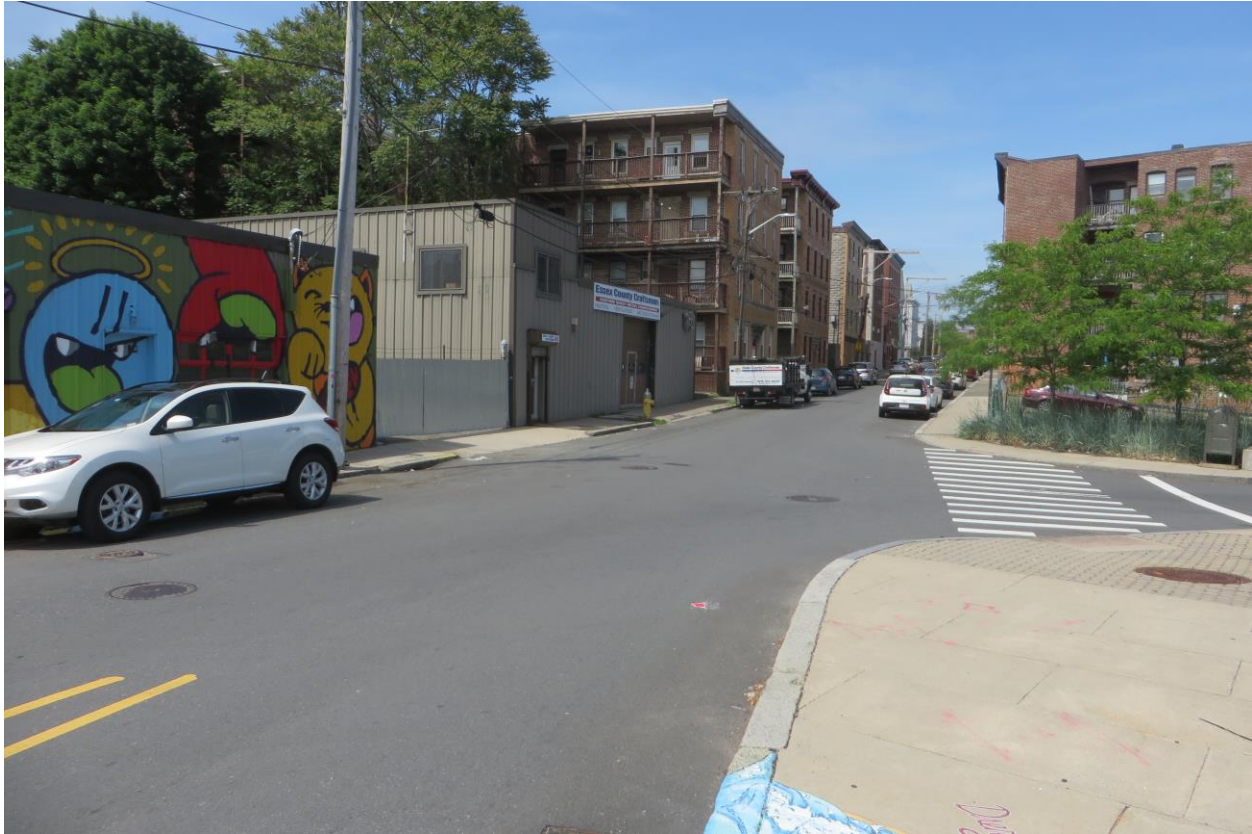
Narrowing the turning radii and extending the double yellow centerline at Peabody Street and Ward Street will create more predictable vehicular movements and calm traffic.

The crosswalk across Peabody Street at Ward Street is relatively long and because of the wide curb radius, drivers turn left from the one-way section of Peabody Street at high speeds without slowing down. In addition, the vehicular travel lanes are not clearly defined on the short two-way section of Peabody Street that connects Ward Street and Congress Street, and as a result drivers turning left from the one-way section of Peabody Street often take the wrong lane. Walk audit participants also noted that the curb ramps at this location are oriented at a 45-degree angle to the crosswalk, which can have the unintended effect of directing people with visual impairments or mobility aides into the middle of the intersection. **Strategies to improve walking safety include the following:**

- **Add bumpouts/curb extensions at the crosswalk across Peabody Street to reduce the long crossing distances, narrow the turning radii and calm traffic.** Bumpouts can be added at low cost in the near term using paint, planters and/or plastic flex posts.
- **Extend the double yellow centerline and add arrows/pavement markings to more clearly delineate vehicular movements on the two-way section of Peabody Street.**
- **Reorient the curb ramps and tactile warning panels at the crosswalk across Peabody Street so that they are directly aligned with the crosswalk.**

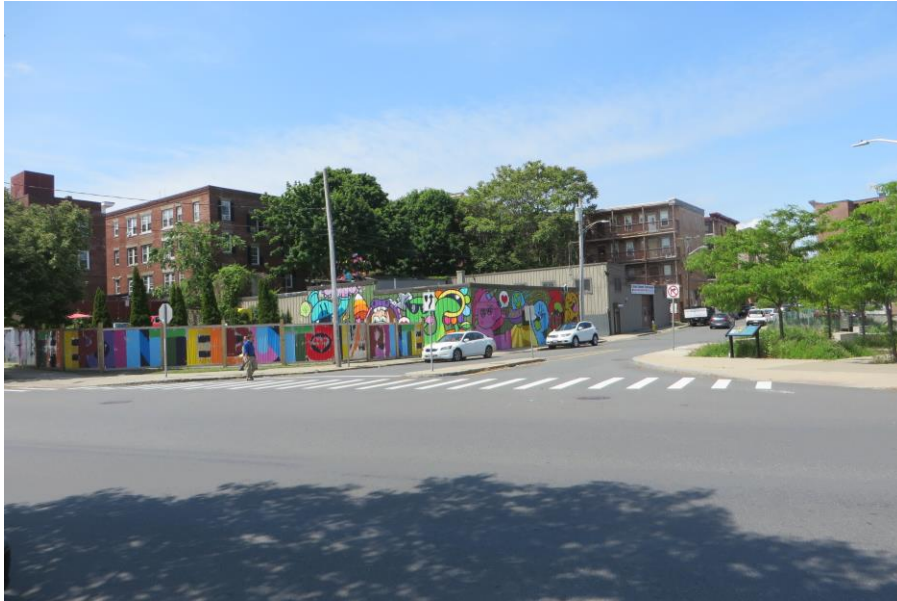
Congress Street at Peabody Street

Long crossing distances and wide turning radii create safety hazards for pedestrians at Congress Street and Peabody Street.

The crosswalks at the intersection of Congress Street and Peabody Street are very long for pedestrians. In addition, the turning radii for motor vehicles at this intersection are very wide. Both these conditions create safety hazards for pedestrians, as they are exposed to vehicular traffic that can take turns without slowing down. In addition vehicles frequently park right next to the crosswalks, thus blocking sightlines for pedestrians and drivers.

Walk audit participants also noted that there are no crosswalks across Congress Street between Peabody Street and Derby Street – a distance of nearly a quarter-mile. In addition to creating potential safety hazards, this dearth of crossing options also limits pedestrian access to the Harborwalk on the west side of Congress Street, just south of the Congress Street Bridge.

- **Add bumpouts/curb extensions at the crosswalks to reduce long crossing distances, narrow turning radii, and improve visibility between pedestrians and drivers.** Bumpouts can be added at low cost in the near term using paint, planters and/or plastic flex posts.

- **Daylight crosswalks to further improve visibility between pedestrians and drivers.** As described above, bumpouts at crosswalks can accomplish this goal. Adding “No Parking” signs near the crosswalks and enforcing the new restrictions and/or physically restricting parking next to the crosswalks using paint, planters and/or flex posts can also improve crosswalk visibility.

- **Consider adding a midblock crosswalk where the Harborwalk meets Congress Street, along with wayfinding signage to let pedestrians know the Harborwalk is there.** This crosswalk should utilize a highly visible ladder design as well as daylighting measures to ensure visibility.

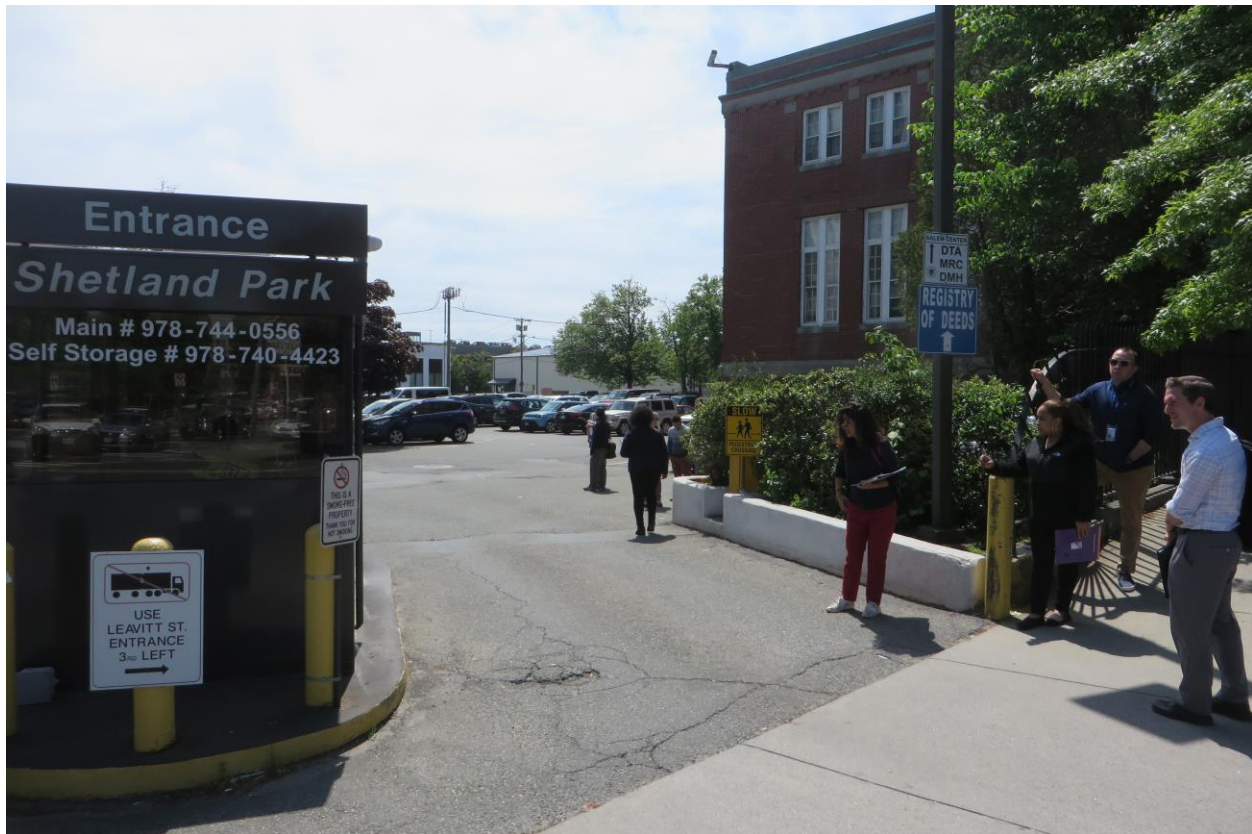
The entrance to the Shetland Park Small Business Center lacks a marked pedestrian path.

Students attending the Salem Academy Charter School on Lynch Street often use the parking lot of the Shetland Park Small Business Center as a pedestrian cut-through to and from Congress Street. While there are marked pedestrian lanes with yellow paint in the business center parking lot, there is no such path at the entrance/exit to the parking lot at Congress Street. Walk audit participants suggested that the City of Salem could work with the business center to create a clearly marked pedestrian path at this location.

At the far end of the parking lot closer to the school, there is a crosswalk with a Rectangular Rapid Flashing Beacon, which is activated when pedestrians push a button to alert drivers to their presence in the crosswalk. Walk audit participants suggested that a similar traffic calming measure could be implemented at the nearby intersection of Lynch Street and Perkins Street. This intersection is immediately adjacent to the school and sees high volumes of students crossing the street.

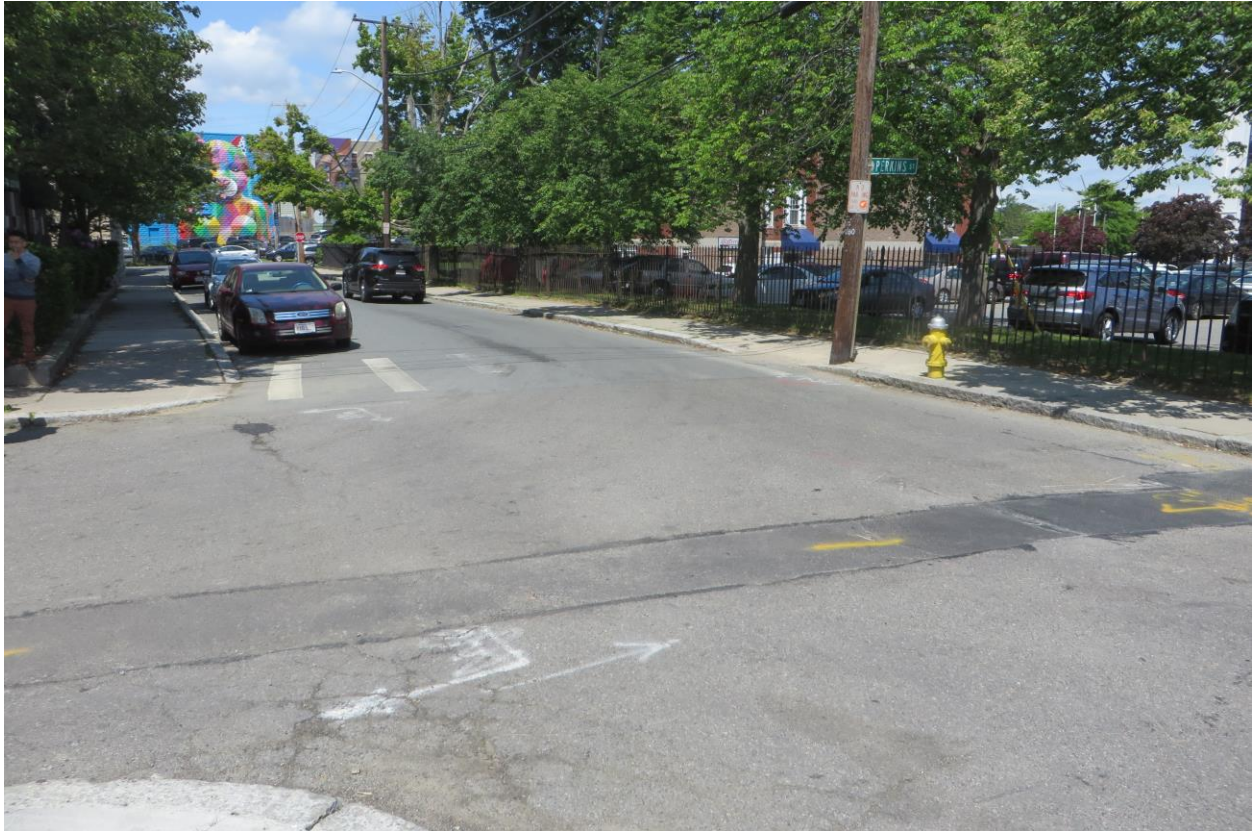
Lynch Street at Perkins Street

Students attending the Salem Academy Charter School often walk through the intersection of Lynch Street and Perkins Street.

The intersection of Lynch Street and Perkins Street is heavily utilized by students walking to and from the nearby Salem Academy Charter School. **Strategies to improve walking safety include the following:**

- **Install STOP signs, STOP lines, and crosswalks with highly visible ladder design at all three legs of the intersection.**
- **Consider the installation of raised crosswalks or a raised intersection (also known as a speed table) to calm traffic and increase pedestrian visibility.**
- **Consider the installation of a flashing light or a pedestrian-activated Rectangular Rapid Flashing Beacon as a traffic calming measure.**

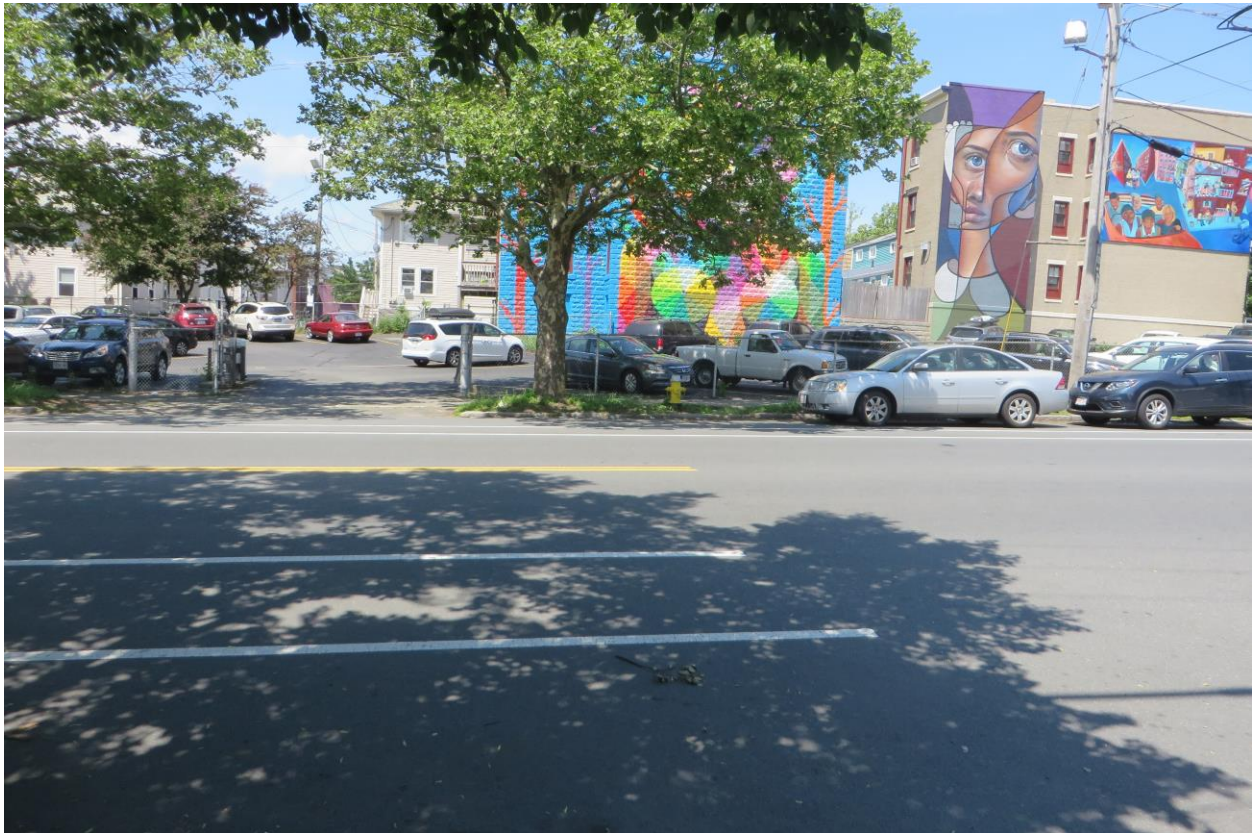
Congress Street at Lynch Street

There is no crosswalk across Congress Street at Lynch Street, even though this is an important pedestrian route for children walking to and from the Salem Academy Charter School on Lynch Street.

The intersection of Congress Street and Lynch Street lacks a marked crosswalk across Lynch Street, even though the ramps for this crosswalk exist (albeit in poor condition and without tactile warning panels for ADA compliance). This intersection also lacks a crosswalk across Congress Street, which presents safety hazards for children walking to and from the Salem Academy Charter School on Lynch Street. **Strategies to improve walking safety include the following:**

- **Add a crosswalk with highly visible ladder design across Lynch Street.**
- **Repair curb ramps and add tactile warning panels for ADA compliance.**
- **Explore the addition of a crosswalk with highly visible ladder design and ADA-compliant curb ramps across Congress Street.** To ensure pedestrian visibility this crosswalk should be installed in tandem with daylighting strategies (installation of “No Parking” signs and enforcement and/or physical parking restrictions using paint, planters and/or flex posts).

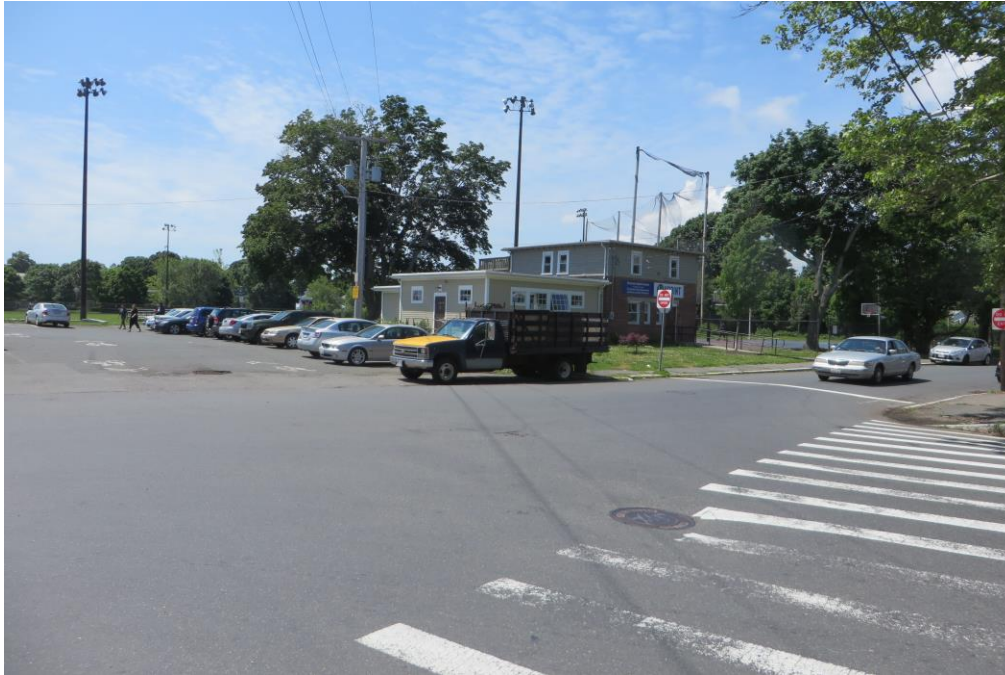
Congress Street at Leavitt Street

Bike and pedestrian access to Palmer Cove Park is inhibited by a lack of crosswalks and paths and the presence of parked vehicles at Santisi's Garage.

The intersection of Congress Street and Leavitt Street is relatively wide, which causes traffic to move at high speeds through the open expanse of pavement. The intersection is also next to Palmer Cove Park, which is popular with local residents for its walking and biking paths, but access to the park from this intersection is dangerous and unattractive. There are no crosswalks across Leavitt Street to the park and parked vehicles at Santisi's Garage present an additional obstacle for people walking and biking.

- **Add bumpouts/curb extensions at the crosswalk across Congress Street to reduce the long crossing distance, narrow turning radii and calm traffic.** Bumpouts can be added at low cost in the near term using paint, planters and/or plastic flex posts.
- **Add crosswalks with highly visible ladder design and ADA-compliant curb ramps across Leavitt Street to create safe pedestrian crossings to Palmer Cove Park.**
- **Add STOP lines and STOP signs on all three legs of the intersection to calm traffic.**
- **Paint a fog line on Leavitt Street to narrow the wide travel lane and calm traffic.**
- **Consider restricting and/or reorienting parking at Santisi's Garage to provide more space for pedestrian and bicycle access to Palmer Cove Park.** Adding and creating wider pedestrian sidewalks and/or dedicated walking and biking paths will create more comfortable and accessible conditions.

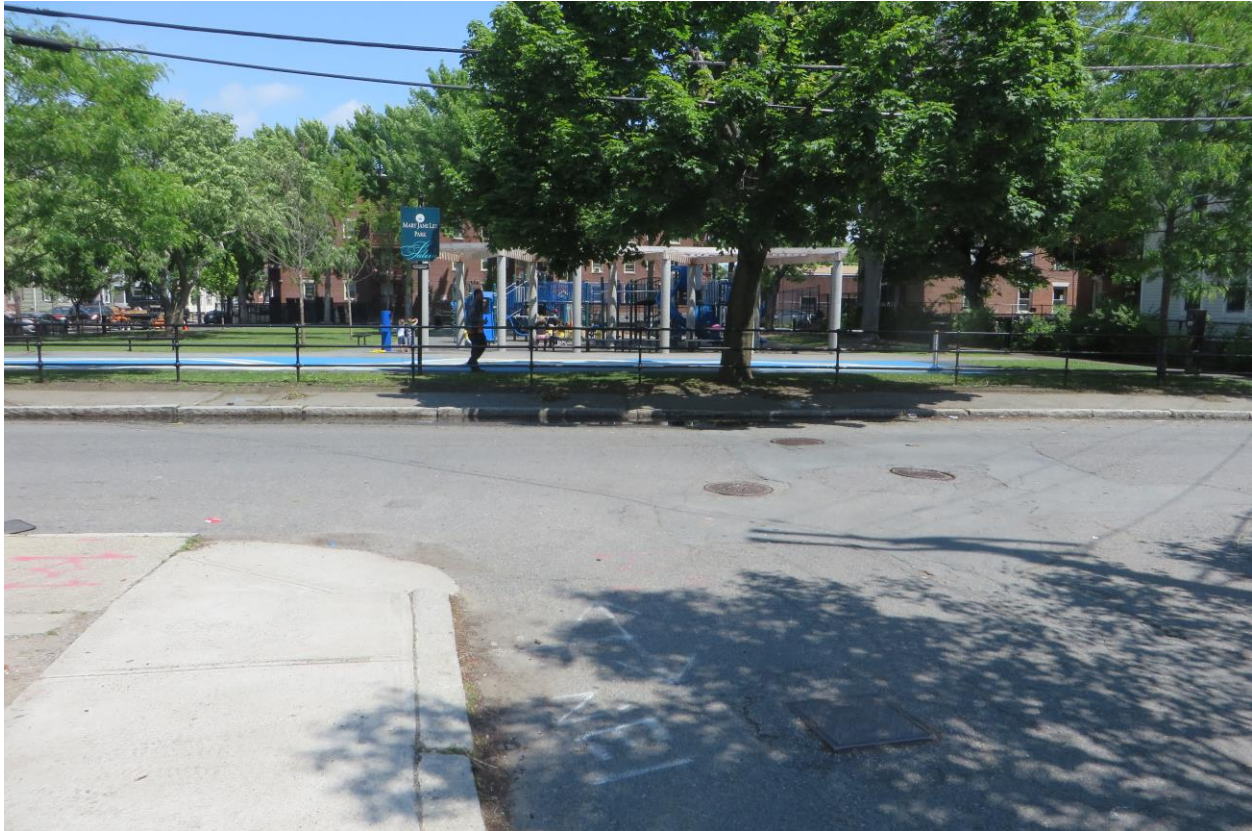
There are no crosswalks in the immediate vicinity of Mary Jane Lee Park, even though this park is heavily utilized by neighborhood residents.

Mary Jane Lee Park sees heavy use from residents of the Point, but there are no crosswalks in the immediate vicinity of the park, even though a number of nearby intersections have pedestrian ramps (some of them recently installed and including ADA-compliant tactile warning strips). **Installation of crosswalks with highly visible ladder design, ADA-compliant curb ramps and appropriate signage should be prioritized at the following locations:**

- **Palmer Street at Congress Street**
- **Palmer Street at Naumkeag Street**
- **Palmer Street at Prince Street**
- **Dow Street at Prince Street**
- **Dow Street at Park Street**
- **Dow Street at Salem Street**

Some walk audit participants also suggested that “SLOW ZONE” and “20 MPH” pavement markings be added as a traffic calming measure on several of these residential streets around the park.

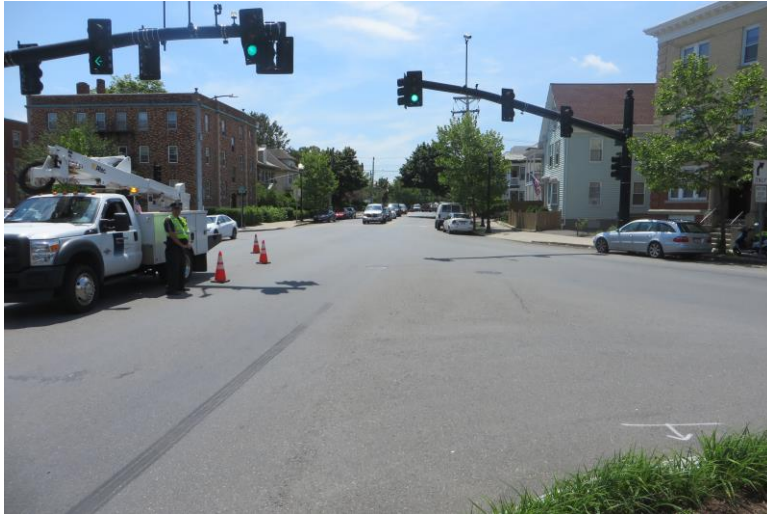
Lafayette Street at Dow Street/Washington Street

Wide expanses of pavement and inadequate pedestrian crossing time present challenges at the intersection of Lafayette Street and Washington Street/Dow Street.

The intersection of Lafayette Street and Washington Street/Dow Street at Lafayette Park presents several challenges for pedestrians. The intersection is very wide and has few pavement markings and as a result traffic movements can be fast and unpredictable. The WALK signal at this location provides a pedestrian countdown, but pedestrians face long waits to get a WALK and the 28 seconds of WALK time currently provided is not enough for pedestrians to get across Lafayette Street, Lafayette Park and Washington Street in their entirety. Several walk audit participants suggested that the installation of adaptive signal technology at this intersection, as well as the nearby intersection of Lafayette Street and Harbor Street, appears to prioritize motor vehicles over people walking. **Strategies to improve walking safety include the following:**

- **Use bumpouts/curb extensions to reduce crossing distances, reclaim excess roadway space and calm traffic.** A curb extension has already been installed on the eastern side of Lafayette Street opposite Lafayette Park. Similar bumpouts/curb extensions could be installed at the crosswalk across Lafayette Street at Dow Street, as well as on the western side of Washington Street opposite Lafayette Park and the southern tip of Lafayette Park. Bumpouts can be added at low cost in the near term using paint, planters and/or plastic flex posts.

- **Add pavement and lane markings to create more predictable motor vehicle movements.**
- **Increase the amount of WALK time provided and consider upgrading the WALK signal to be on automatic recall (no push button required) so pedestrians do not face an inordinate amount of time waiting to cross.**

- **Consider removing the left-turn lane on Lafayette Street southbound.** Some walk audit participants suggested that this lane is unnecessary due to the long setback from Dow Street and low volumes of left-turning traffic. The roadway space freed up can then be reallocated for a pedestrian median or bike lanes.

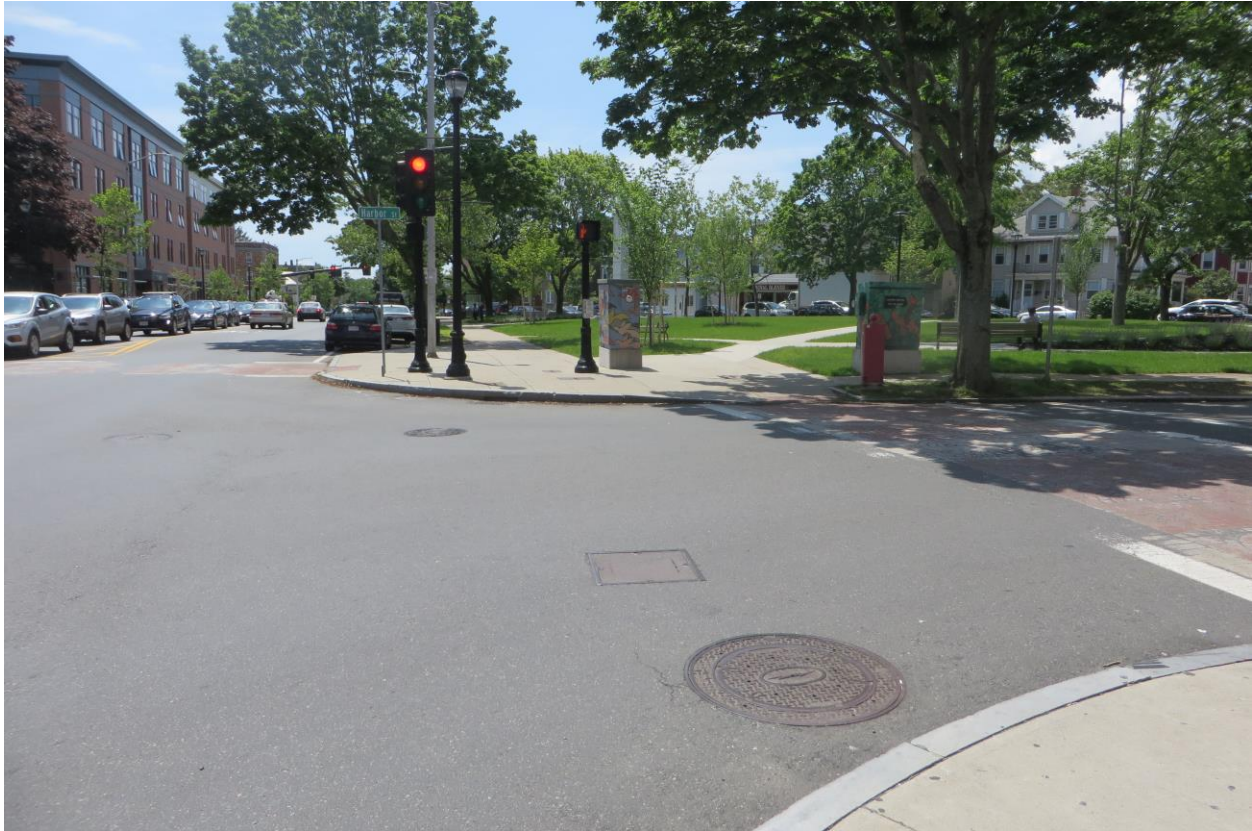
Lafayette Street at Harbor Street

The WALK signal at Lafayette Street and Harbor Street does not provide adequate pedestrian crossing time.

The exclusive phase WALK signal at Lafayette Street and Harbor Street only provides 20 seconds of crossing time, which is not enough time for pedestrians to clear both legs of the intersection. Pedestrians also face long wait times for the WALK signal at this location. **Strategies to improve walking safety include the following:**

- **Increase the amount of WALK time provided and consider upgrading the WALK signal to be on automatic recall (no push button required) so pedestrians do not face an inordinate amount of time waiting to cross.**
- **Consider the implementation of concurrent signalization with a leading pedestrian interval, so that pedestrians cross in the same direction as traffic and get a head-start crossing before motor vehicles begin turning movements.**
