Charlestown Walk Audit, July 19, 2018

Sponsored by Mystic River Watershed Association

Prepared by WalkBoston

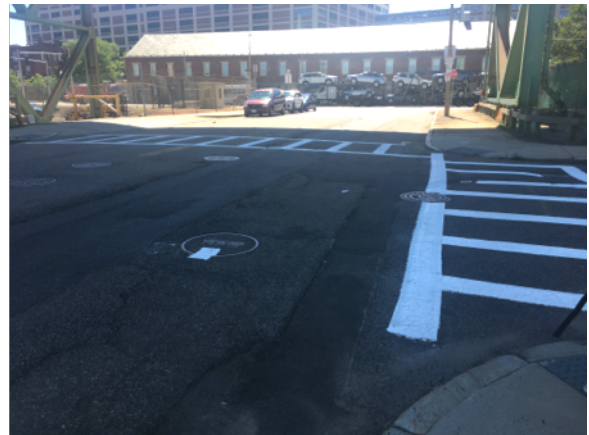
- The noise level is high because of the proximity to the highway.
- The intersection has crosswalks and curb ramps (Figure 1).
- It is not clear how to get to the waterfront from the corner at Medford/Decatur.
- A path to the Harborwalk is located next to Barry Playground.
- The wide turning radius from the parking at [1] serves trucks travelling along Medford St (Figure 1).
- There is no Harborwalk signage at the corner of Chelsea/Medford Street near the parking lot and Barry Field (Figure 2).

Figure1: Crosswalks, curb ramps and turning radii at Medford St. and Decatur St.

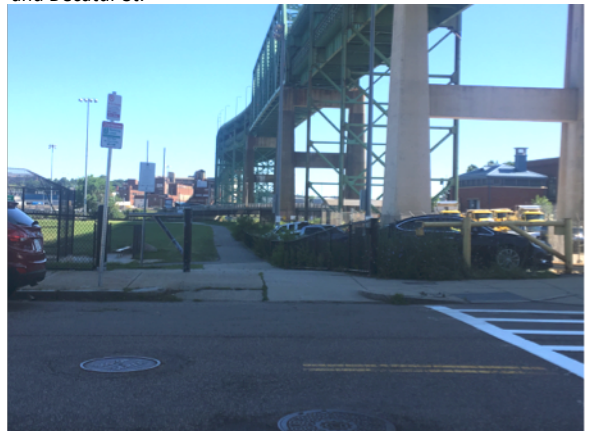
Figure 2: No signage about the Harborwalk at Barry Playground

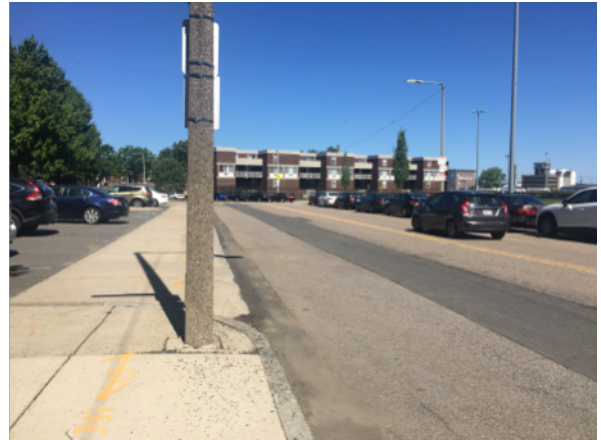
- A continuous driveway curb cut at the parking on the south side of Medford Street makes it uncomfortable to walk on that part of the sidewalk (Figures 3,5)
- Large trash bins on the south side of Medford St. between Decatur Street and Brien Court make an unattractive street edge (Figures 4,5).
- A crosswalk on Medford Street, located between [1] and [2] on the map, connects Barry Playground to the residential area (Figure 5) across Medford Street.

Figure 3: Continuous curb cut on Medford St. close to Decatur

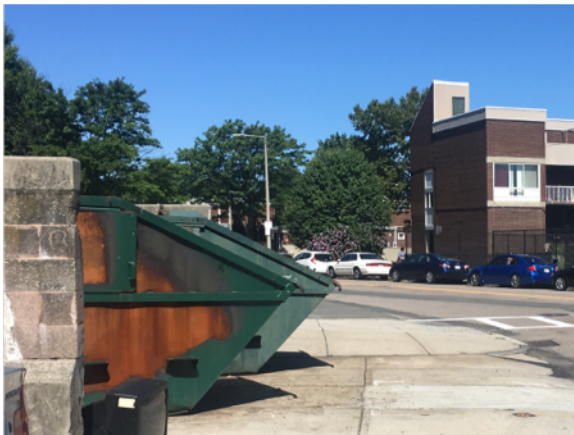
Figure 4: Large open trash bins adjacent to the sidewalk

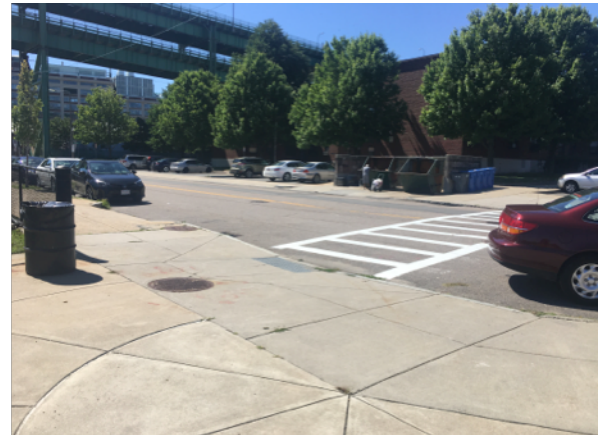
Figure 5: Crosswalk on Medford St at the Playground

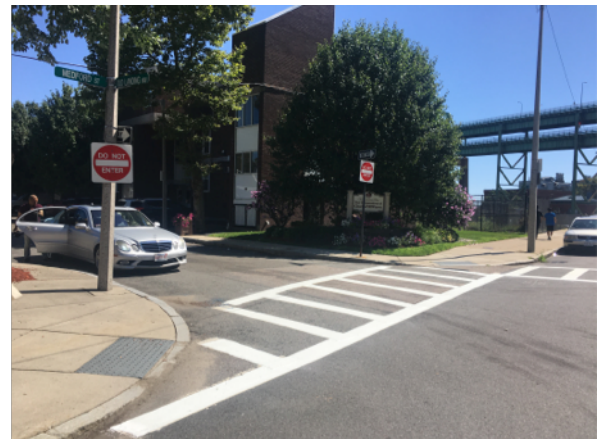
- Crosswalks and curb ramps are on both streets (Figure 6). The wall-like fences of the residential buildings at Old Landing Way block views and create an uninviting street edge on the northern side of Medford Street (Figure 7).
- The Harborwalk lacks shade and the environment along the Little Mystic Channel is not conducive to growing trees. The addition of benches and shade would make this portion of the Harborwalk more comfortable for pedestrians (Figure 8).

Figure 6: Crosswalks and curb ramps on both Medford Street and Old Landing Way

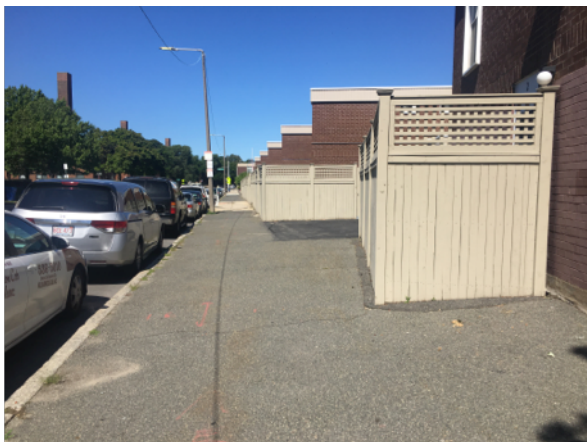
Figure 7: The uninviting walls along the residential complex at Old Landing Way

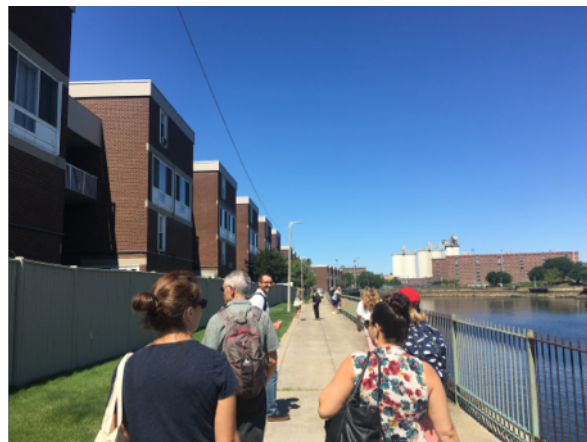
Figure 8: The narrow Harborwalk lacks shade and is very close to the residential buildings

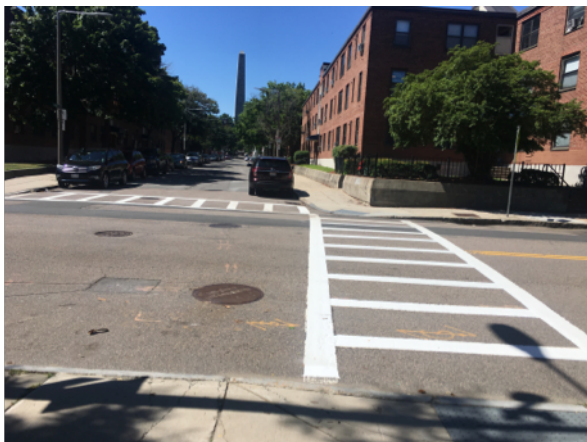
- The intersection has crosswalks and curb ramps (Figure 9).
- Trees in the sport field provide shade and a more attractive walking environment from Monument Street to Polk Street on the north side of Medford Street (Figure10).

Figure 9: Crosswalk and curb ramp at Monument Street and Medford Street

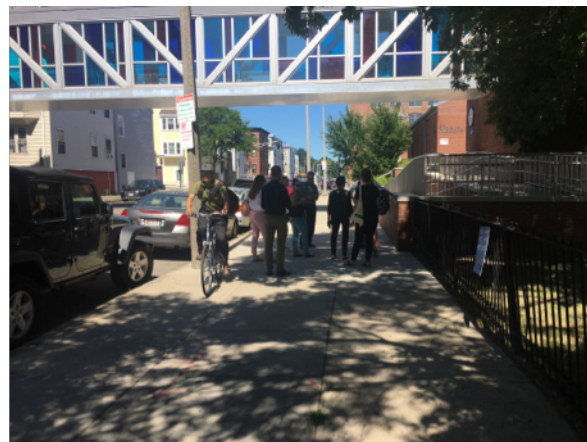
Figure 10: Crosswalk and curb ramp at Polk Street and Medford Street

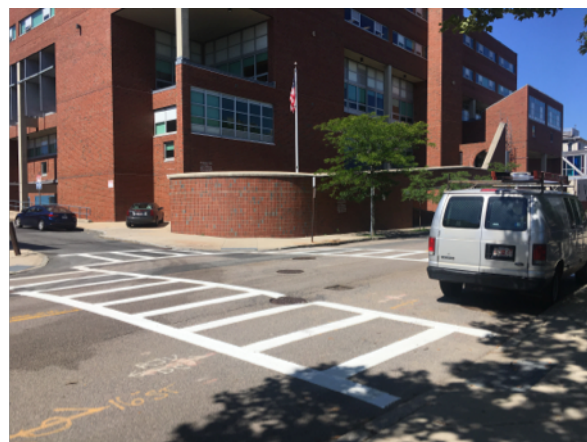
- Crosswalks and curb ramps are on both streets.
- Cars park very close to the crosswalk at Polk Street creating poor visibility at the crosswalk for pedestrians and drivers (Figure11).
- There is a Blue Bikes sign on north side on Medford Street sidewalk between Polk Street and Elm Street. *Does this mean a Blue Bikes station is coming to that spot?*

Figure 11: Crosswalk and curb ramp at Polk Street and Medford Street

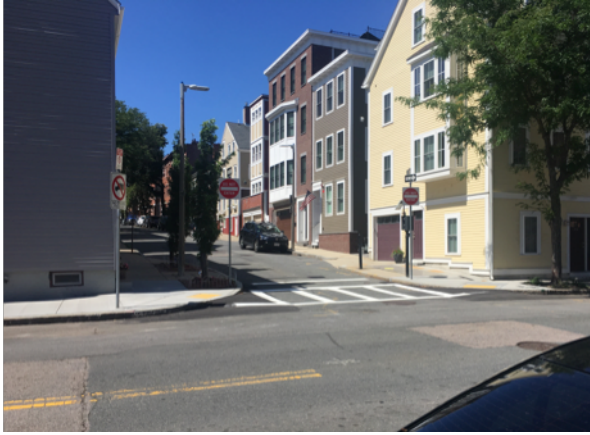
Figure 12: Crosswalk and curb ramp at Elm Street and Medford Street

[5] There are crosswalks and curb ramps at Elm Street and Medford Street intersection (Figure12).

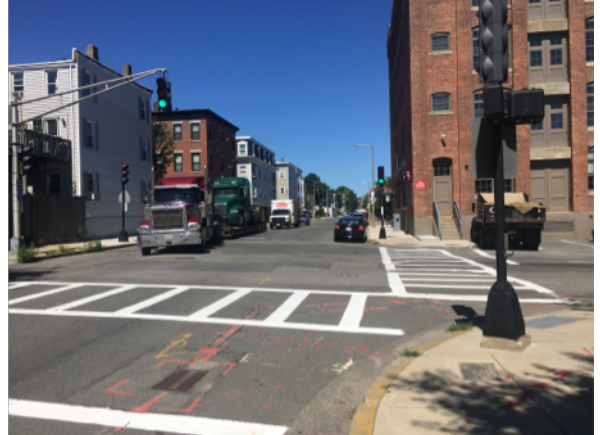
Figure 13: Crosswalks, curb ramps, and signals at Terminal Street and Medford Street

- The traffic signal at Terminal Street and Medford Street has an exclusive pedestrian phase with a 13-second duration WALK plus flashing Don't Walk (Figure 13).
- There is also a school warning sign installed at Terminal Street and Medford Street.
- There are no crosswalks across Mystic Street but there are curb ramps (Figure 14).
- There is a café with tables on the sidewalk on the north side of Medford Street at the corner of Terminal Street and Medford Street (Figure 15).

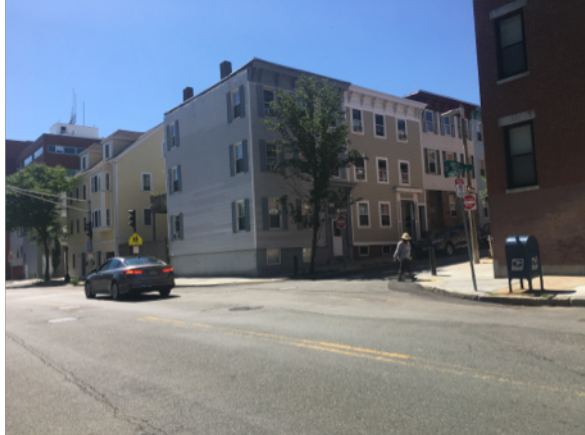
Figure 14: New curb ramps are installed at Mystic Street and Medford Street. There is no crosswalk.

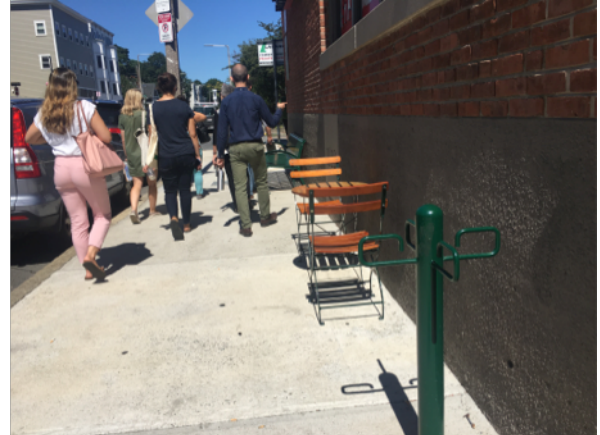
Figure 15: Anna's café table on the sidewalk

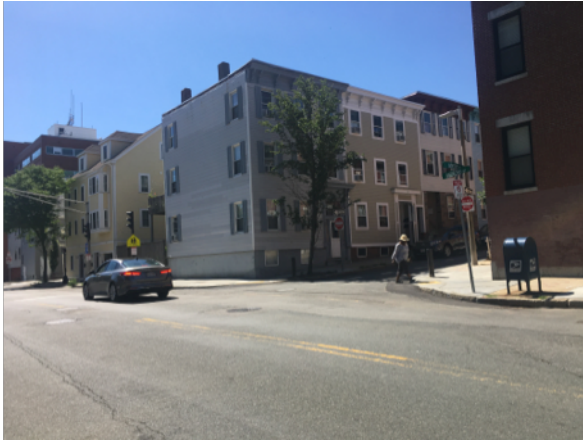
- There are no crosswalks and no curb ramps at the Pearl Street/Medford Street intersection (Figure 16).
- There is only one curb ramp at one side of the Lafarge private roadway and no crosswalk (Figure 17).
- Cars park on the north side of Medford Street and there is a parking lot on the north side of Medford Street at Pearl Street.
- The green buffer and low fencing of the parking lot provides an attractive street edge (Figure 18).

Figure 16: New curb ramps are installed at Pearl Street and Medford Street but no crosswalks

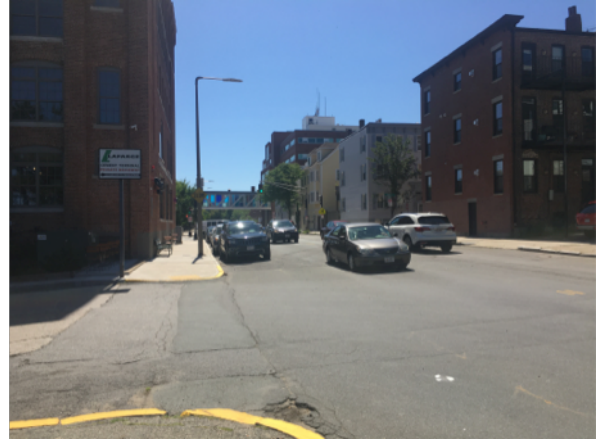
Figure 17: Only one ramp at one side of Lafarge private driveway and no crosswalks

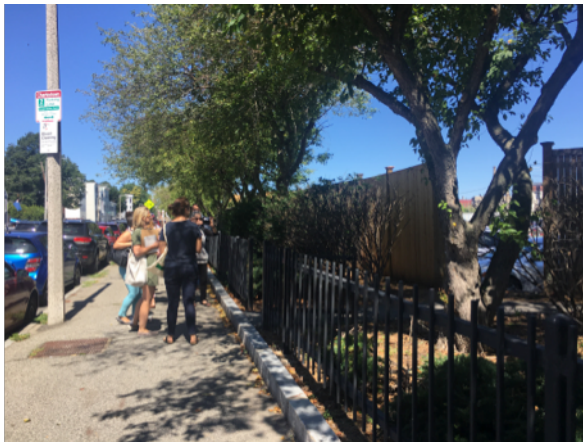
Figure 18: The green buffer and low fences of the parking lot

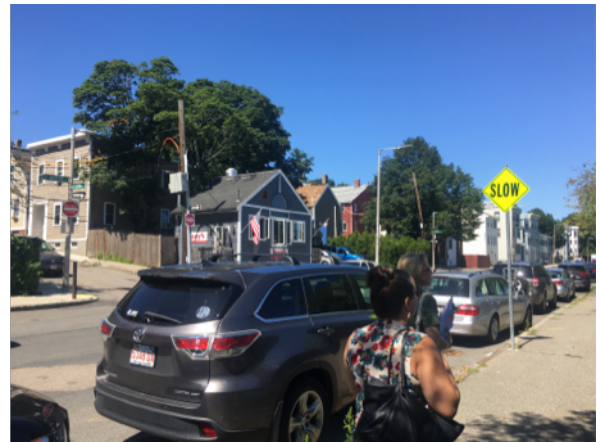
Figure 19: No crosswalk, new curb ramps and a "Slow" sign at Allston Street and Medford Street

- Allston Street has Curb ramps at Medford Street but there are no crosswalks at this intersection.
- There is a "Slow" sign on north side of Medford Street at Allston Street (Figure 19).

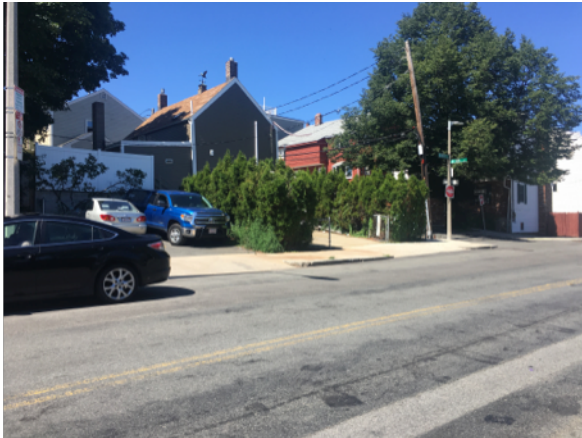
- There is a wide driveway curb cut on the south sidewalk of Medford Street at Cook Street and Allston Street. There are curb ramps on Cook Street, but there aren't any crosswalks (Figure 20).

Figure 20: Wide driveway curb cut between Allston Street and Cook Street. Curb ramps available on Cook Street but no crosswalks

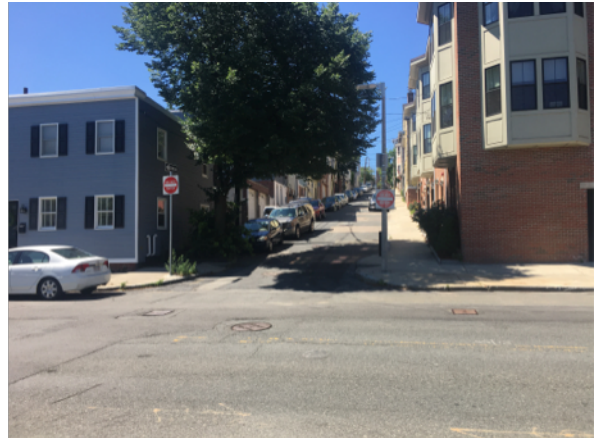
- At Sackville Street and Medford Street, there are curb ramps but no crosswalk (Figure 21).
- There is no stop sign or "yield to pedestrians" sign at the driveway entering Medford Street from the industrial zone, which processes quite a lot of traffic.

Figure 21: Curb ramps but no crosswalks at Sackville Street and Medford Street

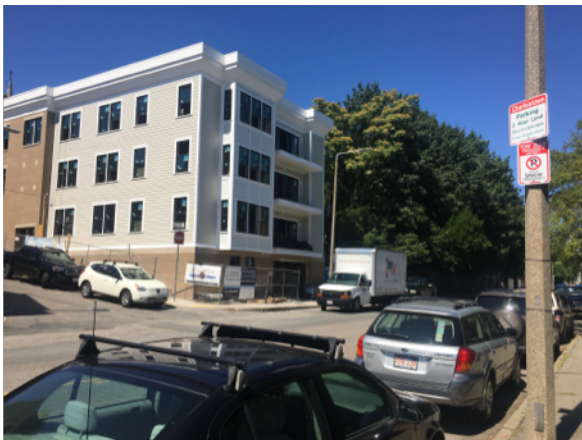
- The Belmont /Medford Street intersection has curb ramps but lacks a crosswalk (Figure 22).
- There is a dog park along the north side of Medford Street between [9] and [10] with a tall chain link fence along the sidewalk.
- There are trees and sidewalk shade along the dog park on the north side of Medford Street (Figure 23).

Figure 22: Curb ramps with warning pads at Belmont Street and Medford Street. No crosswalks

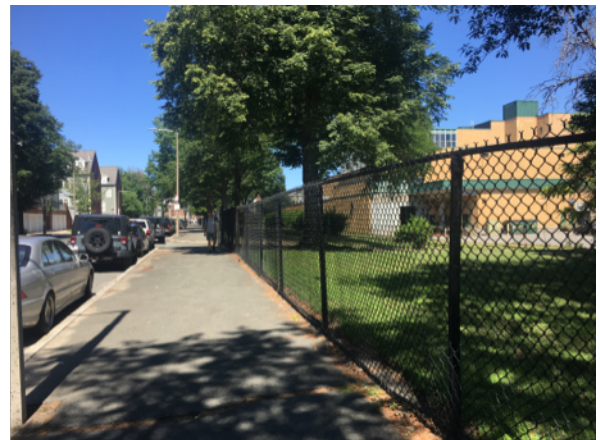
Figure 23: A dog park with tall chain link fence along Medford Street.

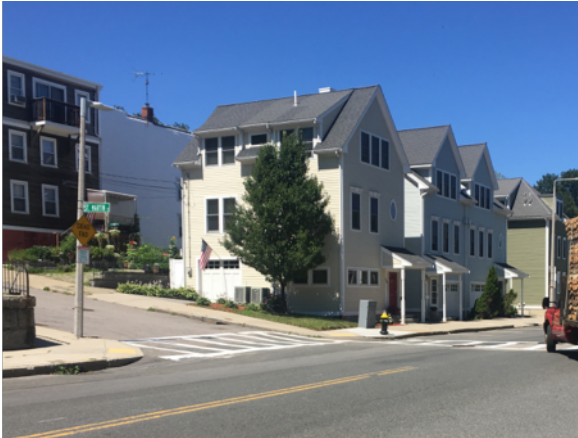
- Crosswalks and curb ramps are provided at the St. Martin Street/Medford Street intersection (Figure 24).
- There are curb ramps and warning pads without a crosswalk at the Schrafft's entrance close to St. Martin Street (Figure 25).

Figure 24: Crosswalks and curb ramps at Saint Martin Street and Medford Street

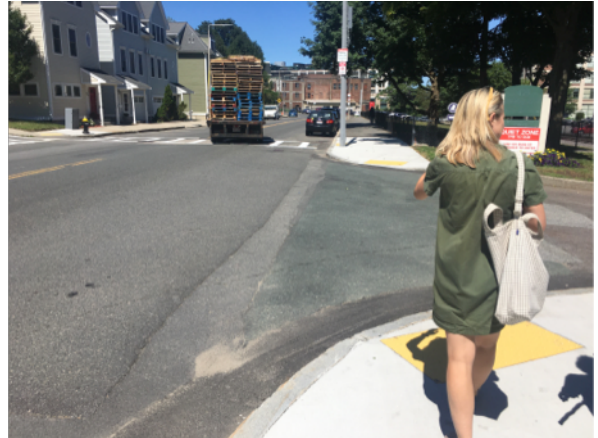
Figure 25: Curb ramps and warning pads at one Schrafft's Company entrance (opposite Saint Martin Street).

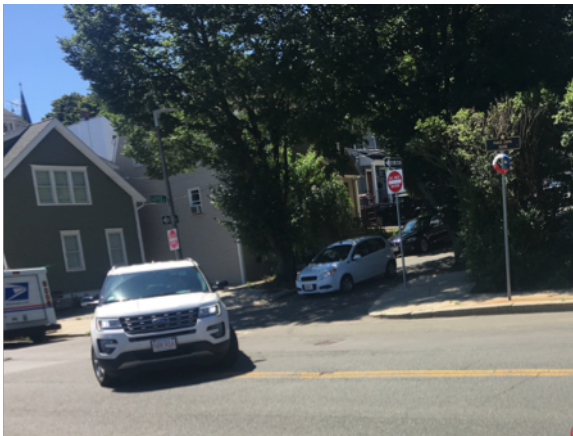
- There are curb ramps but no crosswalks at Chappie Street/Medford Street (Figure 26).
- There are no crosswalks or curb ramps at the Schrafft's complex parking entrance.
- The sidewalk next to Schrafft's Complex on Medford Street is in poor condition (Figure 27).

Figure 26: Curb ramps on Chappie Street at Medford Street but there are no crosswalks

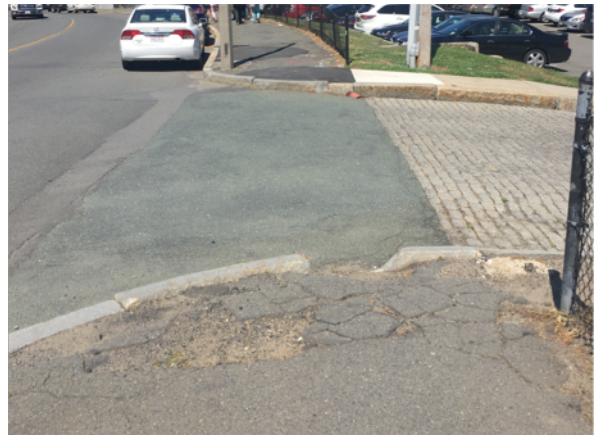
Figure 27: Poor quality sidewalk and a driveway without curb ramps at an entrance of a Flatley company property.

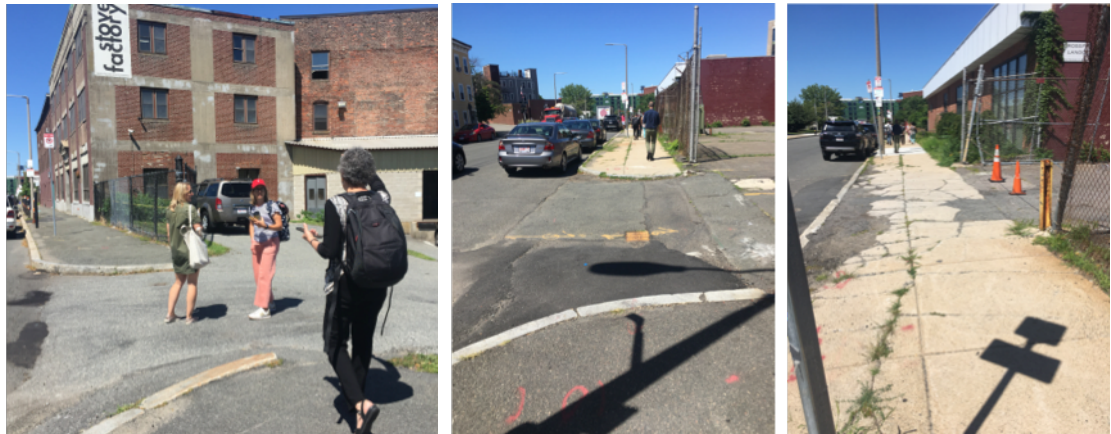
[12] The sidewalk is in poor condition next to the commercial building on the north side of Medford Street in front of the Stove Factory building (Figure 28-a).

- There is also a driveway curb cut to the building's parking lot (Figure 28-b).

Figure 28: Driveways and sidewalks in poor condition without curb ramps at Stove Factory Studios and CrossFit Lando

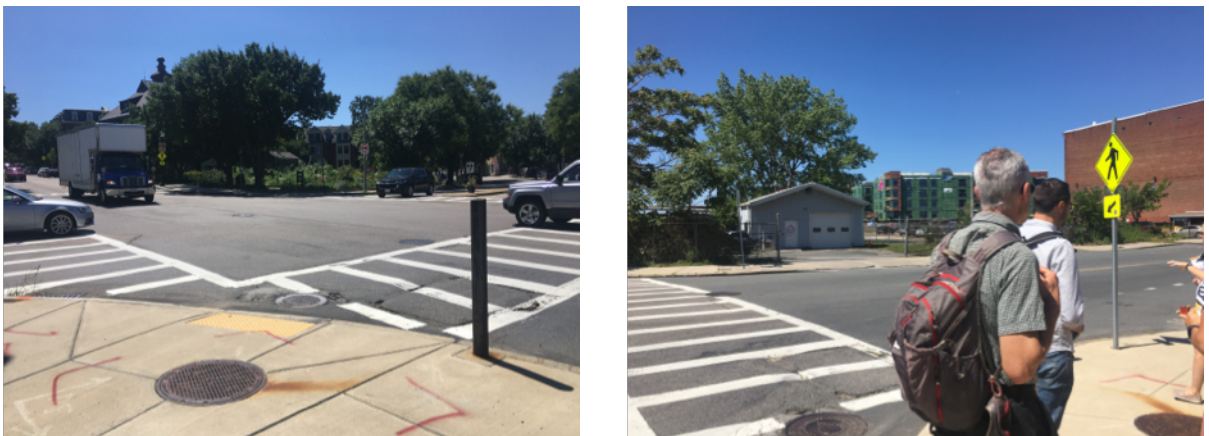
- Crosswalks, curb Ramps, and pedestrian signs are installed at this intersection (Figure 29).

Figure 29: Crosswalks, curb ramps with warning pads and pedestrian sign at Main Street and Medford Street intersection

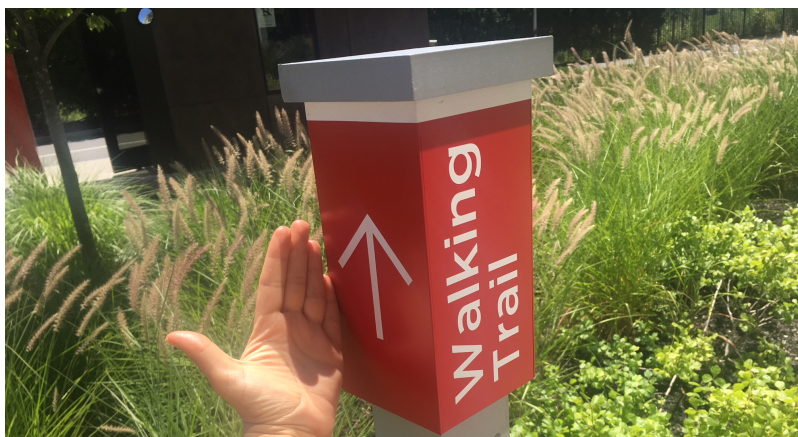
- There is a small walking trail sign pointing to the Harborwalk on Schrafft's campus (Figure 30).
