Age-Friendly Walk Audit - Ware Ware, MA

November 15, 2019

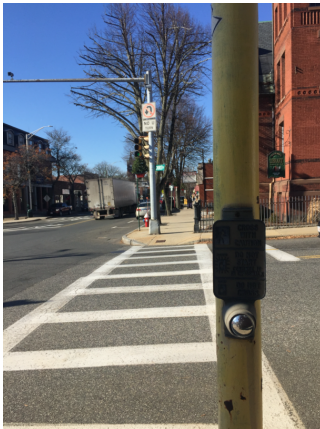
- **Need for signal upgrades:** The pedestrian signals at the signalized intersections were not up to current MUTCD standards. The signal timing did not provide enough WALK time for safe clearance of the crosswalk.

The pedestrian signals on Main St need to be replaced with updated Accessible Pedestrian Signals with countdown WALK signals

Include Accessible Pedestrian Signals (APS) with tactile and audible crossing warnings and countdown WALK signals to the 2024 planned update of the signals on Main Street. Ensure that the signal phasing allows 3.5 feet per second crossing time, or 2.5-3 feet/second walking speed if vulnerable road users (older adults, children, or people with disabilities) frequent the crosswalk.

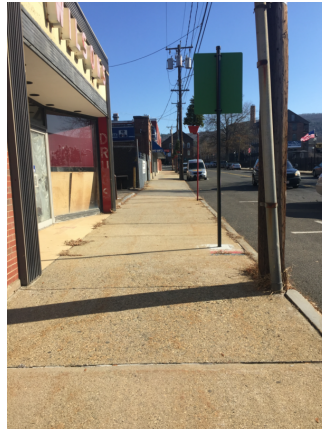
- **Inconsistency of the sidewalk verge:** The separation of people walking on the sidewalk from moving vehicles is missing in some areas and could be improved in others.

The sidewalks are in good condition on Main Street but lack a verge in some places

- **Enhance the sidewalk verge:** Plant street trees in areas with gaps to create a uniform separation of people walking from moving vehicles. Evaluate the installation of tree pit treatments that are

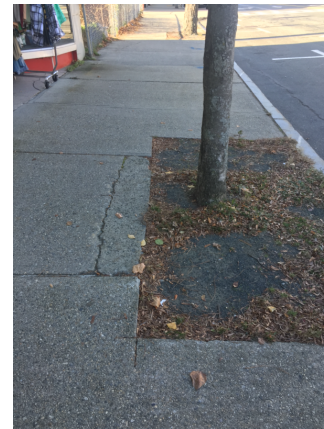
Exposed street tree pits may pose a tripping hazard to older adult pedestrians

contiguous with the level of the sidewalk to prevent tripping hazards.

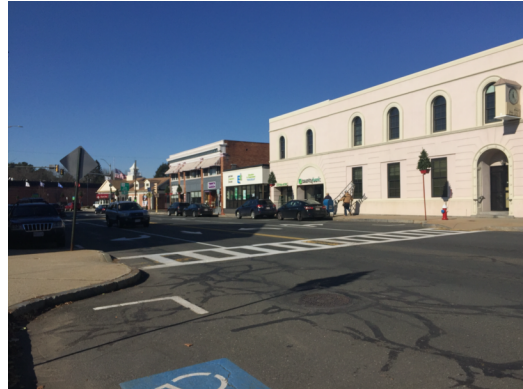
Bumpouts at the Bank Street midblock crossing enhance the visibility of pedestrians and shorten the crossing distance. Adding this feature to other crosswalks on Main Street could further enhance pedestrian safety.

Increase the visibility of the three existing midblock crossings on Main Street with features such as in-crosswalk signage or rectangular rapid flashing beacons (RRFBs). Evaluate adding bump outs (like the ones currently in place at Bank Street) at the crosswalks that do not currently have them to decrease crossing distances and increase pedestrian visibility. Consider parking regulations, such as a no parking zone within 20 feet of a marked crosswalk, to improve visibility.

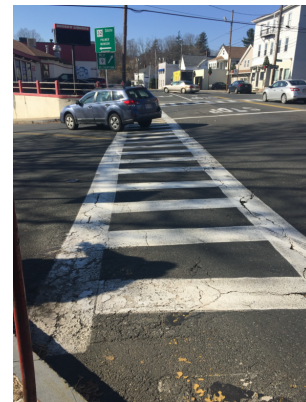
- **Dangerous configuration of the intersection of Route 32 and Main Street:** The skewed alignment of this intersection, vehicular turning movements, and long crosswalk distance across Route 32 in the east-west direction contribute to an unsafe street crossing condition at this intersection.

Poor sight lanes, vehicle turning patterns, and a long crossing distance at the Main Street and SR-32 intersection contribute to an unsafe walking environment in this location

Evaluate the vehicle turning patterns at this intersection and signal phasing to protect pedestrians from high speed turning vehicles. Evaluate re-configuring the alignment of this intersection to tighten the left turn radius from Main Street onto SR-32 to slow speeds and protect people walking in the east-west crosswalk.

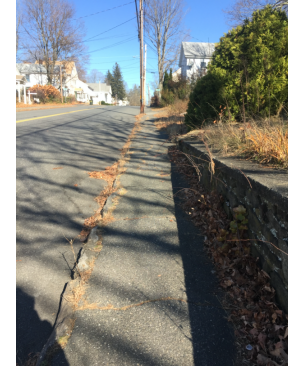
The Church Street sidewalks are narrow and cracked in places

- **Improve sidewalk conditions** in high-priority locations, such as those on Church Street and North Street, which are frequented by vulnerable pedestrians (seniors, children, people with disabilities). Evaluate full replacement of sections in disrepair (on all three streets), widening of Church Street sidewalks on the east side, and trimming of overgrown vegetation.
- **Improve intersection safety and slow vehicle speeds:** Evaluate bringing the North Street and Pleasant Street intersection to a four-way stop. Add advance pedestrian signage at this

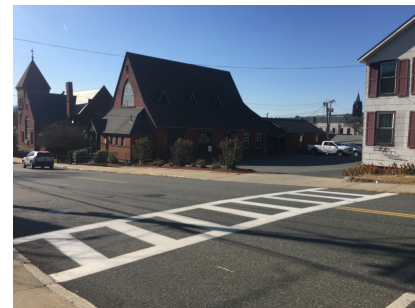
The midblock crosswalk to access the library on Church Street lacks features that make it visible to drivers

- **Evaluate ADA compliance of curb ramps:** Ensure that curb ramps on North Street, Pleasant Street, and Church Street are ADA compliant and accessible by pedestrians of all abilities and ages.
- **Enhance the midblock crossing on Church Street:** Consider adding elements to enhance the visibility (in-street signage or an RRFBs) of pedestrians crossing Church Street at Workshop 13.

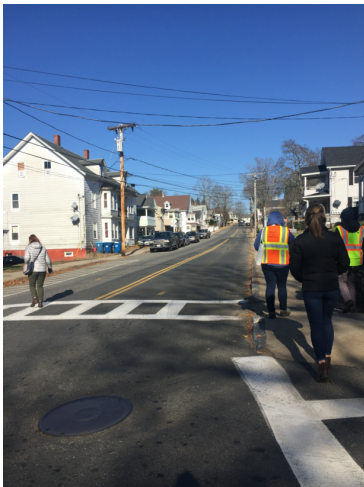
- **Unsafe intersections:** The intersection of North Street and Pleasant Street is a four-approach intersection that has stop signs at the Pleasant Street approaches. The intersection has crosswalks at all approaches. Without stop signs at the North Street approaches, vehicles travel at high speed through this intersection. Furthermore, there is no pedestrian crossing advance signage to signify that people might be crossing the intersection. The intersection of Pleasant and Church Street is a four-approach intersection with a blinking yellow traffic light at the Church Street approaches, and a blinking red light at the Pleasant Street approaches. There are crosswalks at all approaches, which also lack advance signage. High vehicles speeds on Church Street in the downhill, southbound direction is a concern at this intersection. Wide lane widths on Church Street may contribute to high speeds.

The intersection of North St and Pleasant St is traveled at high speeds and lacks advance pedestrian crossing signage

intersection and at the intersection of Pleasant Street and Church Street. Consider placing a speed feedback sign on North Street and on Church Street to slow vehicle speeds and add speed limit signs. If not already adopted, consider adopting a 20 MPH prevailing speed limit on residential streets (“slow zone.”). Consider adding fog lines or other elements to reduce the lane widths on Church Street, North Street, and Pleasant Street to slow vehicle speeds.

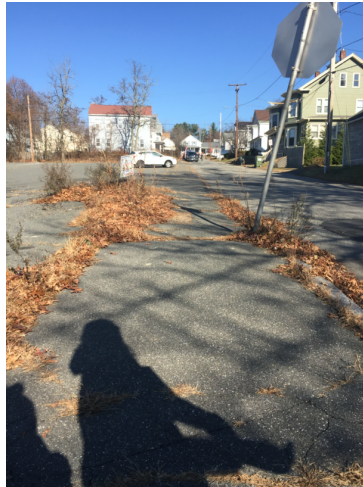
- **Poor sidewalk conditions:** the sidewalks on North Street, Pleasant Street, and Church Street are in varying states of disrepair with cracks and unlevel surfaces creating tripping hazards, broken or nonexistent curb ramps, interruption by utility poles, and overgrown vegetation in places. The Church Street sidewalk conditions are of particular concern, as they provide connectivity to and from senior housing and to the town’s public park.

The sidewalks of the residential neighborhood north of town center are in need of repair and vegetation trimming in places

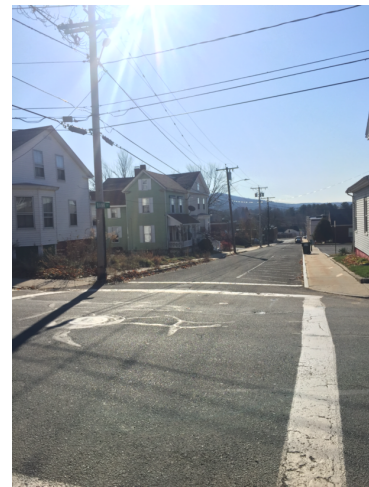
Updating all crosswalks with continental striped paint and advanced pedestrian crossing signage could improve walking safety for neighborhood residents

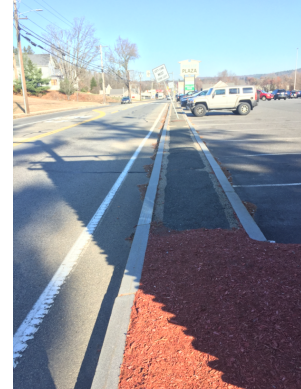
There is no sidewalk along much of the south side of SR-32

- Repair, replace, and install sidewalks on the north and south sides of SR-32:** This is a key sidewalk for connecting the town’s residents with goods and services. Improvements to this sidewalk would create a safer, more comfortable walking environment on this corridor and would provide a walking connection from nearby residential streets and the Council on Aging to downtown Ware. If a resident in Ware’s environmental justice neighborhood were making a walking trip to Phillip’s Shopping Plaza, there would be long stretches without a sidewalk and the trip would require several unmarked, unsafe crossings to access the fragments of sidewalk that are in place on the route. The reality of this fragmented sidewalk trip is highlighted in this map, which indicates sidewalk gaps in red.

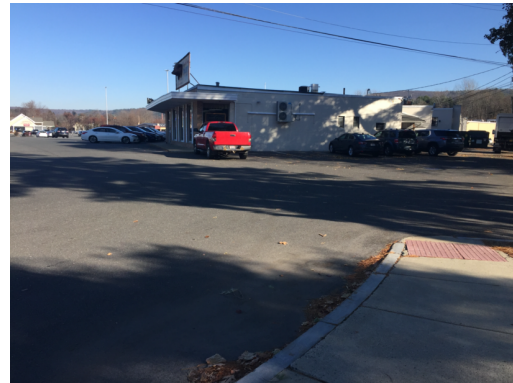
- **Disconnected sidewalk configuration at the Crystal Springs Dairy Barn Driveway:** The sidewalk and curb ramp on the south side of SR-32 dead ends into the parking lot of Crystal Springs Dairy Barn parking lot at the signalized intersection. The sidewalk does not continue on the south side of SR-32 in front of the shopping plaza. There are some resident concerns about the signal pattern at the Dairy Barn driveway entrance onto SR-32, which serves as one of the entrances to the shopping plaza. May consider evaluation of the signal pattern and driveway configuration to improve vehicle traffic and pedestrian conflict at this intersection.

The sidewalk dead ends into a parking lot on the south side of SR-32

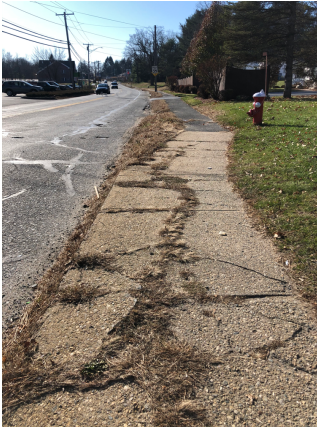
- **Poor sidewalk conditions:** The sidewalk conditions are poor or nonexistent along the SR-32 corridor near the shopping plaza and between town center and the shopping plaza. The sidewalk is too narrow to be passible in a wheelchair in sections, interrupted by utility poles, and broken and uneven in many segments. The sidewalk is nonexistent for stretches of SR-32, and there are no safe crossings to get to the other side of the street to use the existing sidewalk when it ends.

The sidewalks of SR-32 are cracked and impassible in places

- **Improve sidewalk conditions:** Ensure that the sidewalk network is accessible to pedestrians of all ages and abilities. Work towards establishing a complete sidewalk network that runs along both sides of SR-32 and provides connectivity to other town destinations (Main Street, residential streets, Council on Aging, churches, etc.).

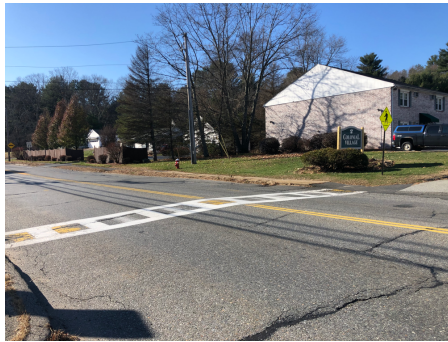
- **Need for safety improvements at the midblock crossing on SR-32 near Colonial Village Apartments.** There are no elements to enhance the visibility of the unsignalized midblock crossing at Colonial Village Apartments on SR-32 and the curb ramps are inaccessible at this intersection. This crosswalk is heavily utilized by residents in this apartment complex, which includes many older adults. Given the curve south of the crosswalk on SR-32, visibility of people in the crosswalk for drivers traveling northbound on SR-32 may be compromised. The location of this crosswalk should be evaluated for sight distance.

The safety of the midblock crossing at Colonial Village apartments could be enhanced with an RRFB

- Improve the visibility of the midblock crossing on SR-32 near Colonial Village Apartments:** Given that vulnerable road users utilize this crosswalk and that vehicles travel at high speeds on SR-32, evaluate adding an RRFB at this intersection that is motion-activated (not push-button activated alone). Add advance pedestrian crossing signage for this crossing. Given the road geometry at this location, may consider moving this crosswalk northward for better lines of sight to improve pedestrian visibility.
- Ensure that the south-side sidewalk does not strand pedestrians and people in wheelchairs in the parking lot:** Continue the south-side sidewalk in front of the length of the shopping plaza to create safer accessibility for people walking.

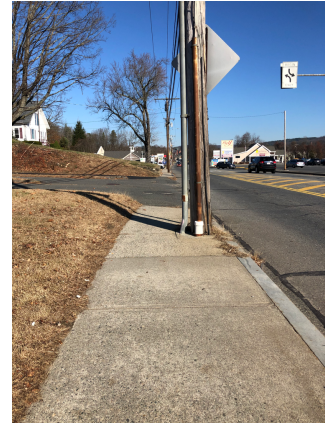
Utility poles narrow the width of the sidewalk, making it difficult to navigate for persons in wheelchairs
