Walk Assessment Brockton, MA

October 21, 2014

Massachusetts Department of Transportation
Bicycle and Pedestrian Safety Program

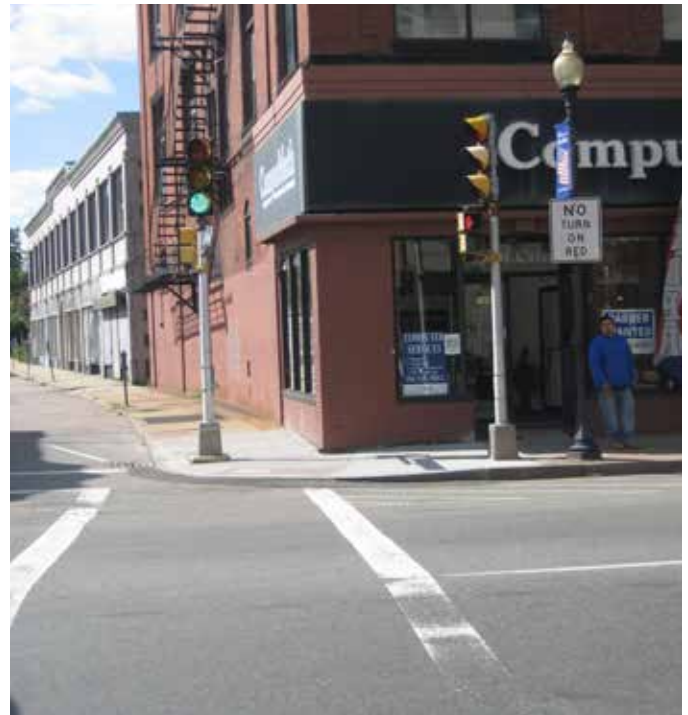
The pedestrian signal head is not lined up with the crosswalk entrance on N Main Street

- Pedestrian signal indication is not lined up with crosswalk entrance; adjacent to crosswalk, but easy to miss
- Exclusive pedestrian phase on traffic signal; wait time seems long given one-way traffic pattern; not a countdown signal
- Crosswalk pavement markings were minimal; may be temporary given that construction project is still underway
- Travel lanes are wide and crossing distances are relatively long

- Determine if pedestrian signal head could be rotated or moved to pole visible at crosswalk entrance
- Evaluate signal phasing to determine if a concurrent phase is possible and if the pedestrian crossing time is sufficient. Before switching to a concurrent phase, evaluate the red light running frequency, clearance and change interval, and crash data to be sure motorists typically comply with the existing signal. Add leading pedestrian indicator (LPI) with concurrent phase, if appropriate
- Enhance pavement markings with a ladder design, or stamped colored asphalt

- Install curb bump-outs to better define parking zones, narrow travel lanes and shorten crossing distances; long-term fix given recent curb ramp upgrades

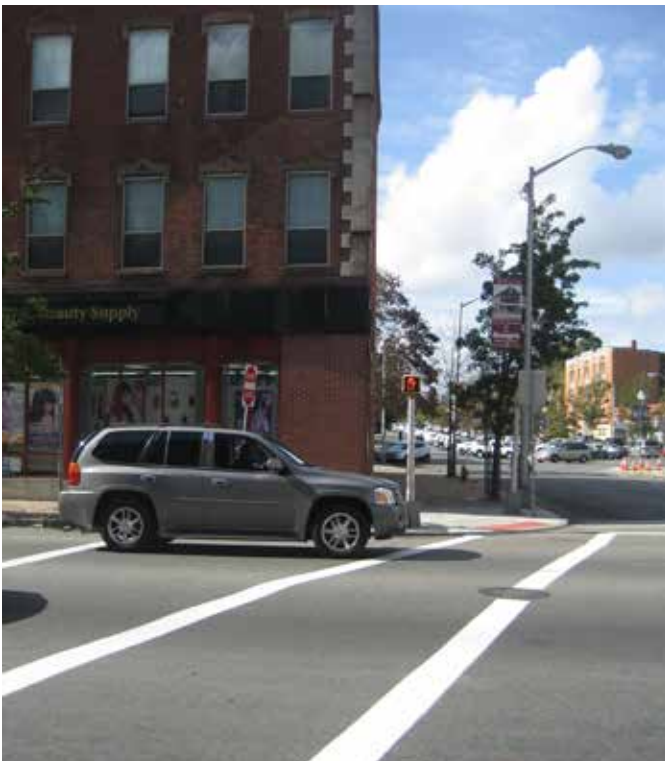
- Multiple pedestrian push buttons and traffic control equipment on the east side of Main Street intersection; the older of the two pedestrian push buttons continues to control pedestrian phase; could be due to construction in progress
- Crossing time is not sufficient when crossing Legion Parkway, unless intersection is timed as a 2-phase crossing; if 2-phase crossing, there is no pedestrian push button in the median
- Median in Legion Parkway is being used as a pedestrian refuge island, but does not provide adequate protection

- Pedestrian traffic signal is not a countdown signal
- Crosswalk pavement markings are minimal; may be temporary given that construction project is still underway
- Travel lanes are wide and crossing distances are relatively long; particularly across Legion Parkway

There are two pedestrian push buttons at this location; only one of which controls the signal

- Remove one of the two pedestrian push-button to eliminate confusion around which button controls the signal
- Evaluate signal phasing to determine if a concurrent phase is possible and if the pedestrian crossing time is sufficient, particularly across Legion Parkway. Pedestrians cross the entire width of Legion Parkway in one phase and the crossing time should reflect this practice. Before switching to a concurrent phase, evaluate the red light running frequency, clearance and change interval, and crash data to be sure motorists typically comply with the existing signal. Add leading pedestrian indicator (LPI) with concurrent phase, if appropriate

- Redesign median to work as a pedestrian refuge island to protect pedestrians who get stuck in roadway; install pedestrian push button to facilitate a protected crossing from the island

- Install pedestrian countdown signal
- Enhance pavement markings with a ladder design, or stamped colored asphalt
- Install curb bump-outs to better define parking zones and bus stops, narrow travel lanes and shorten crossing distances

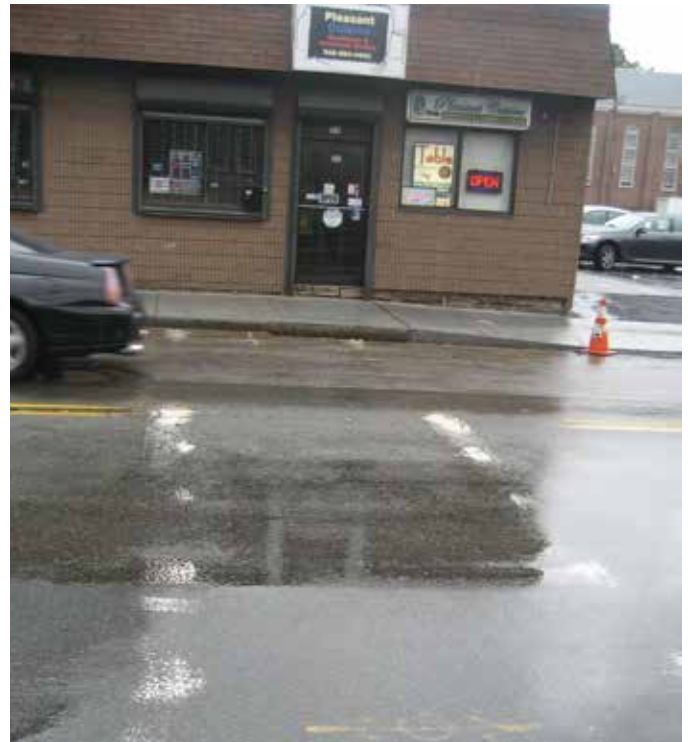
Unprotected mid-block crossing on Pleasant Street

- Mid-block crossing in front of the Mt. Moriah Baptist Church has no curb ramps, detectable warning strips, or pedestrian crossing signage
- Only one marked crossing on Pleasant Street between Main and Warren
- Crosswalks at intersections and mid-block are faded

- Evaluate the safety of the mid-block crossing at the Baptist Church; if appropriate, install ADA-compliant curb ramps, detectable warning strips, and pedestrian crossing signage
- Consider another marked crossing on Pleasant Street; both to provide another recognized crossing point for pedestrians and to increase driver awareness of operating speeds by providing more “visual friction” along the roadway. Visual friction includes signage, landscape elements or other horizontal or vertical features in the roadway that encourage drivers to check their speeds
- Re-stripe crosswalks

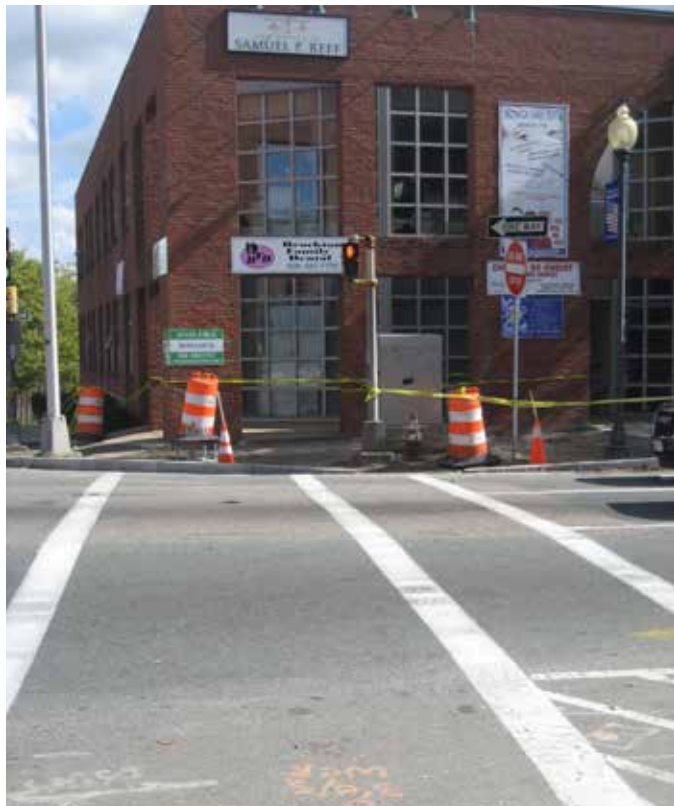
- No accommodations for pedestrians during sidewalk construction; forced into the street at the intersection
- Travel lanes seem wide
- Parking is sporadic and undifferentiated
- Crosswalks are minimal
- Signal phasing is exclusive for pedestrians

Lack of pedestrian accommodations during construction at the intersection of Main Street and Pleasant Street

- Enforce a requirement to provide accommodations for pedestrians during sidewalk construction on all projects within the City of Brockton
- Delineate travel lane (10.5’-11’) on Pleasant Street with an edge line; current edge line provides for wider travel lane
- Regularize and delineate parking zones on Pleasant Street
- Enhance pavement markings with a ladder design, or stamped colored asphalt
- Evaluate signal phasing to determine if a concurrent phase is possible and if the pedestrian crossing time is sufficient. Before switching to a concurrent phase, evaluate the red light running frequency, clearance and change interval, and crash data to be sure motorists typically comply with the existing signal. Add leading pedestrian indicator (LPI) with concurrent phase, if appropriate

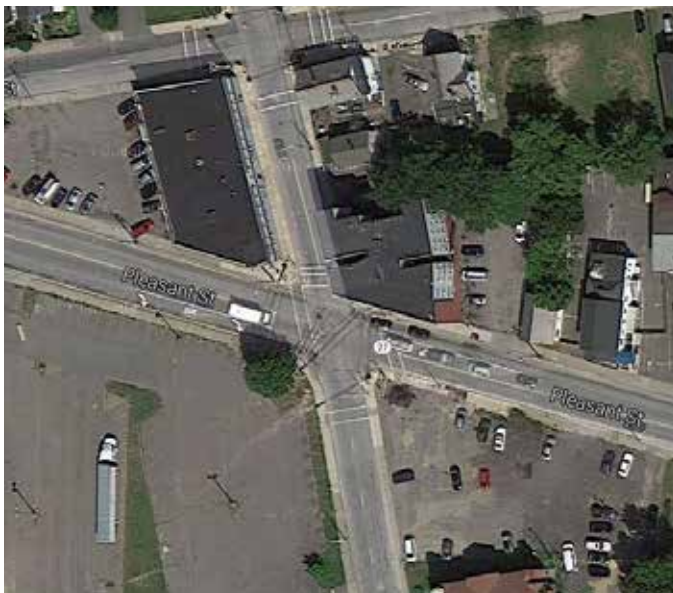
This intersection is irregular as Warren Avenue crosses Pleasant Street at an angle. The angles create long crossing distances across Pleasant Street and complicate the location of a crosswalk in relationship to the traffic signal. The sidewalks, curb ramps and traffic signals at and near the Pleasant/Warren intersection were replaced in the summer of 2014 – within the timeframe of this assessment. The final pavement markings were not yet in place at the time of the assessment.

The intersection geometries were not changed during the sidewalk replacement project, but the location of the curb ramps did change. The ramps were moved away from the intersection and placed on the tangent to the curve along each curb. These locations shorten crossing distances and provide a straight path from one sidewalk to the next. However, the crosswalks and ramps are outside pedestrian desire lines; in some cases, the crosswalk is back so far from the intersection that pedestrians may not walk within the crosswalk and cars may stop beyond the stop line and block the crossing.

Pleasant Street and Warren Street intersection geometry creates complicated crossing issues

- Crosswalks and curb ramps are outside pedestrian desire lines
- No countdown pedestrian traffic signals
- Traffic signal is exclusive for pedestrians despite one-way traffic on Warren Street
- Grocery store is a major change in land use and will alter pedestrian patterns

- Re-evaluate curb ramp and crosswalk locations to maximize pedestrian compliance with traffic signals while meeting ADA requirements
- Replace pedestrian traffic signal equipment with countdown signals. Evaluate signal phasing to determine if a concurrent phase is possible and if the pedestrian crossing time is sufficient. Before switching to a concurrent phase, evaluate the red light running frequency, clearance and change interval, and crash data to be sure motorists typically comply with the existing signal. Add leading pedestrian indicator (LPI) with concurrent phase, if appropriate
- Evaluate bus stop locations in conjunction with grocery store site plan and coordinate pathways to the store with bus stops to serve public transit users
- Study the pedestrian patterns around the new grocery store once completed, and alter the pathways to improve pedestrian safety, if needed

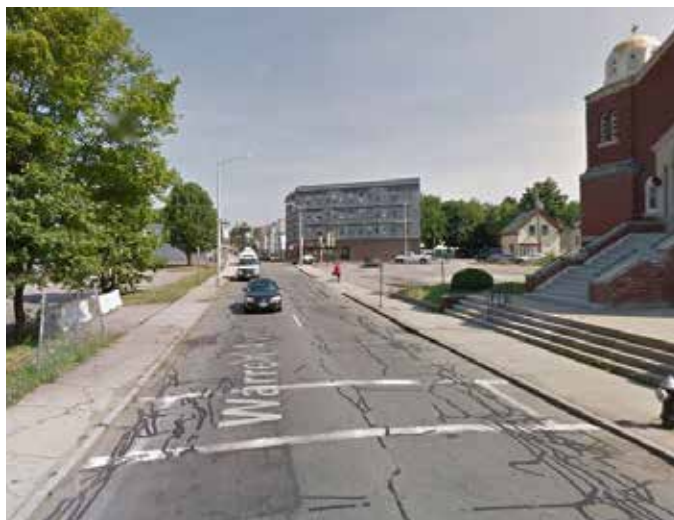
- Mid-block crosswalk has no curb ramps, pedestrian crossing signs or tactile warning panels
- Sidewalks are poorly maintained; vegetation is overgrown

Mid-block crosswalk on Warren Street may not be in the appropriate location

- Evaluate the current location of the mid-block crosswalk in conjunction with the planned grocery store site plan. If appropriately located, install curb ramps, pedestrian signage, and tactile warning strips to make this crossing ADA compliant
- Upgrade sidewalks on both sides of Warren Avenue to promote walking to the new grocery store
- Work with the service station owners to reduce the width of the curb cuts to improve sidewalk network

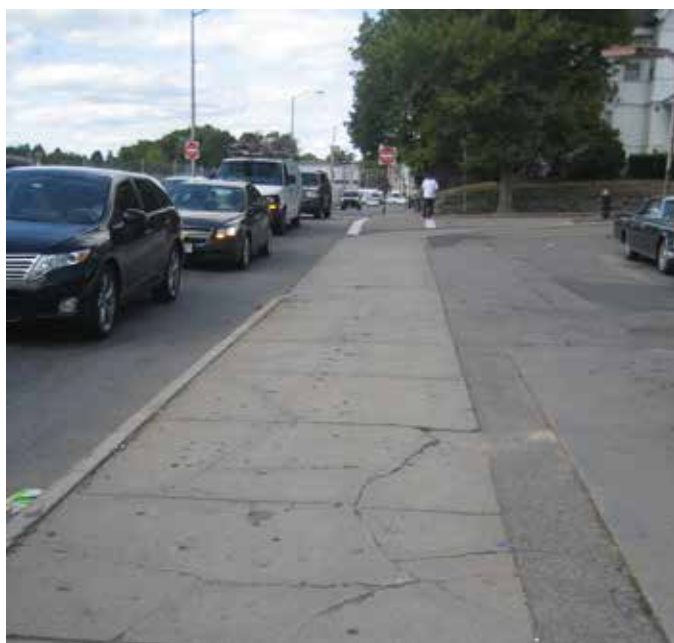
- Service stations on both sides of the Green Street intersection have extensive curb cuts which compromise the safety of the sidewalks

Wide curb cuts along Warren Street compromise sidewalks

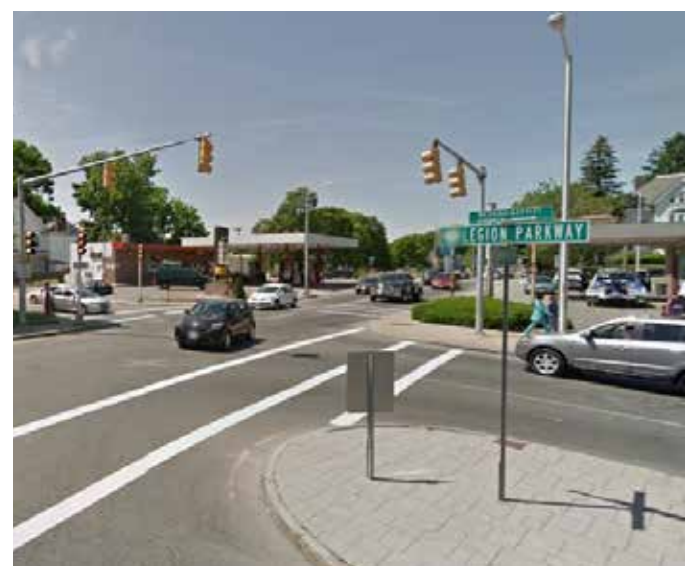
- No protected crossing for pedestrians in any direction at the Warren Ave/Legion Pkwy intersection; no pedestrian signal heads and no pedestrian phase
- Long crossing distances particularly across the Legion Parkway – the equivalent of six lanes of traffic
- Limited lane definition on both eastbound and westbound lanes on Legion Parkway; promotes faster turning movements and allows drivers to interpret the number of acceptable travel lanes
- The northeast and southeast corners of Legion Parkway are occupied by service stations with wide curb cuts, which compromise the pedestrian zone. Pedestrians must watch for oncoming traffic, turning traffic and motorists leaving the service stations
- The median functions as a pedestrian refuge island, but was not designed for this purpose; the median is not ADA-compliant
- No tactile warning panels on the curb ramps

Legion Parkway and Warren Street intersection has no pedestrian crossing phase

- Upgrade traffic signal equipment and install pedestrian countdown signals. Include a pedestrian phase that is long enough to allow pedestrians to cross the entire distance across Legion Parkway
- Consider installing curb extensions across Legion Parkway to shorten the crossing distance
- Use pavement markings to improve lane definition and narrow wide travel lanes
- Work with the service station owners to reduce the width of the curb ramps to minimize the number of entrances pedestrians need to scrutinize before crossing the street
- Redesign median to function as an effective, ADA-compliant pedestrian refuge island
- Install tactile warning panels on all curb ramps

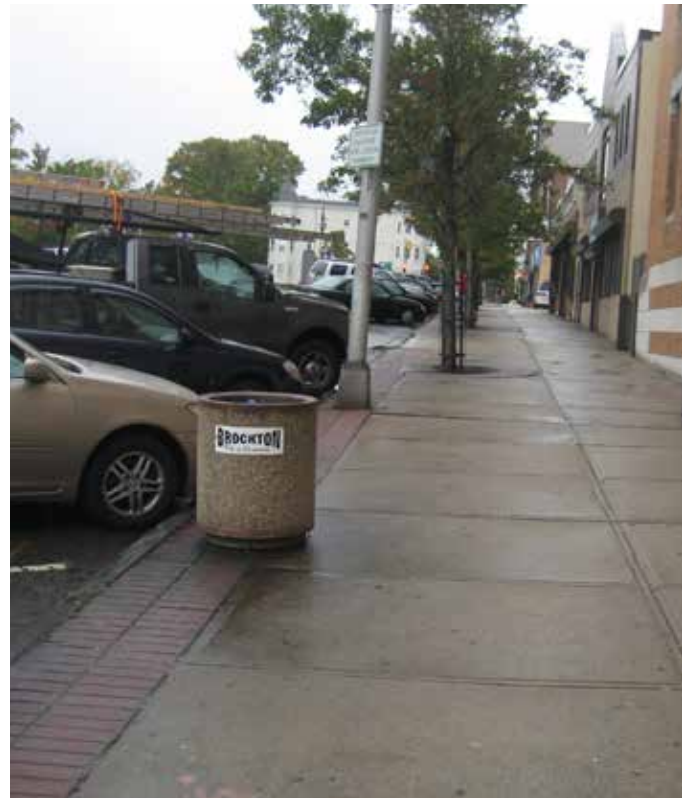
Wide sidewalk on Legion Parkway

Sidewalks along the storefronts are wide with an adequate walking zone. Street trees help to mitigate the otherwise automobile-dominated space. Once away from the storefronts, Legion only accommodates the needs of the car. Pedestrians cross at will from between cars parked along the median.

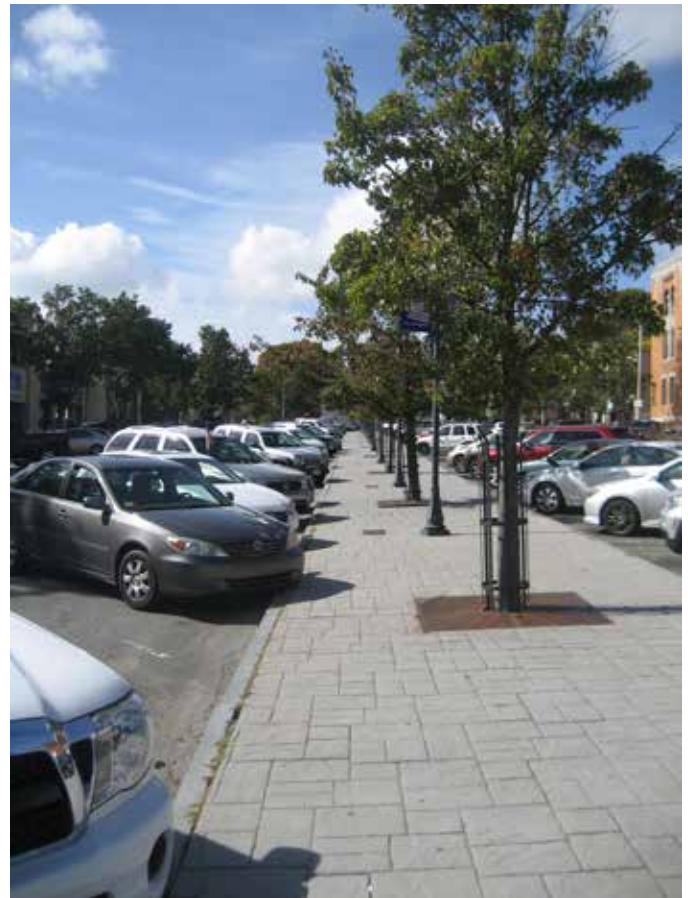
- No marked crosswalks between Warren Avenue and Main Street
- Median is not accessible – no curb ramps; could be re-designed as a useable open space
- Travel lanes and bus stops could be better defined
- Angled parking layout causes drivers to back blindly into the roadway

Wide median runs continuously down Legion Parkway between the two rows of angled parking. There may be an opportunity to rethink this space as a people-oriented gathering space.

Median is not accessible – no curb ramps; could be re-designed as a useable open space	Redesign the median to provide accessible crossing point(s) that correspond with new crosswalk(s); consider redesigning median as a linear park – increase width to provide central gathering spaces with street furnishings; create pedestrian-friendly spaces	Long-term	City of Brockton
Travel lanes and bus stops could be better defined	Evaluate lane widths and bus stop locations; use pavement marking to better define lanes and bus stops	Short-term	City of Brockton
Angled parking layout causes drivers to back blindly into the roadway	Consider re-striping parking from front-in angled parking to back-in angled parking. Maintains the current number of spaces, but increases safety for all road users; better line of sight for drivers to on-coming traffic including bicyclists and pedestrians; passenger doors, when open, direct passengers directly to the sidewalk (helps to prevent kids running toward moving traffic)	Long-term	City of Brockton

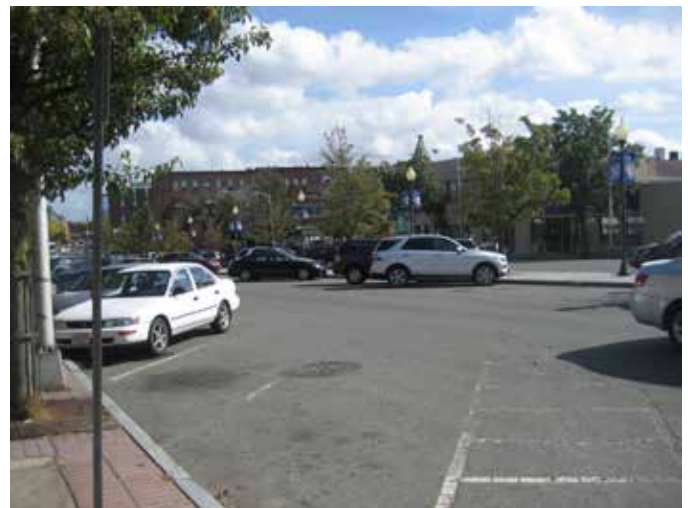
There are no marked crosswalks for the length of Legion Parkway. Pedestrians wait for a gap in traffic and cross from between parked cars to reach neighboring businesses.

- Evaluate locations for one or more pedestrian crosswalks across Legion Parkway based on land use and current pedestrian patterns and install permanent street crossings

- » Test different locations with temporary removal of parking spaces and delineation of crossing zones; use in-street pedestrian signs to bring awareness to the crossing area

- » Install permanent curb extensions and pavement markings at appropriate location(s); pavement markings could be enhanced crosswalks, such as a ladder design, or stamped asphalt

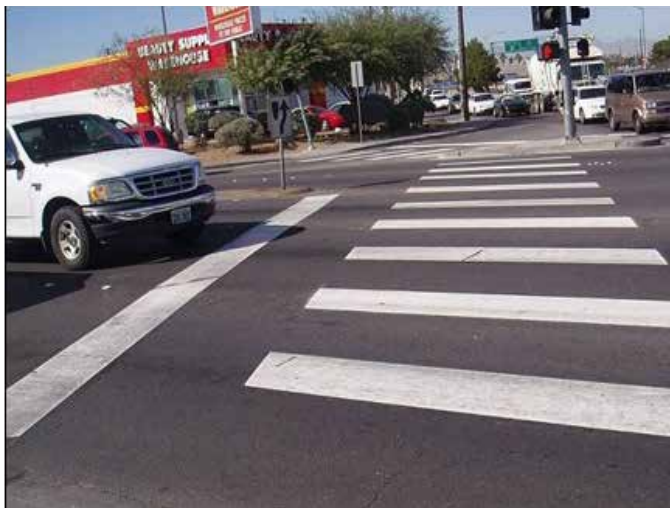
Crosswalks can be painted in a variety of ways, some of which are more effective in warning drivers of pedestrians. Crosswalks are usually accompanied with stop lines. These lines act as the legally mandated stopping point for vehicles, and discourage drivers from stopping in the middle of the crosswalk.

Crosswalk and stop line
Source: http://safety.fhwa.dot.gov/ped_bike/tools_solve/ped_scdproj/sys_impact_rpt/images/fig16.jpg

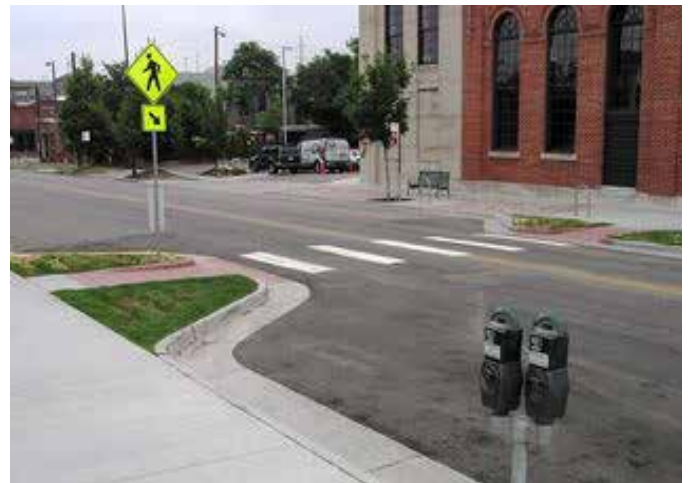
A sidewalk extension into the street (into the parking lane) shortens crossing distance, increases visibility for walkers and encourages eye contact between drivers and walkers.

Curb extensions are often associated with mid-block crossings

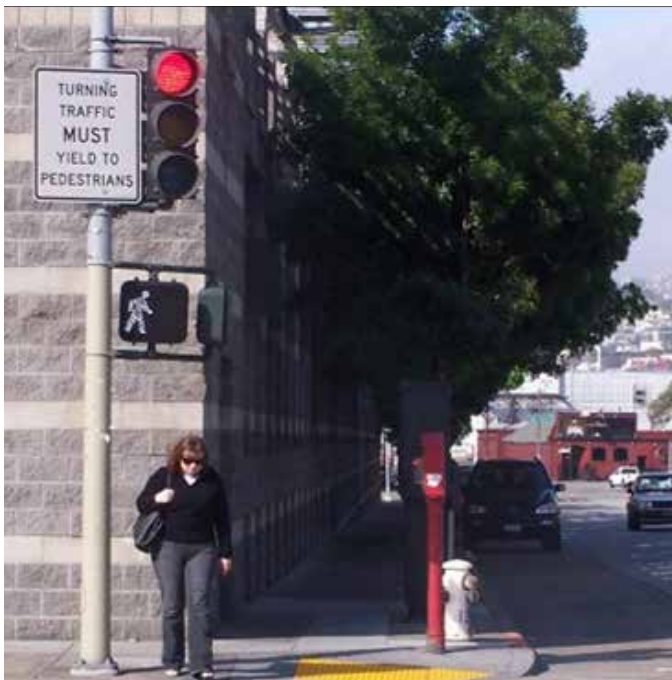
A leading pedestrian indicator gives pedestrians an advance walk signal before motorists get a green signal, giving the pedestrian several seconds to start walking in the crosswalk before a concurrent signal is provided to vehicles. This makes pedestrians more visible to motorists and motorists more likely to yield to them. Typical LPI settings provide 3 to 6 seconds of advance walk time.
