# ***Ashley Park Walk Audit - New Bedford, MA***

## ***Safe Routes to Parks***

October 17, 2017

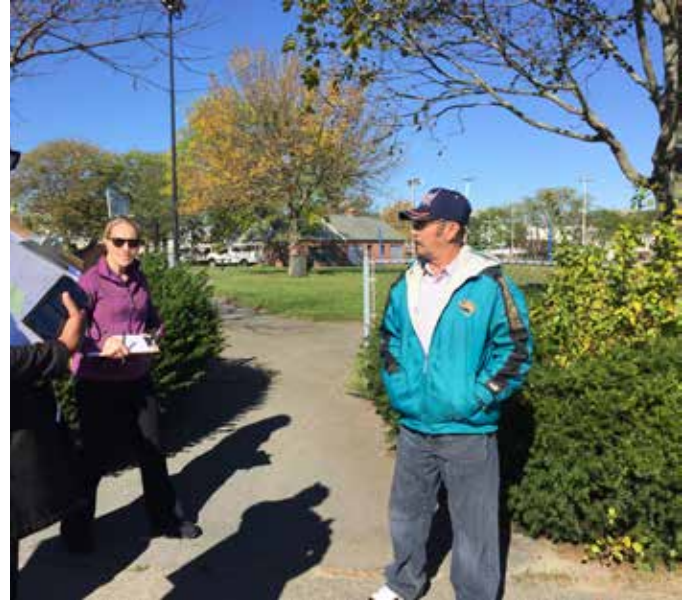
*Entrances to Ashley Park could be more frequent, better marked, and located where people need them.*

Ashley Park has fences along all of its edges except at the Rivet Street/Bolton Street intersection where the brick plaza and seating area are located. The fences are chain link – varying in height with the taller fences/netting along the first base line of the softball field. There are several entrances along the perimeter marked with bollards, shrubs and pathways leading into the park. None of the entrances have gates or are locked. However, the entrances are not well marked and, in many cases, are not located along a desire line. For example, there is no park entrance at the corner of Swift and Bolton Streets. Park users must walk outside the park either along Swift Street or Bolton Street to reach an entrance.

- Find a different field for the adult softball league currently using the field.
- Fix broken fence along Swift Street where chain link has been peeled back to the pole (presumably for truck access).
- Increase visibility of existing park entrances by trimming existing vegetation. Install temporary signage, pavement markings and seasonal plantings to better announce entrances.
- Include reuse of softball field, location and design of park entrances, and alternative fence solutions in scope for park redevelopment.

- Secure funding for Ashley Park design and construction.
- Determine if streetscape improvements, such as sidewalks, curb ramps, and lighting, can be included in the scope of the park redesign project. Coordinate with the New Bedford Department of Public Infrastructure on timing and potential funding streams for road design improvements.

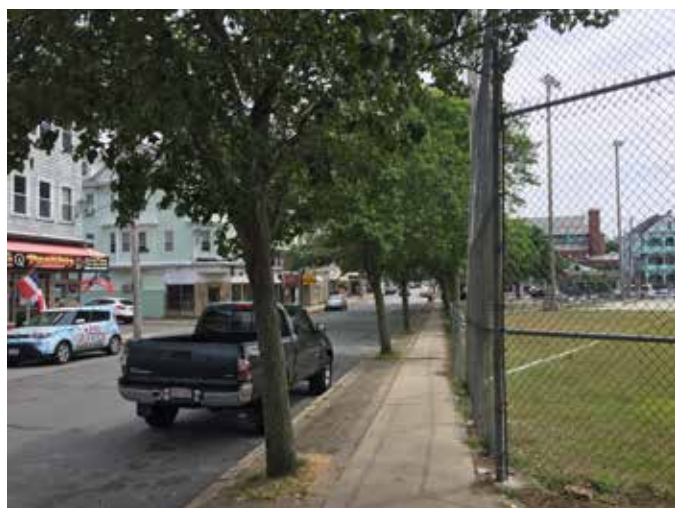
Issues remain between the neighboring businesses along Rivet and Orchard Streets with the softball field. Business owners complain of errant balls breaking

windows and endangering patrons. No serious injuries have been reported, but the concern is real. The Department of Parks, Recreation and Beaches knows of the issues and plans to relocate the softball league to another more suitable location and redesign the park to better fit community needs.

*The high fences along the softball diamond create a barrier to entering the park, and do not do enough to keep foul balls and homeruns from breaking windows in neighboring businesses. A more open, passive seating area along this edge would better serve the business owners and patrons.*

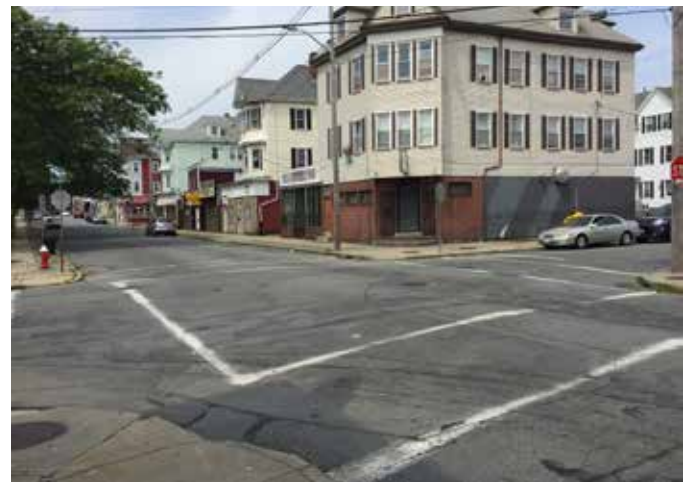
*Rivet Street/Orchard Street intersection*

The majority of intersections have marked crosswalks across all approaches. Those approaches missing crosswalks are listed below in the “short-term fixes” section. Most of the crosswalks in the study area are painted with two parallel lines, except those near the DeValles School, which have a ladder crosswalk pattern. The ladder crosswalk pattern is more visible and more distinct from the stop lines used at stop-controlled intersections. Ladder crosswalks are more expensive to paint and to maintain, but the additional paint has been shown to increase awareness of the crossings and positive driver yielding behavior.

*Ladder crosswalks versus standard crosswalk pavement markings along the walking route around Ashley Park.*

- Missing crosswalks:
  - » All approaches at the Bolton/Swift intersection (particularly important now due to recent leasing of the mill building south of Ashley Park)
  - » @Bolton/Larch Street intersection near the walkway leading to the Community Center (no stop lines or traffic signals)
  - » Across Rivet Street @Briggs Street (no stop lines or traffic signals)
- Crosswalk signage recommended at these crossings:
  - » Across Orchard Street @Katherine Street intersection
  - » Across Orchard Street @Swift Street intersection
  - » Across Bolton Street @ Swift Street intersection
  - » Across Bolton Street @ Larch Street
  - » Across Rivet Street @ Briggs Street
- Repaint stop lines at the Bolton Street/Rivet Street intersection.
- Enforce parking restrictions near crosswalks around Ashley Park.

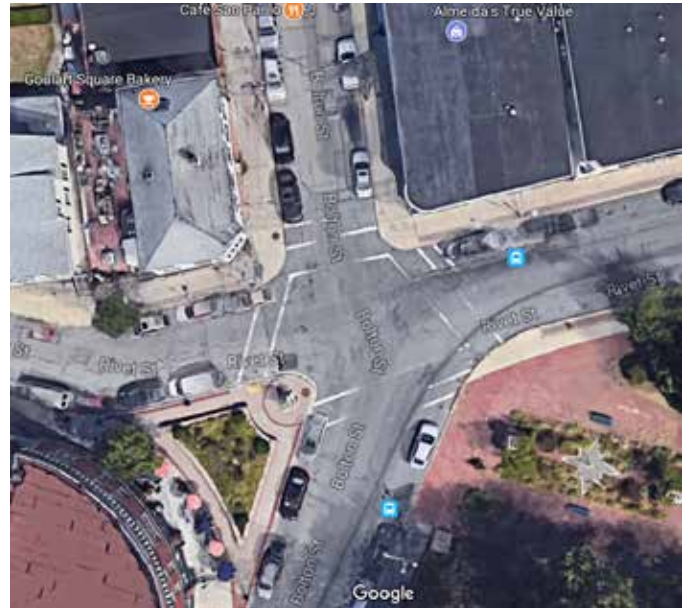
The pedestrian crossings at the Bolton Street/Rivet Street intersection are long as they run diagonally between apex curb ramps. Furthermore, drivers park their cars up to or on the crosswalk while running into the bakery or hardware store. The parked cars limit a pedestrian’s ability to see oncoming traffic and a driver’s ability to see people crossing the street. Redesigning the Bolton/Rivet Street intersection with curb bump-outs would reduce crossing distances, slow traffic speeds, and improve pedestrian visibility.

The stop lines at the Bolton/Rivet Street intersection are painted at an angle rather than perpendicular to the road edge. Repainting them would help to distinguish them from the crosswalks and give pedestrians more space to cross safely.

*Bolton Street/Rivet Street intersection has long crossing distances and minimal pavement markings.*

- Redesign Bolton Street/Rivet Street intersection with curb bump-outs or other traffic calming devices to shorten crossing distances, slow traffic and improve pedestrian visibility.

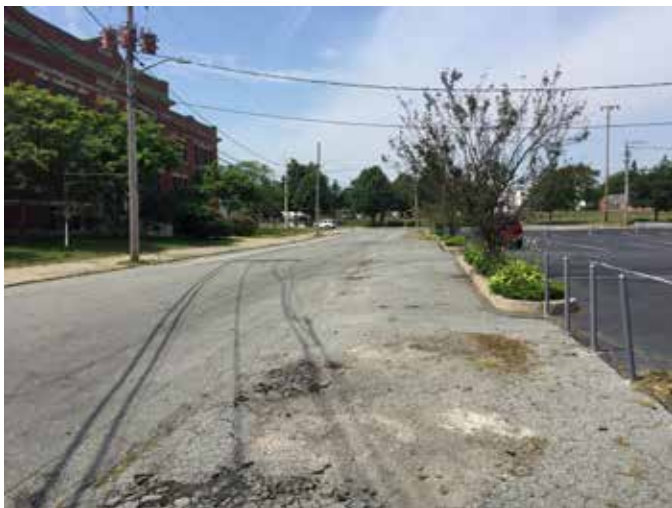
As discussed earlier in this report, the neighborhood has a connected network of sidewalks along almost every street. Many of the sidewalks around the park, however have not been replaced in many years and are showing signs of wear. The sidewalk on Katherine Street in front of the DeValles School has a dramatic cross-slope which is particularly difficult to navigate in icy conditions. Tree roots and the freeze/thaw cycle have upended some concrete panels, while other panels have cracked with age. In order to ensure people with all abilities have access to the park, it is important to make sidewalk repairs so that wheelchair users and strollers are not forced into the streets.

1. Along the north side of Katherine Street adjacent to the surface parking lot and across from DeValles Elementary School
2. Along the west side of Bonney Street between Winsor Street and the Bonney Street playground.

*Sidewalks are crumbling or nonexistent along Katherine Street across from DeValles Elementary School. In addition to walking to school, people come to markets held in the parking lot on the right side of this photograph. A smooth, continuous sidewalk should be a priority in this location.*

- Make repairs to sidewalks around Ashley Park where possible, before full sidewalk reconstruction is funded.
- Consider including new sidewalks in Ashley Park redesign project scope.
- Locate areas with missing or non-compliant curb ramps.

- Install sidewalk and curbing along the north side of Katherine Street adjacent to the surface parking lot and across from DeValles Elementary School.
- Install sidewalk and curbing along the west side of Bonney Street between Winsor Street and the Bonney Street playground.
- Repair all non-compliant curb ramps and install curb ramps where they are missing.

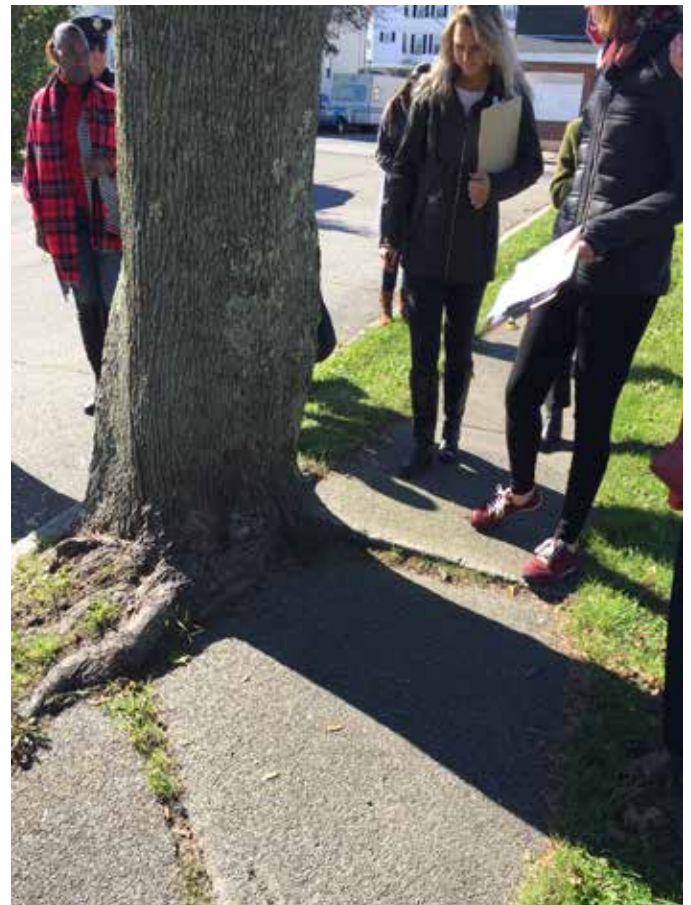
*Trees have uprooted concrete sidewalk panels along all sides of Ashley Park. Sidewalks - in general - have not been upgraded in this area in several years.*

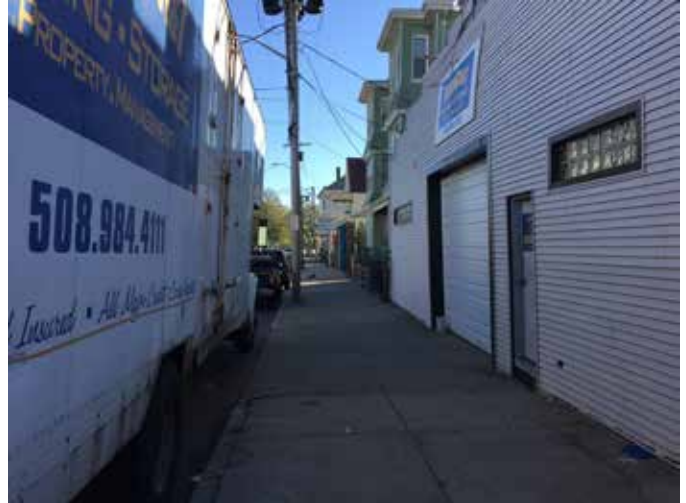
*Walking between moving trucks and blank walls does not feel comfortable along Bolton Street between the Congdon School and Ashley Park.*

The Congdon School is less than a 5-minute walk from Ashley Park (.11 miles). However, the land uses and lack of trees along Bolton Street do not create a comfortable, walkable street. This block of Bolton Street is lined with light industrial uses, such as a moving company and warehouse spaces, where trucks and driveways dominate the street. The sidewalks are wide, but feel empty and uncomfortable with few pedestrian scale elements. While changing land uses is unlikely, improving the streetscape with trees and enforcing no parking on the sidewalks would greatly enhance the safety and comfort of the walk from Congdon to Ashley Park.

- Enforce parking restrictions along Bolton Street.
- Determine if street trees can be planted along Bolton Street given current land uses and utility locations.
- Identify potential funding stream for tree planting.

- Review zoning code to determine if appropriate to change land uses in the long-term. Form-based code is in development for Goulart Square.

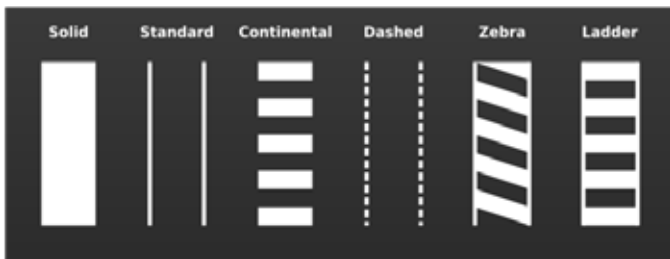
Crosswalks can be painted in a variety of ways, some of which are more effective in warning drivers of pedestrians. Crosswalks are usually accompanied with stop lines. These lines act as the legally mandated stopping point for vehicles, and discourage drivers from stopping in the middle of the crosswalk.

*Crosswalk patterns*  
Source: USFHA

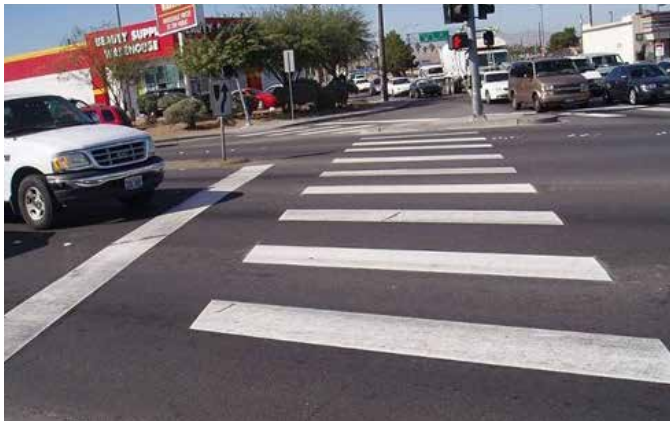
*Crosswalk and stop line*  
Source: [http://safety.fhwa.dot.gov/ped\\_bike/tools\\_solve/ped\\_scdproj/sys\\_impact\\_rpt/images/fig16.jpg](http://safety.fhwa.dot.gov/ped_bike/tools_solve/ped_scdproj/sys_impact_rpt/images/fig16.jpg)

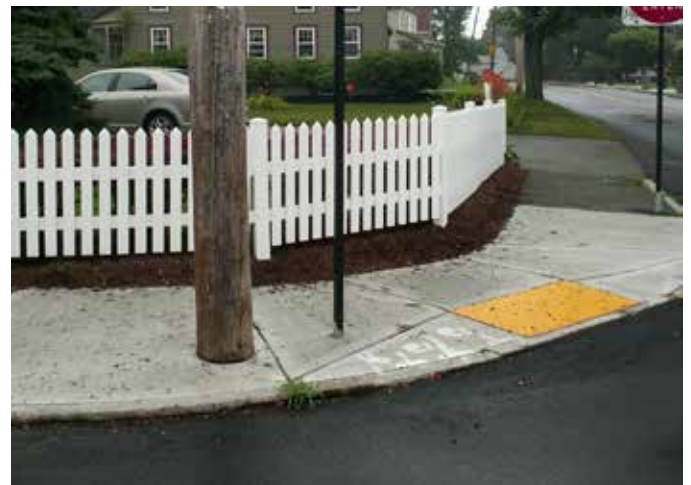
Curb ramps provide access from the sidewalk to the street for people using wheel chairs and strollers. They are most commonly found at intersections. While curb ramps have improved access for wheelchair-bound people, they are problematic for visually impaired people who use the curb as an indication of the side of the street. Detectable warning strips, a distinctive surface pattern of domes detectable by cane or underfoot, are now used to alert people with vision impairments of their approach to streets and hazardous drop-offs.

*Curb ramp and detectable warning strip*

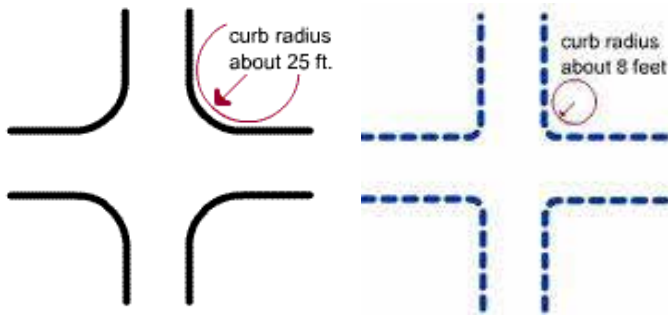
A longer curb radius (on the left in figure below) allows vehicles to turn more quickly and creates longer crossing distance for pedestrians. A shorter curb radius (on the right in the figure below) slows turning speeds and provides pedestrians shorter crossing distances.

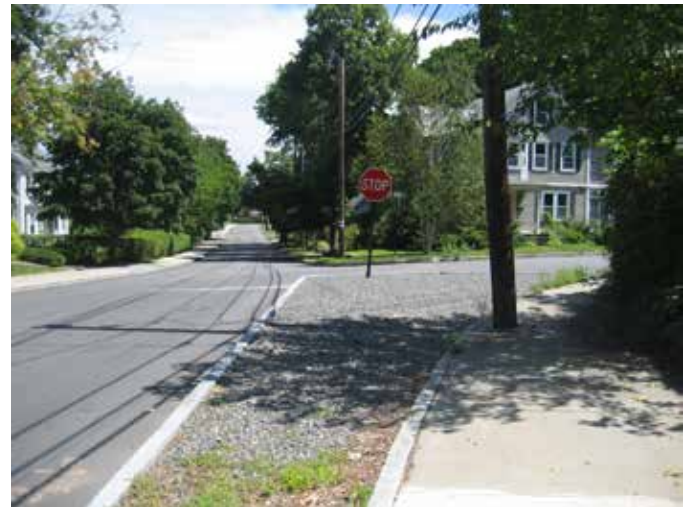
(A) Gravel-filled curb extension

There are two excellent examples of the shortening of curb radii in Woburn, MA. The first (A) is a low-cost solution using a gravel-filled zone between the original curb line and the newly established road edge. The second is a higher-cost solution using grass and trees and extending the sidewalks to the new curb. Both work to slow traffic.

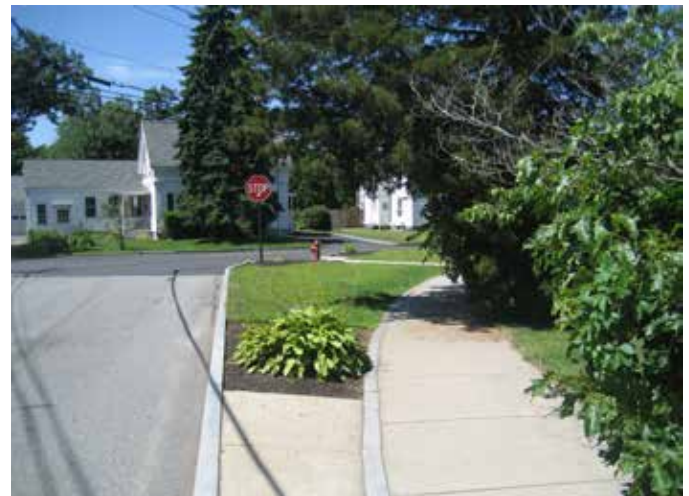
(B) Grass, trees and extended sidewalk in curb extension

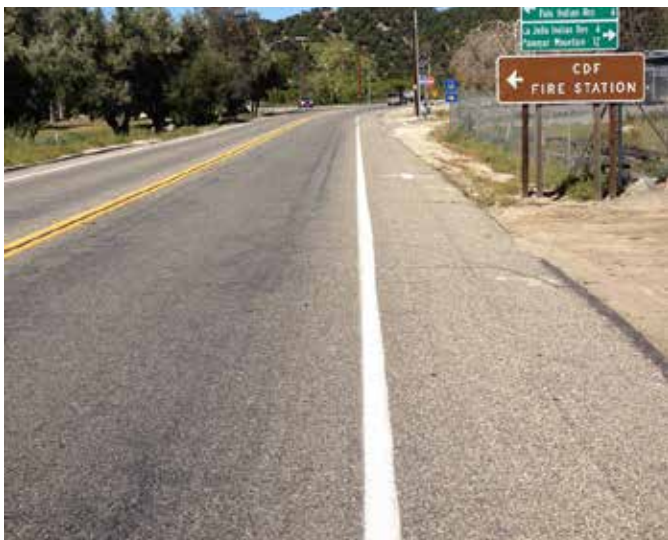
A fog line is a solid white line painted along the roadside curb that defines the travel lane. It narrows a driver's perspective and helps to slow traffic speeds. Fog lines are used in urban, suburban and rural locations.

Fog lines delineate the vehicular driving zone on wide roadways.

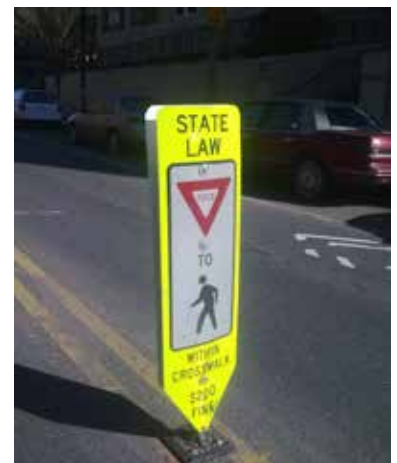
In-street pedestrian crossing signs are used at the road centerline within crosswalks to increase driver awareness of pedestrians in the area. These signs are a relatively low-cost, highly effective tool in slowing traffic by the narrowing travel lanes. They are popular with road maintenance departments since they can be easily moved for snow removal.
