## Walk/Bike Assessment

### Main Street

Northampton, MA

## Main Street Corridor: Elm/West/State/New South Streets to King/Pleasant Streets (Rt. 5)

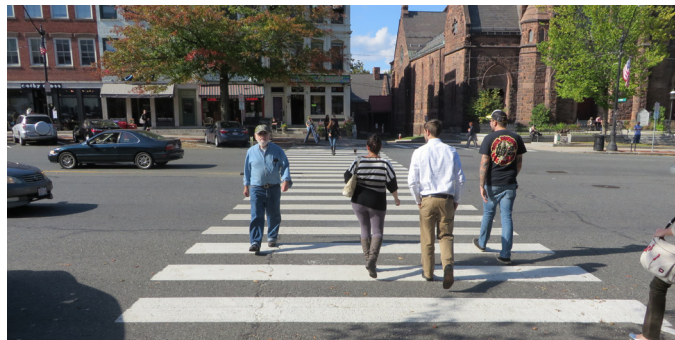
*Pedestrian activity in the crosswalk across Main Street at Center Street*

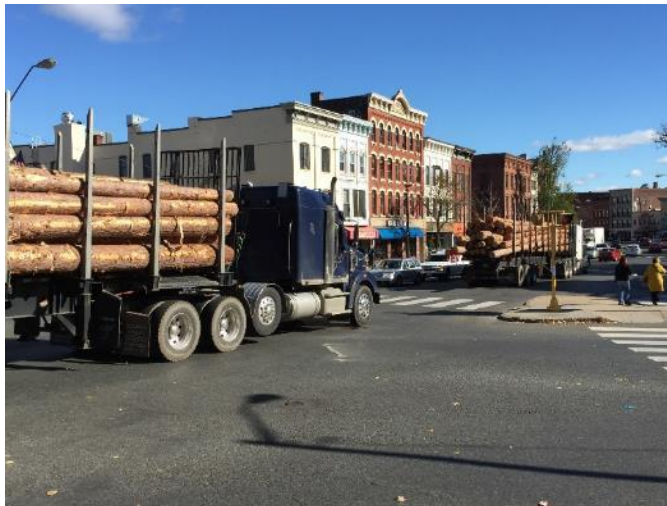
Members of the team observed several large tractor trailer trucks and logging trucks traveling through downtown which did not appear to be local trips. City staff noted that large vehicles typically have to detour up King Street to Damon Road in order to avoid the low railroad bridge east of King Street and continue east on Route 9 towards Interstate 91. Given that the existing through route is extremely indirect and that the heavy truck volumes are incompatible with the heavy volumes of people walking and on bikes, the City and MassDOT should explore strategies to reroute through trucks away from Main Street through downtown. It would be necessary to provide a sufficient alternate route for through trucks on Route 9.

Figure 2 - Logging trucks pass through the New South Street intersection on Main Street.

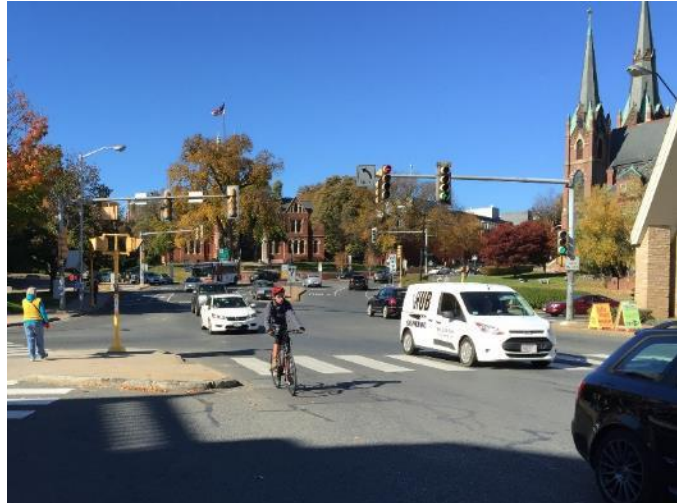
Figure 3 - A bicyclist passes through the New South Street intersection on Main Street.

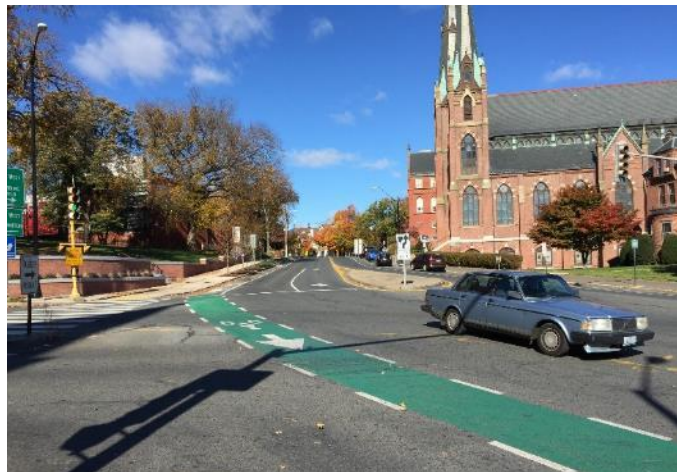
Bike lanes are provided on Elm Street west of State Street/New South Street. The eastbound bike lane includes green paint through the intersection of West Street to highlight the conflict zone. Members of the team noted that eastbound vehicles on Main Street that plan on turning right at New South Street frequently transition through the bike lane over a long distance due to the road alignment and curvature, creating a large conflict zone. The eastbound approach to State Street/New South Street also provides a bike box across all four lanes, however, the markings are faded.

Figure 4 - Bike lane intersection markings transition through the West Street intersection.

Members of the team noted that the wide, multi-lane approaches make it difficult for bicyclists to make the left turn to State Street or New South Street, especially for bicyclists who arrive on green and are unable to use the eastbound bike box. The City should consider installing two-stage turn queue boxes at the State Street and New South Street to allow bicyclists to make the left turn during the side street green phase. The city should also restripe the existing bike box and install green pavement markings.

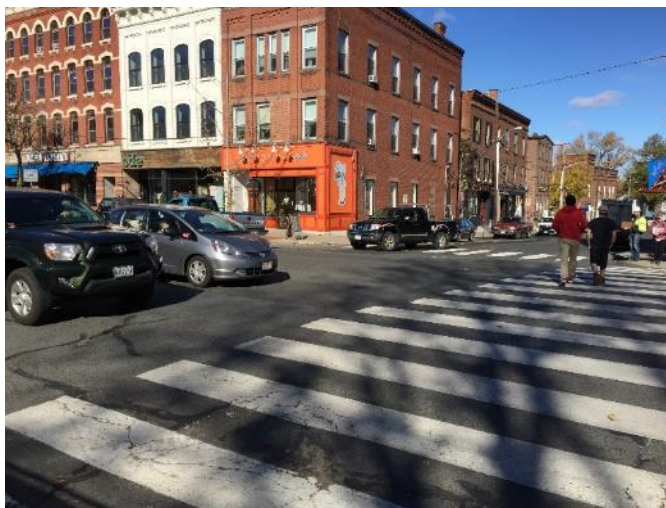
Members of the team noted that parking adjacent to the crosswalk on the eastbound and westbound approaches limits sight distance for pedestrians. The City should consider removing one parking space on each approach to provide sufficient sight distance for pedestrians crossing Main Street. Members of the team also observed that the existing bus stop on Main Street eastbound west of Masonic Street is heavily utilized, and that the narrow sidewalk has limited space for pedestrians to disembark from the bus, especially when the wheelchair loading ramp was deployed from the bus. Construction work is ongoing for the adjacent park, and it is expected that the park will include a bus shelter, wider sidewalk facilities, and bike parking.

Figure 6 - Pedestrians cross Main Street at Masonic Street.

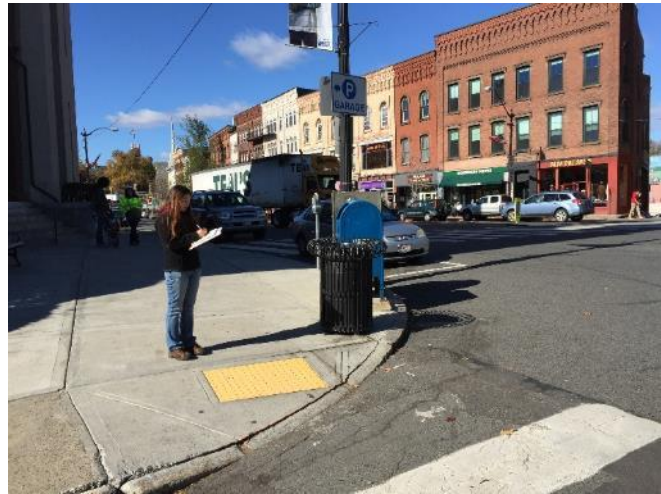
Members of the team noted that the existing parking, sidewalk furniture, and roadway geometry at the Crafts Avenue intersection results in poor sight distance and high vehicle turning speeds which impact both crosswalks. The City should consider removing the two parking spaces and relocating sidewalk furniture in front of City Hall in order to improve sight distance to both crosswalks. In the long term, the City should consider reconstructing the south side of Main Street to provide curb geometry that follows the curvature of the roadway and provides a reduced turning radius to Crafts Ave. This will reduce turning speeds and improve driver and pedestrian expectancy.

Figure 7 - Parked cars block sight distance for pedestrians at Crafts Avenue.

City staff noted that the City has explored the possibility of closing Crackerbarrell Alley to vehicular traffic, converting it to a pedestrian access to the rear parking lot. Given that the existing parking lot is also served by driveways on Masonic Street immediately north of the intersection, this closure would reduce conflicts between vehicles and pedestrians while having minimal impact on vehicular access to the parking lot. Closing Crackerbarrell Alley would allow the crosswalk in front of City Hall to be relocated from its current angled position to a more direct alignment improving visibility and decreasing the crossing distance. City staff also noted that the sidewalk on Main Street adjacent to Crackerbarrell Alley is a pinch point. The City should consider widening the sidewalk along this segment in order to match sidewalks along the rest of the corridor.

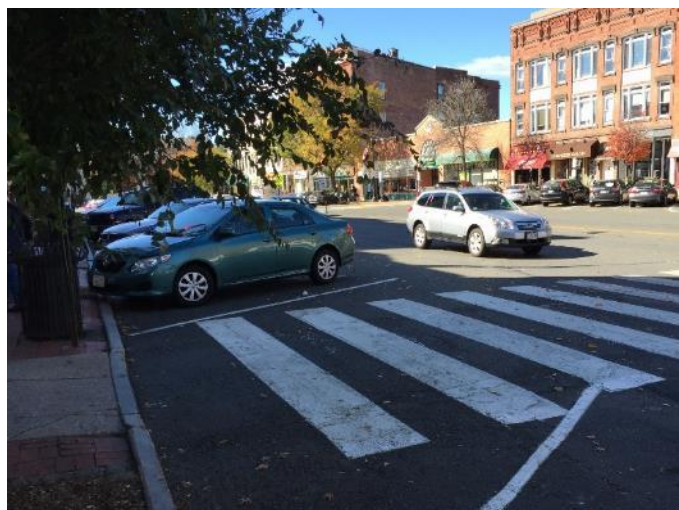
Members of the team also noted that the angle parking spaces adjacent to both crosswalks across Main Street limit sight distance for pedestrians. At the crosswalk across Main Street, the handicap accessible parking space on the north side west of the crosswalk requires drivers to back into the crosswalk in order to exit the space. The City should remove four angle parking spaces and relocate the handicap accessible space in order to improve sight distance and prevent drivers from backing into the crosswalk. As a long term measure, the City should consider constructing curb extensions at both crosswalks, which may create an opportunity for a pocket park. In the short term, it may be necessary to

Figure 8 - Parked cars block sight distance to a midblock crosswalk.

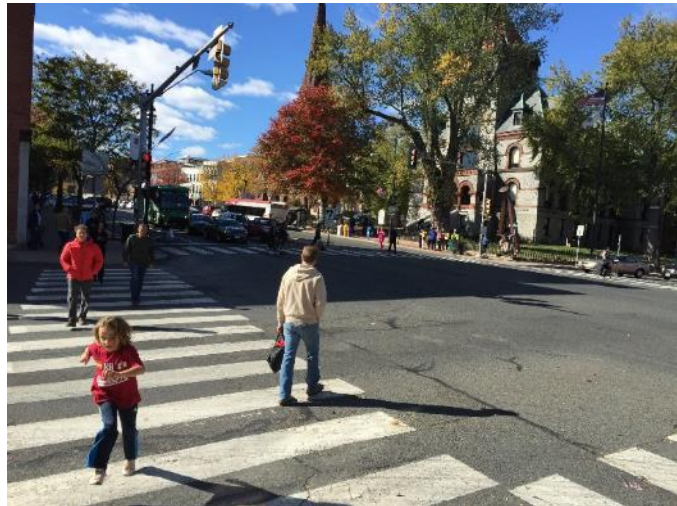
Members of the team noted that due to the large size of the intersection and the complex signal phasing, pedestrians typically comply with the traffic signals and cross during the exclusive pedestrian phase. Many pedestrians were observed crossing the intersection diagonally during the pedestrian phase. The City should consider installing continuous corner ramps to allow for diagonal crossing and updating the signal timing to provide appropriate clearance for the diagonal crossing. Members of the team suggested that the intersection may be reconstructed as a raised table intersection, allowing for pedestrian crossing in all directions during the pedestrian phase.

Figure 9 - Pedestrians cross during the exclusive pedestrian phase.
