Downtown/Cultural District Walk Assessment Springfield, MA

September 25, 2015

MAKING MASSACHUSETTS MORE WALKABLE

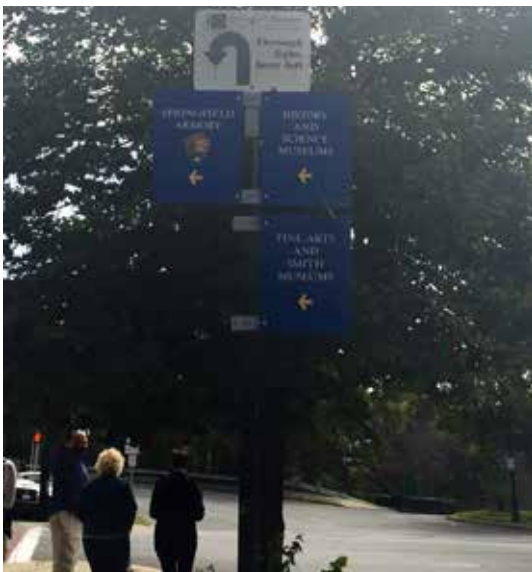
- Wayfinding signs are designed to direct drivers to destinations. Most signs are out of the line of sight of pedestrians, and are too high on existing street signs or utility poles

Wayfinding signage is designed primarily for drivers

- Develop a pedestrian scale wayfinding system linking the neighborhoods, museums and downtown districts

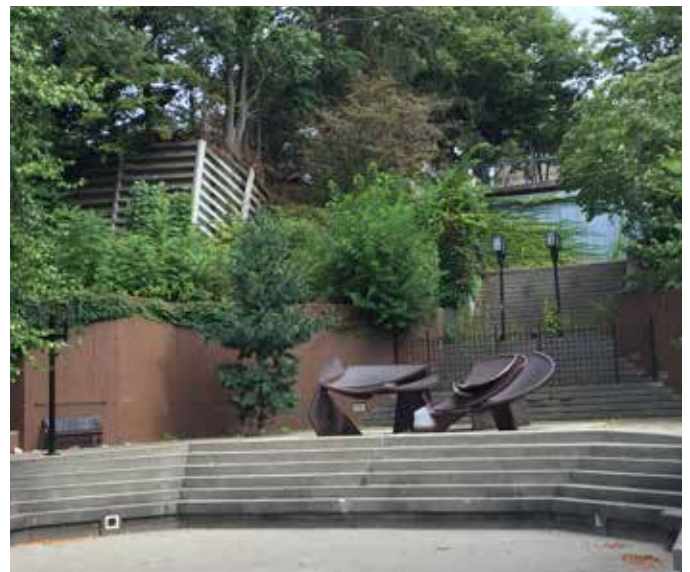
Renovation of Pynchon Park would restore a key connection between the downtown business district, residences, and the museums

Pynchon Plaza is at the terminus of Falcons Way. The plaza is in need of reinvestment and is currently closed for public use. Its original design included a grand staircase and an outdoor elevator which helped people negotiate the significant grade change between Dwight Street and Chestnut Street. While the park is currently not operational, it has the potential to serve as a vibrant and lively community gathering space and reconnect the seemingly distant museum district from downtown.

- Revitalize parks and open space, both physically and programmatically, to serve as pedestrian gathering spaces. Pynchon Plaza in particular is a critical link between the museums and downtown.

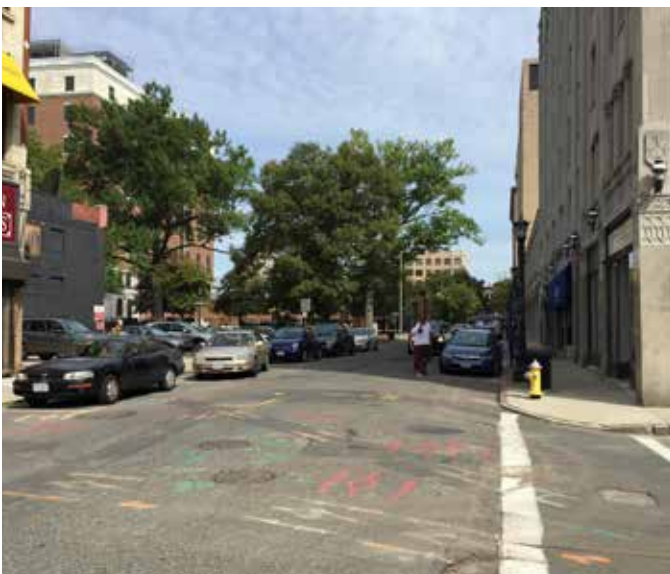
Example of a high-risk, unattractive road segment

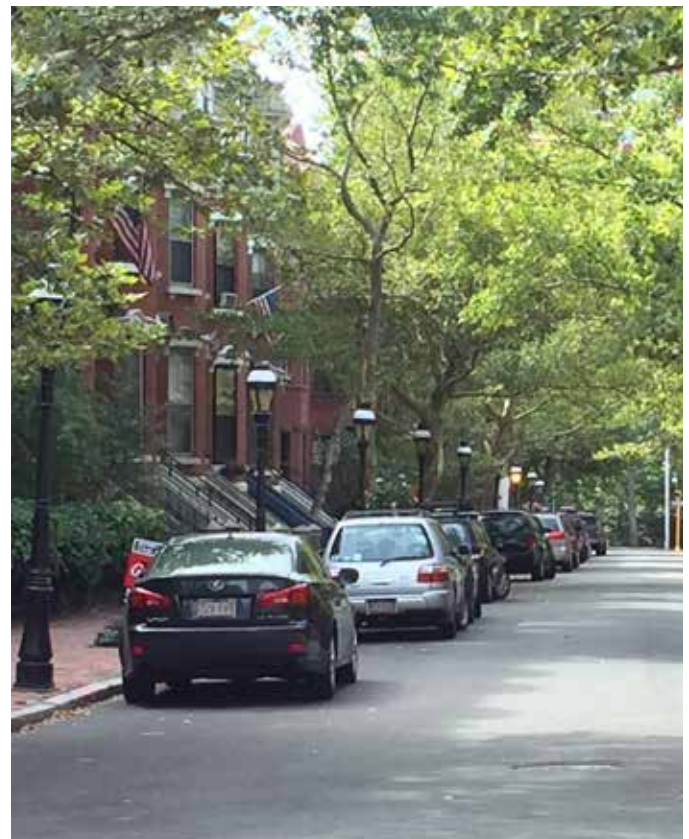
Example of a low-risk, attractive road segment

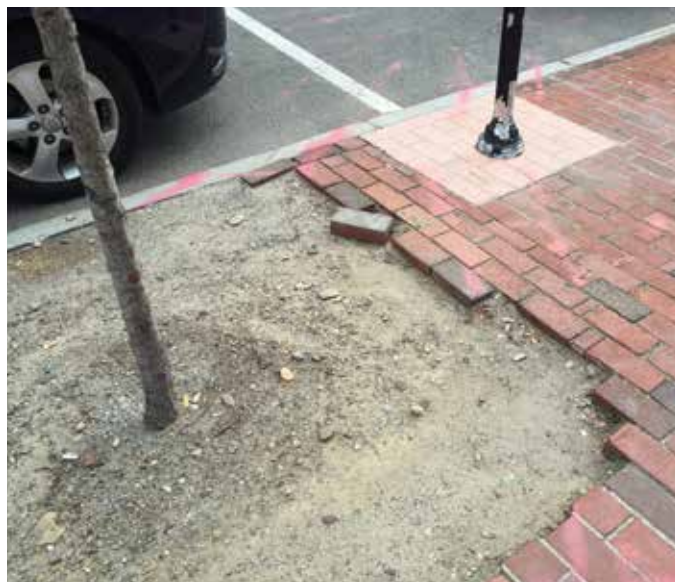
Main Street is a highly walkable corridor with lots of shops, restaurants, and hotels. Crosswalks are short and painted with a red/white design at nearly all intersections along the corridor. Brick sidewalks are wide with trees and street furniture providing an adequate buffer between pedestrians and the roadway. There is an exclusive pedestrian signal at the intersection of Main Street and Falcons Way that provides adequate time for pedestrians to cross safely.

While the Main Street sidewalks are generally in good shape, there are ongoing maintenance issues with brick sidewalks that can create tripping hazards

- Continue maintenance of sidewalks and street furnishings
- Repair loose bricks and dips near lampposts, trees and street signs

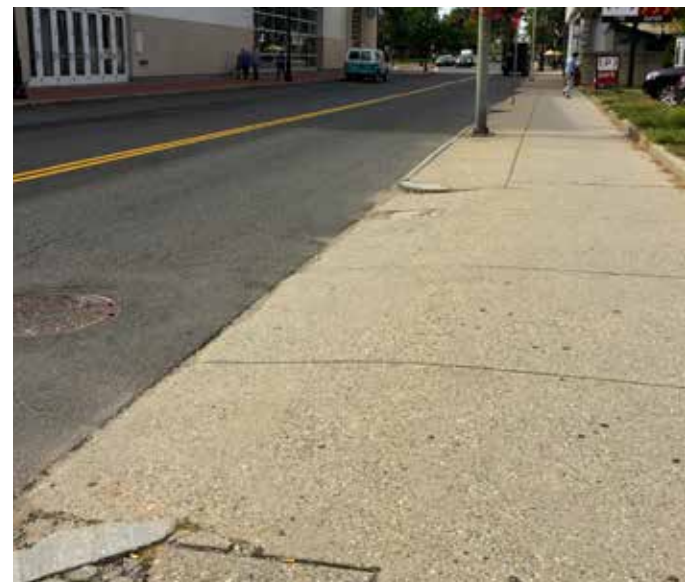
Each side of the Falcons Way corridor presents a very different walking experience. The north side of the street offers few pedestrian amenities. Parking is the primary land use on this side of the street and the curb cuts at the parking entrance and exit are particularly long with wide curb radii. There is an entrance to a brick-paved alley along the former Market Street alignment that connects to Harrison Avenue. It is lined with street trees and pedestrian-scale lighting.

The south side of Falcons Way is more accommodating to pedestrians, as it offers wider sidewalks with planters serving as buffers from the street. There is a raised crosswalk on Falcons Way between the parking structure and the MassMutual Center. The condition of the sidewalks is fair with several deteriorating concrete panels near the garage and alley entrances.

The combination of multiple, wide curb cuts, a singular large building facade, and parking as the primary land use compromises the pedestrian experience along Falcons Way

- Plant trees and add street furnishings to improve the quality of the pedestrian environment. Trees can help to hide the parking lots and structure.
- Consider reducing the number and width of curb cuts
- Repair and/or replace crumbling sidewalk panels

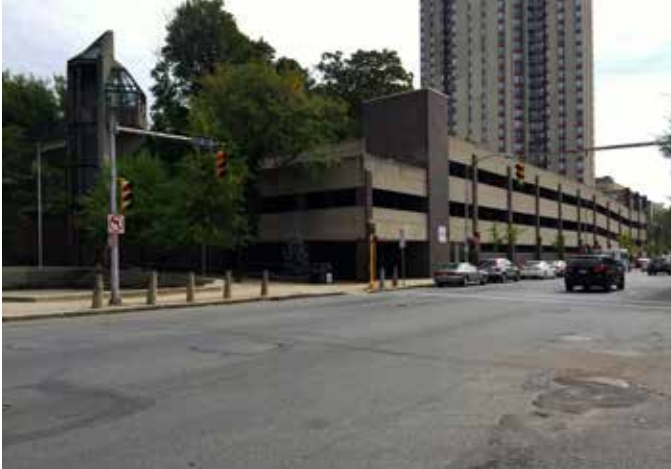
The Dwight Street crossing is long and not well-marked.

The crossing distance from Falcons Way to Dwight Street is long and marked with one faded crosswalk. Vehicles travel quickly down Dwight Street, a one-way three-lane collector with two parking lanes, which is approximately 50' wide. Curb ramps are missing from the Dwight Street crossing (an apex ramp exists but does not line up with the crossing). The intersection is signalized, but not all approaches have pedestrian signals.

- Consider installing curb bump outs at the Falcons Way/Dwight Street intersection to reduce the crossing distances
- Repaint the existing crosswalk and paint a second crosswalk on the northwest side of Falcons Way using a ladder design to increase the visibility of crossings
- Install curb ramps and detectable warning strips to comply with accessibility requirements

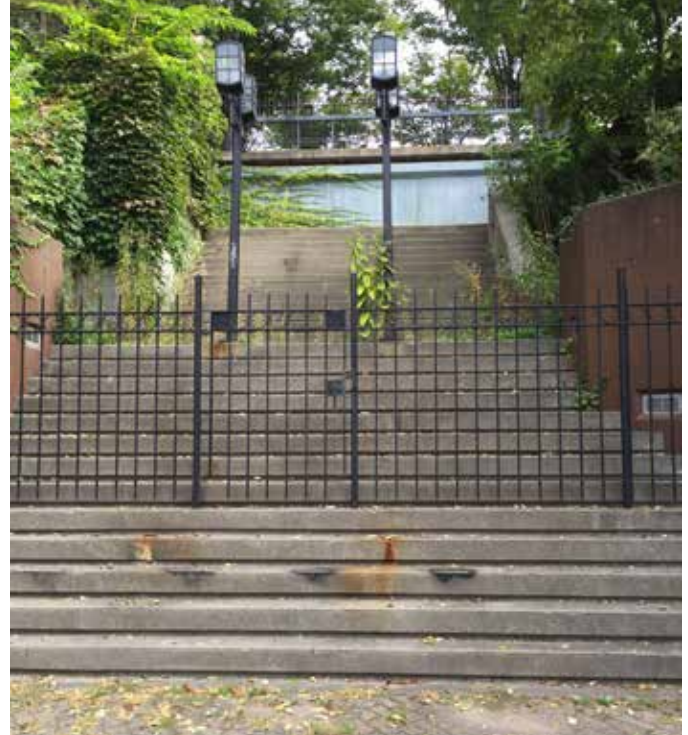
Pynchon Plaza was designed to bridge the elevation change between Dwight Street and Chestnut Street providing a key connection between downtown and the cultural institutions on the quadrangle

- Reinvest in Pynchon Plaza. Consider a phased approach, beginning with simple maintenance and park programming and studying alternatives for mitigating the grade change between Dwight and Chestnut Streets

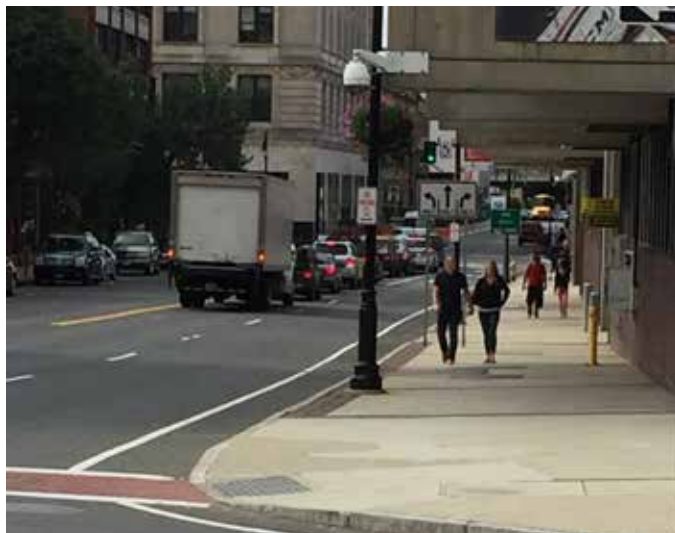
The State Street corridor has seen recent investment in marked crossings, curb ramps and sidewalks. Trees and street furniture line the sidewalk. However, there are some tripping hazards, such as empty planters and uneven patches of sidewalk. The steep grade change from Dwight Street to Chestnut Street is a challenge on State Street; the elevation rises significantly as pedestrians travel north along this corridor. In terms of wayfinding, there is no signage present to indicate pedestrians are close to the Quadrangle and Springfield Museums.

This section of State Street has wide, smooth sidewalks and recent intersection enhancements that improve pedestrian safety

- Repair sidewalks and remove tripping hazards along State Street
- Consider installation of wayfinding signs to the museums along Chestnut Street

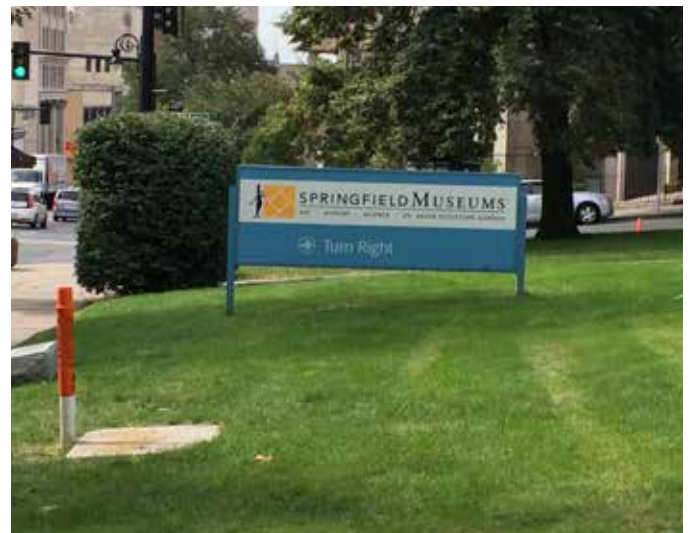
Signs announcing the museums are set back from the road and understated. Visitors and residents alike may miss them. The museum district and quadrangle are inward facing which keeps them hidden from those driving down State Street. Improved wayfinding signage would do a lot for advertising the location of the museums and their close proximity to downtown.

Institution and wayfinding signage should be improved to reveal the cultural assets along the State Street corridor to all

- Consider re-locating the crosswalk and addressing the cross-slope on the northern side of Chestnut Street
- Improve wayfinding signage for walkers and drivers to better advertise the presence of the museums and quadrangle at this intersection

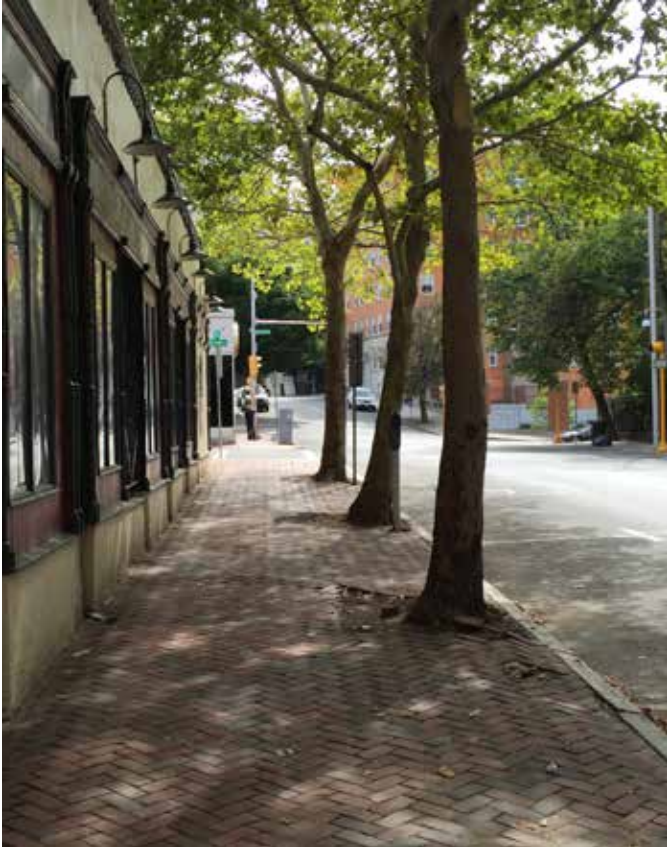
The brick sidewalks and tree wells on Chestnut street need to be repaired. Particular attention should be made to maintaining the tree canopy

Chestnut Street is a one-way corridor that carries high volumes of traffic traveling to Route 291. The intersection of Mattoon Street and Chestnut Street is missing crosswalks, and there are some tripping hazards located on the sidewalk. There is a well-maintained triangular park located at the intersection of Chestnut Street, Bridge Street, and Pearl Street. While nearly all crosswalks are present at this intersection, they are only marked by two parallel lines.

- Consider painting crosswalks across Chestnut Street at the Mattoon Street intersection
- Remove tripping hazards and repair sidewalks along this section of Chestnut Street
- Continue to study possibility of instituting two-way traffic on Chestnut Street

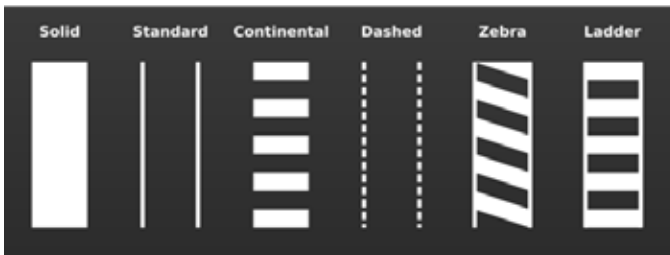
Crosswalks can be painted in a variety of ways, some of which are more effective in warning drivers of pedestrians. Crosswalks are usually accompanied with stop lines. These lines act as the legally mandated stopping point for vehicles, and discourage drivers from stopping in the middle of the crosswalk.

Crosswalk patterns
Source: USFHA

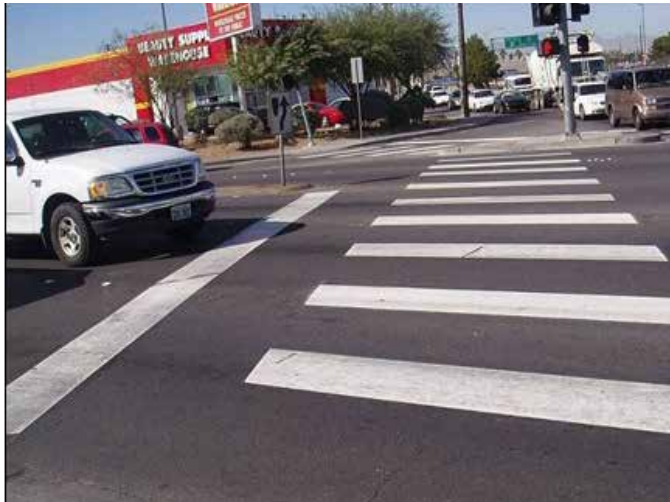
Crosswalk and stop line
Source: http://safety.fhwa.dot.gov/ped_bike/tools_solve/ped_scdproj/sys_impact_rpt/images/fig16.jpg

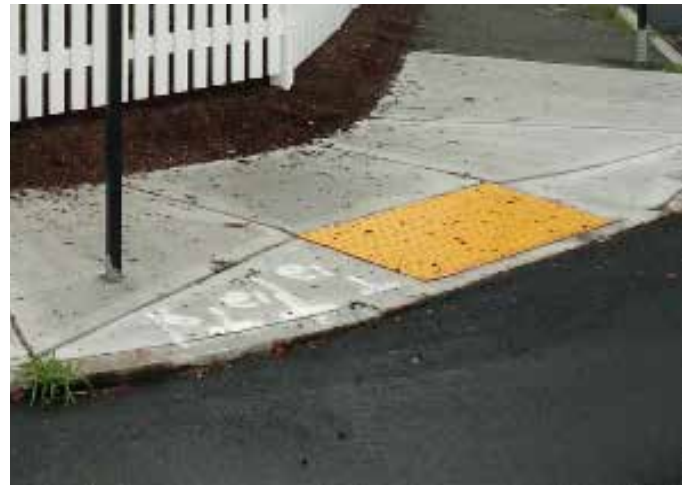
Curb ramps provide access from the sidewalk to the street for people using wheel chairs and strollers. They are most commonly found at intersections. While curb ramps have improved access for wheelchair-bound people, they are problematic for visually impaired people who use the curb as an indication of the side of the street. Detectable warning strips, a distinctive surface pattern of domes detectable by cane or underfoot, are now used to alert people with vision impairments of their approach to streets and hazardous drop-offs.

Curb ramp and detectable warning strip in Woburn, MA

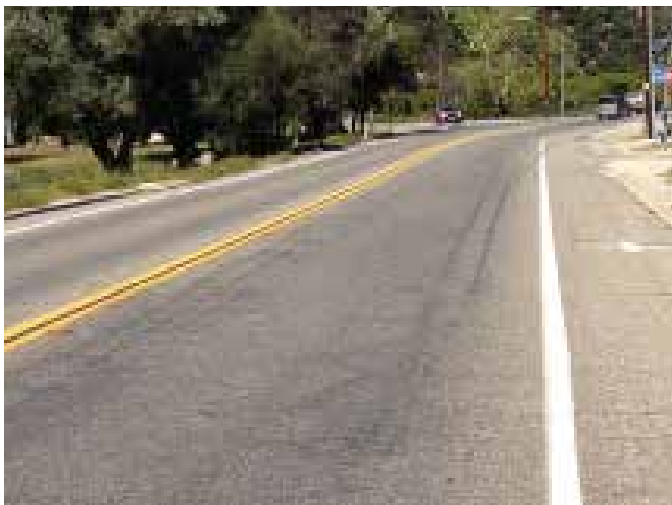
A fog line is a solid white line painted along the roadside curb that defines the driving lane and narrows the driver's perspective. Fog lines are most often used in suburban and rural locations, but may be appropriate in some urban conditions.

Fog lines delineate the vehicular driving zone on wide roadways.

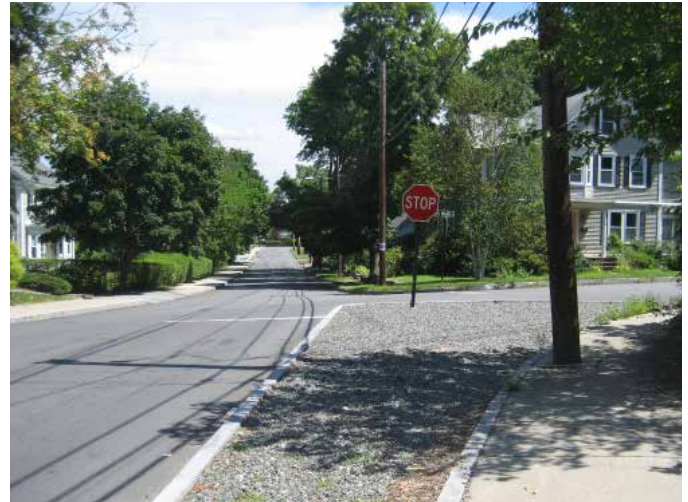
There are two excellent examples of the shortening of curb radii in Woburn, MA. The first (A) is a low-cost solution using a gravel-filled zone between the original curb line and the newly established road edge. The second is a higher-cost solution using grass and trees and extending the sidewalks to the new curb. Both work to slow traffic.

(A) Gravel-filled curb extension

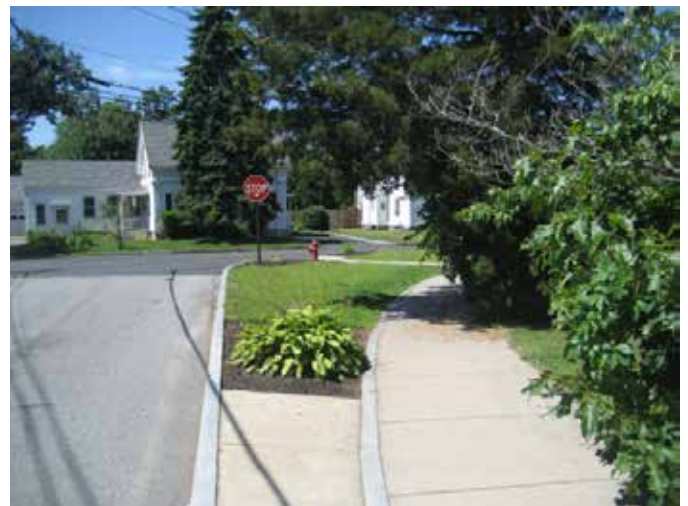
(B) Grass, trees and extended sidewalk in curb extension

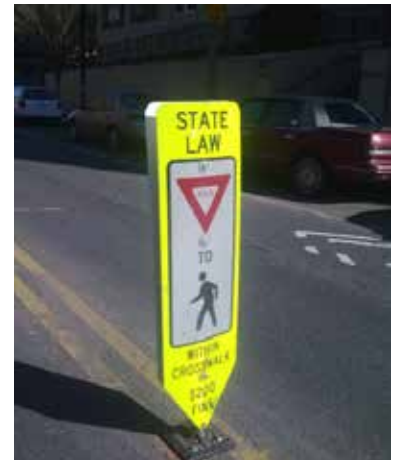
In-street Pedestrian Crossing Sign

In-street pedestrian crossing signs are used at the road centerline within crosswalks to increase driver awareness of pedestrians in the area. These signs are a relatively low-cost, highly effective tool in slowing traffic by the narrowing travel lanes. They are popular with road maintenance departments since they can be easily moved for snow removal.

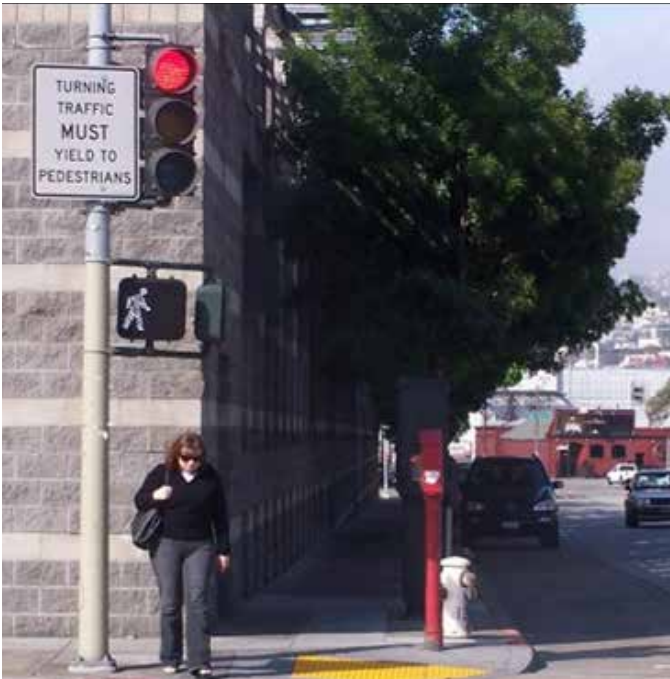
Leading Pedestrian Interval (LPI)

A leading pedestrian interval gives pedestrians an advance walk signal before motorists get a green signal, giving the pedestrian several seconds to start walking in the crosswalk before a concurrent signal is provided to vehicles. This makes pedestrians more visible to motorists and motorists more likely to yield to them. Typical LPI settings provide 3 to 6 seconds of advance walk time.
