## ***Downtown Walk Assessment Pittsfield, MA***

June 1, 2016

## Purpose of Walk Assessment

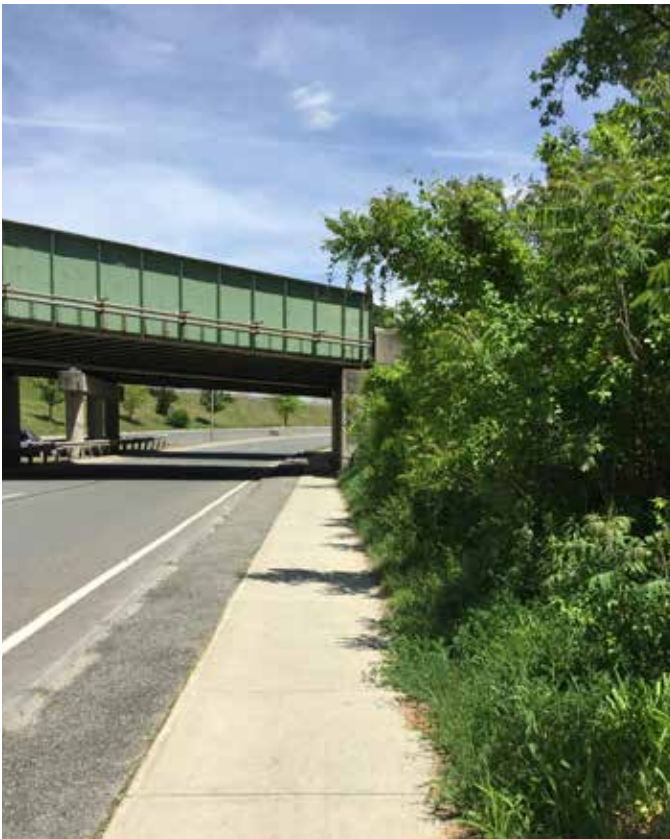
*Example of a high-risk, unattractive road segment*

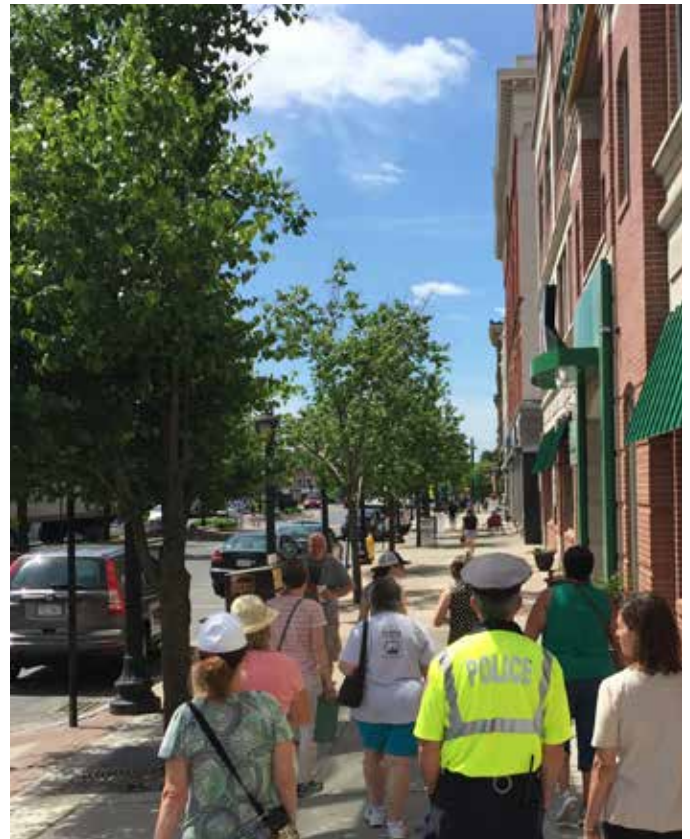
*Example of a low-risk, attractive road segment*

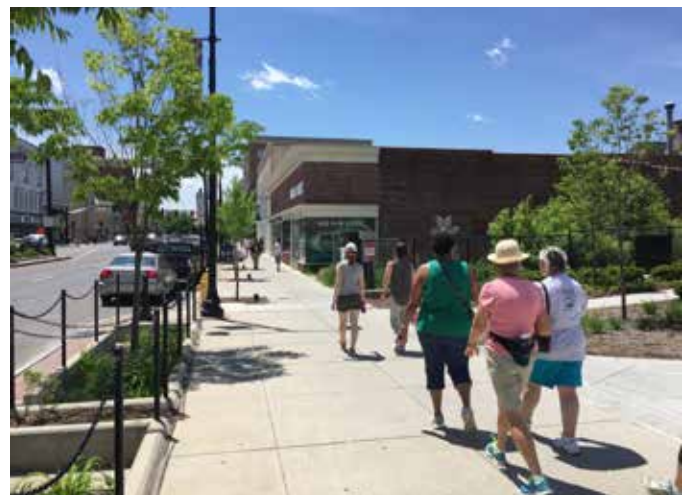
North Street is a highly walkable corridor with lots of shops, restaurants, and other businesses. This area has undergone a transformation within the past five years. Crosswalks are frequent and painted with a red/white design at all intersections along the corridor. Bump-outs at crosswalks shorten crossing distances and make pedestrians more visible. Brick and concrete sidewalks are wide and lined with trees, rain gardens, and street furniture, including restaurant seating. A parking lane along North Street provides an adequate buffer between pedestrians and the roadway.

*Redesigned sections of North Street with wide sidewalks, enhanced greenery, and curb bump-outs*

- Repair sidewalks including loose pavers and broken slabs of concrete, where needed
- Enforce city ordinance to maintain a clear sidewalk walking zone where outdoor dining/seating is offered

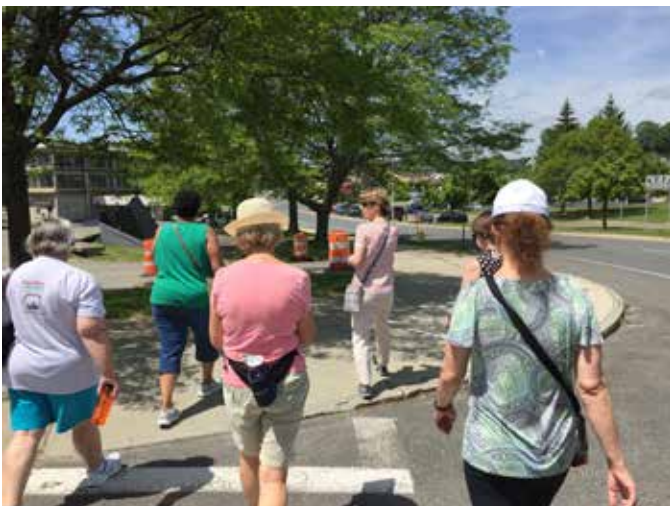
West Street is a wide, four-lane road with a center island. This segment of West Street has driveway access to parking and drive-through service for multiple banks, as well as access to a large downtown parking structure. Given the wide road and steep downhill grade moving west along this section, cars can pick up significant speed. There are no crosswalks across West Street between North Street and Center Street. Sidewalks run along both sides of West Street at a good width and with a small grass buffer between pedestrians and traffic. The sidewalk surfaces, however, are often uneven or cracked.

*West Street has wide sidewalks and a buffer between moving traffic and the sidewalk. However, the sidewalks are in need of repair.*

- Repair and/or replace sidewalks and curb ramps along West Street
- Narrow driveway entrances and consider eliminating those no longer in use
- Consider adding a crosswalk across West Street on the west side of the unsignalized intersection of Edwin Street and West Street. Construction would require that the median be redesigned as a pedestrian refuge island and the installation of curb ramps

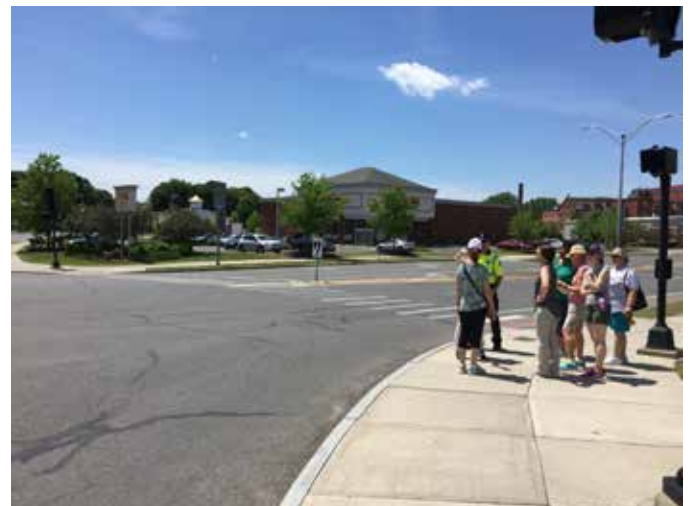
The West Street/Center Street intersection is a large, four-way intersection with two approaches that widen to six lanes to include turning lanes. The presence of curb ramps, detectable warning strips, and well-marked crosswalks improves the safety of pedestrians using this intersection. The pedestrian signal timing for people crossing the road provides a reasonable amount of time to cross. Traffic approaching this intersection from both West Street and Center Street build up considerable speed before reaching the intersections. Wide curb radii allow drivers to maintain those high speeds while turning. Because the signal phasing allows for cars to turn while pedestrians have a walk sign (e.g., concurrent phase), the wide curb radii and speed associated with them can create an added danger to pedestrians.

*Intersection of West Street and Center Street*

- Study alternative signal phasing options to determine its impact on traffic congestion and pedestrian safety. Consider a leading pedestrian interval.
- Consider tightening curb radii to slow the speed of cars before they make turns. Short-term fixes could include paint and flex-posts. Long-term fixes would include moving curbs and narrowing travel lanes.

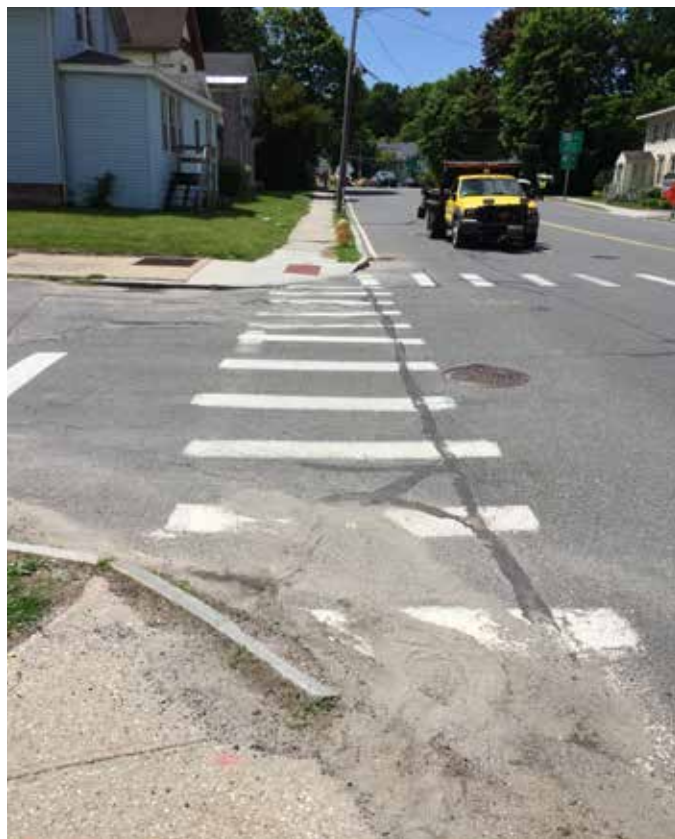
The curb ramps and sidewalks along the eastern side of the intersection are in poor shape and do not allow for easy access. The northeast corner of the intersection is overgrown with plants, crowded with trash, and has sidewalks in need of repair. The northwest corner of the South Church Street/Center Street intersection has a wide curb radius, which lengthens the crossing distance for pedestrians.

*Broken curb ramps, sidewalks, and debris make this intersection an unwelcome crossing.*

- Maintenance of sidewalks, curb ramps, and crosswalks including fixing broken concrete slabs, clearing overgrown plants, cleaning up trash, and repainting crosswalks
- Examine possibilities for adding a crosswalk across Center Street on the north side of the intersection. Potential areas of conflict include the gas station driveway, carousel driveway, and sight distances from the Center Street and Church Street intersections
- Add an in street pedestrian sign to raise awareness of pedestrians crossing Center Street
- Reduce the crossing distance on the intersection's northwest corner using curb bump-outs.
- Narrow travel lanes on South Church Street using pavement markings

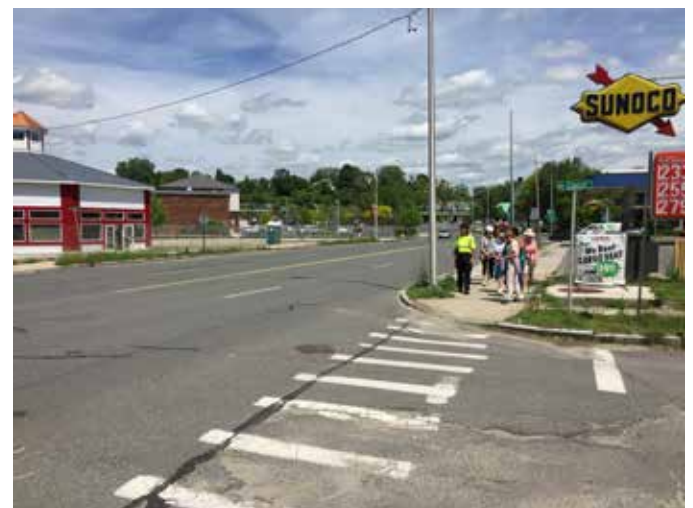
*High speeds and the lack of a crosswalk at a natural pedestrian desire line make this a potentially dangerous crossing to the carousel.*

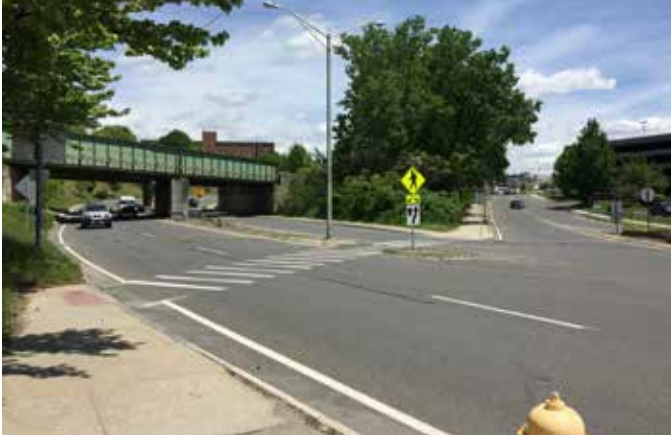
*This crossing at Center Street can be dangerous given the high driving speeds and the changes in light drivers experience moving south beneath the overpass.*

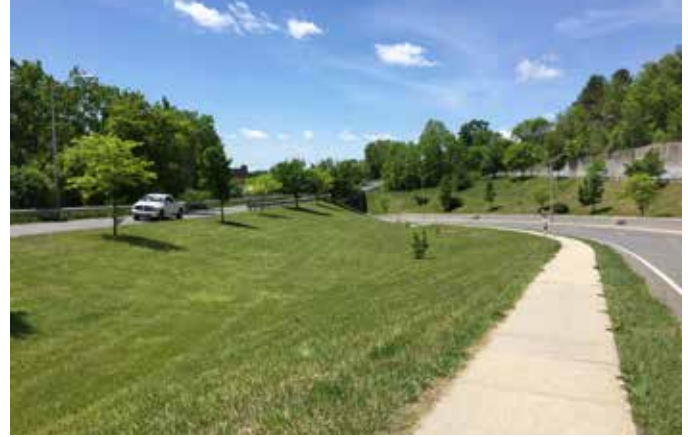
This section of Center Street has sidewalks that are discontinuous and intersections with no marked places to cross. On the east side of Center Street, the sidewalk curves along a right-turn slip lane to Depot Street, but there are no crosswalks across Depot Street to continue north on Center Street.

The sidewalk along the west side of Center Street ends just past Depot Street. There is a crosswalk with flashing pedestrian signs across Center Street to allow people to continue walking north on Center Street. However, people frequently don't cross as evidenced by a path worn in the grass along the west side. This walking behavior is dangerous and has resulted in one fatality in this area. Cars pick up considerable speed coming south on Center Street and go under an overpass almost immediately north of the crosswalk at Depot Street. The overpass partially shades the road causing visibility issues; drivers' eyes need to adjust to the change from dark to light and may not see a pedestrian walking along the roadway.

*The sidewalk and buffer along Center Street are nice. However people attempt to walk along the road to the left in the picture, which has no sidewalk.*

- Install two crosswalks across Depot Street where it intersects with Center Street; (1) across the right-turn slip lane to the island, and (2) across Depot Street to the corner of Center Street
- Install appropriate "yield to pedestrian" signs to raise driver awareness of potential pedestrians crossing Center Street at Depot Street

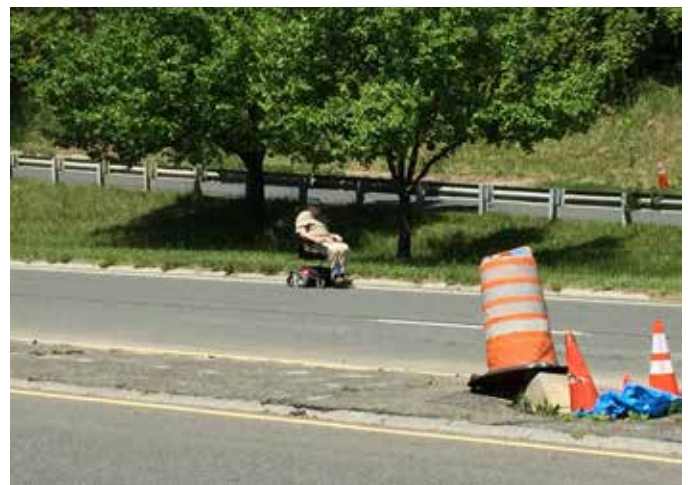
The lack of sidewalk on the west side of Center Street has not deterred people from walking on that side of the road where drivers pick up significant speed as they travel downhill under the overpass. A worn walking path through the grass shows the frequency of walkers using this side of the road. During the assessment, a man in an electric wheelchair scooter drove up the hill in the street rather than using the sidewalk because he claimed the sidewalk on the east side of Center Street was not smooth enough for his chair.

*People continually walk on the side of Center Street where there is no sidewalk despite multiple lanes of fast-moving traffic.*

- Repairing cracked concrete sidewalks and clear away debris
- Encourage a police presence to reduce vehicle speeds and encourage walking on the side of the road with a sidewalk
- Consider conducting pedestrian safety seminars or distributing pedestrian safety information to the apartment and housing development residents on Columbus Avenue

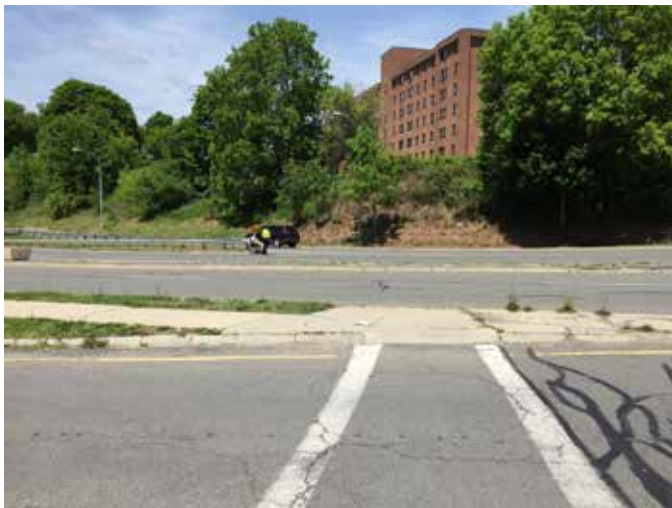
*Cars coming from the access road onto Center Street do not yield at this crosswalk, which is poorly painted and not well signed.*

At the top of the hill, drivers coming from the neighborhood west of downtown connect with Center Street to continue north via an access road over Center Street. Drivers must yield at this intersection and walkers must cross the access road to reach the sidewalk. There is a crosswalk, but it is faded and there are no advance warning or yield to pedestrian signs. Drivers are most likely looking left to see if there is oncoming vehicle traffic since they are merging onto Center Street. As a result, they may not see someone attempting to cross. In fact, drivers did not yield to the group of walk assessment participants (which included a uniformed police officer).

- Replace the yield sign with a stop sign for cars entering Center Street
- Repaint the crosswalk using either a ladder or continental style
- Install advance crosswalk and yield to pedestrian signs before the access road/ Center Street intersection
- Encourage a police presence to reduce vehicle speeds

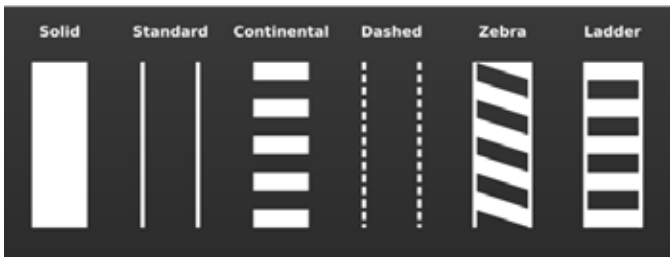
Crosswalks can be painted in a variety of ways, some of which are more effective in warning drivers of pedestrians. Crosswalks are usually accompanied with stop lines. These lines act as the legally mandated stopping point for vehicles, and discourage drivers from stopping in the middle of the crosswalk.

Crosswalk patterns  
Source: USFHA

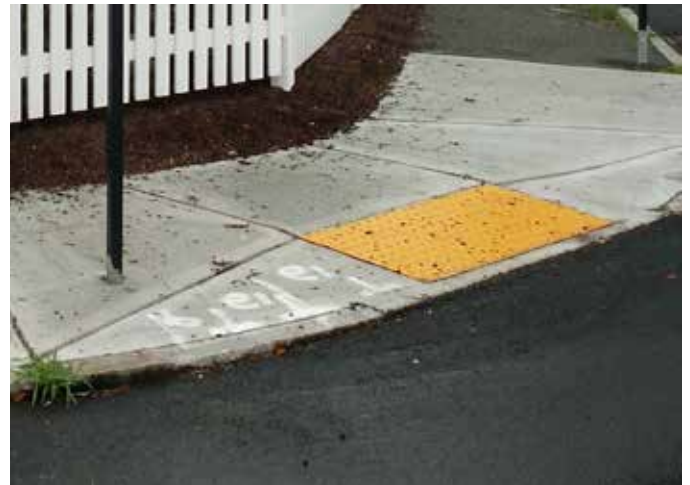
Curb ramps provide access from the sidewalk to the street for people using wheel chairs and strollers. They are most commonly found at intersections. While curb ramps have improved access for wheelchair-bound people, they are problematic for visually impaired people who use the curb as an indication of the side of the street. Detectable warning strips, a distinctive surface pattern of domes detectable by cane or underfoot, are now used to alert people with vision impairments of their approach to streets and hazardous drop-offs.

Curb ramp and detectable warning strip in Woburn, MA

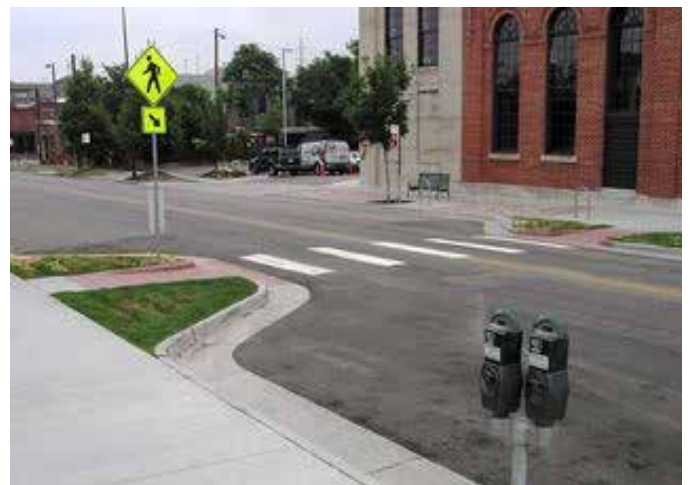
A sidewalk extension into the street (into the parking lane) shortens crossing distance, increases visibility for walkers and encourages eye contact between drivers and walkers.

Curb extensions are often associated with mid-block crossings

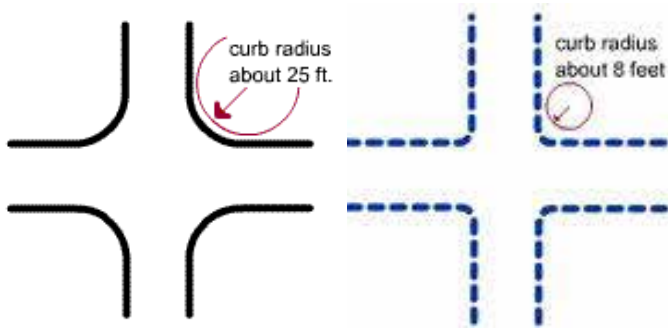
A longer curb radius (on the left in figure below) allows vehicles to turn more quickly and creates longer crossing distance for pedestrians. A shorter curb radius (on the right in the figure below) slows turning speeds and provides pedestrians shorter crossing distances.

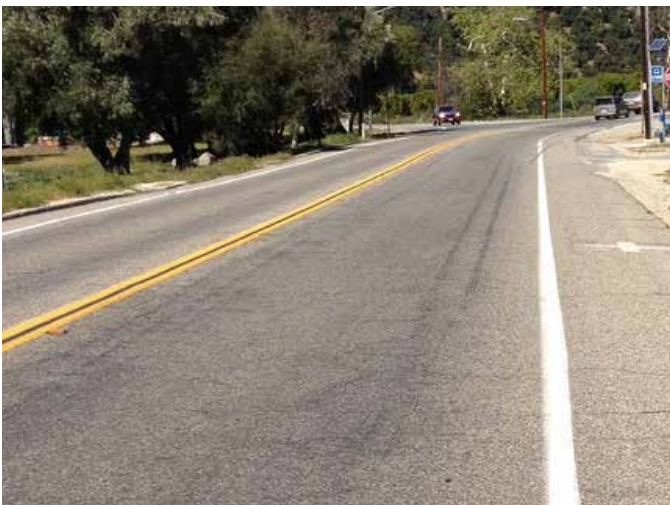
A fog line is a solid white line painted along the roadside curb that defines the driving lane and narrows the driver's perspective. Fog lines are most often used in suburban and rural locations, but may be appropriate in some urban conditions.

*Fog lines delineate the vehicular driving zone on wide roadways.*

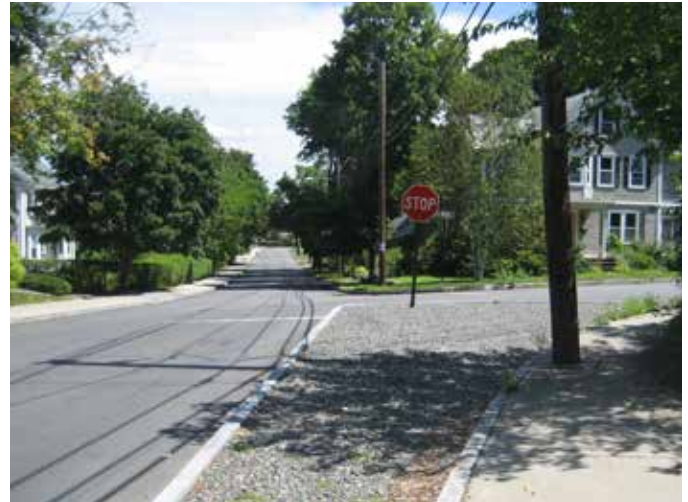
There are two excellent examples of the shortening of curb radii in Woburn, MA. The first (A) is a low-cost solution using a gravel-filled zone between the original curb line and the newly established road edge. The second is a higher-cost solution using grass and trees and extending the sidewalks to the new curb. Both work to slow traffic.

*(A) Gravel-filled curb extension*

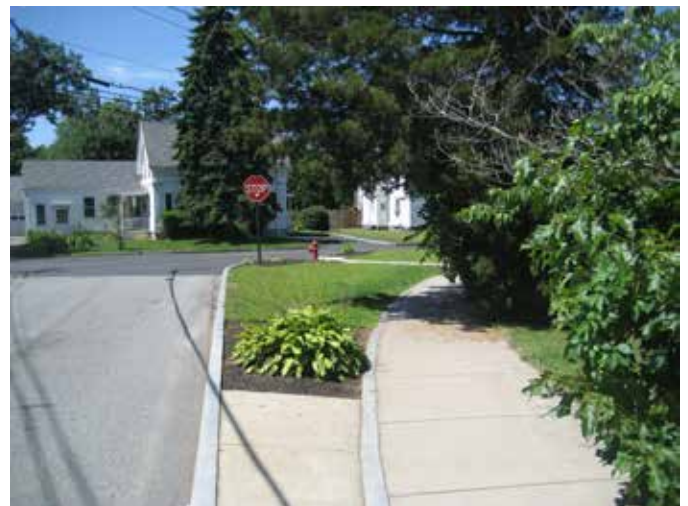
*(B) Grass, trees and extended sidewalk in curb extension*

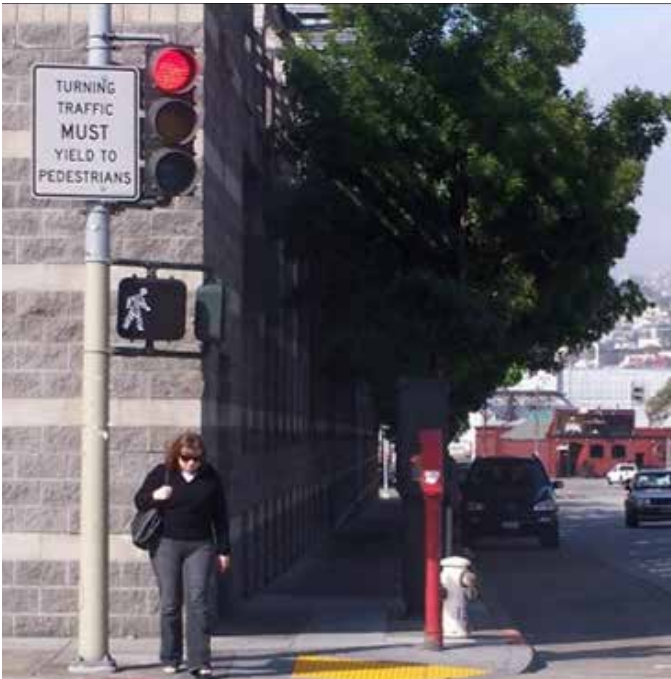
A leading pedestrian interval gives pedestrians an advance walk signal before motorists get a green signal, giving the pedestrian several seconds to start walking in the crosswalk before a concurrent signal is provided to vehicles. This makes pedestrians more visible to motorists and motorists more likely to yield to them. Typical LPI settings provide 3 to 6 seconds of advance walk time.
