## High Street Walk Assessment Lowell, MA

September 19 , 2017

**Walk Assessment Overview**

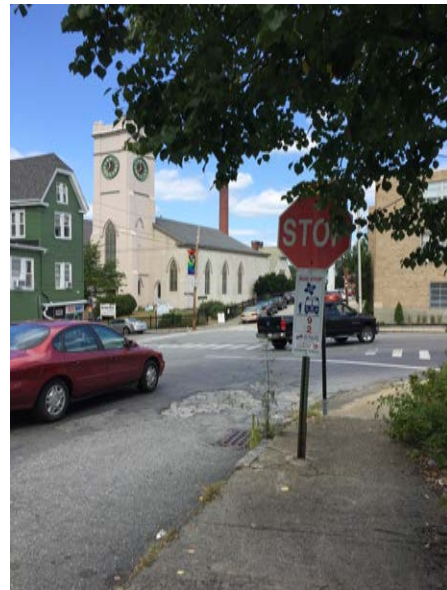
The E Merrimack/High Street intersection is confusing for all users – drivers, walkers, transit riders, and cyclists. Currently, only the High Street northbound approach is controlled with a stop sign. The STOP sign is obstructed by a tree limb and is posted tens of feet before the stop line painted on the street.

*Stop sign is blocked by tree branches and located over 10 feet behind the painted stop line on High Street*

- Install highly visible STOP signs on all approaches. Move or replace STOP sign on northbound High Street approach
- Paint STOP lines to indicate the location where drivers are required to stop
- Install school zone flashing beacons along E Merrimack Street and High Street

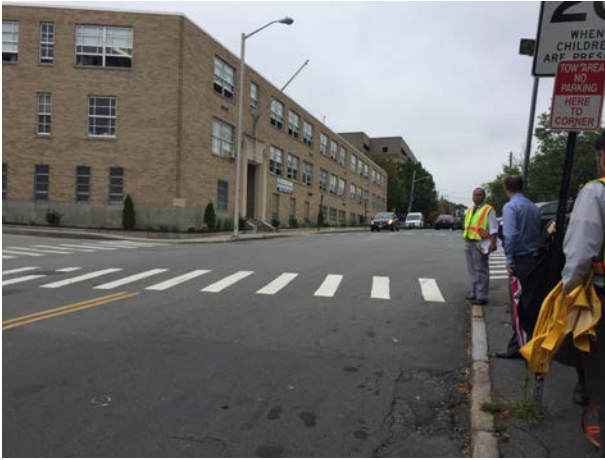
Traffic flows freely on E Merrimack where visibility of pedestrians and other vehicles is compromised by changes in elevation, parked cars, and a cluttered, busy landscape. A traffic study conducted in July, 2016 by the Lowell City Engineer found that the volume of vehicles and pedestrians at this intersection met the warrant of the Manual for Uniform Traffic Control Devices (MUTCD) for an all-way STOP as well as a signal system. City Council did not approve the installation of stop signs at this location.

*View from southwestern corner of E Merrimack and High Street intersection*

This is a very confusing intersection for all users. Drivers are unsure of who has the right of way. Sight lights here are also difficult with one driver reporting that “the intersection is blind.” Many of the sideswipes occur at the southwestern corner of the intersection where a convenience store is located. Drivers reported coming out of the convenience store only to see their cars clipped or their side mirror knocked off. Drivers on High headed north do not always stop at E. Merrimack because they do not see the STOP sign.

- Install traffic signals equipped with accessible pedestrian countdown signals. As discussed above, the pedestrian and vehicle volumes as well as the crash data meet the MUCTD warrant for a traffic signal at this intersection.

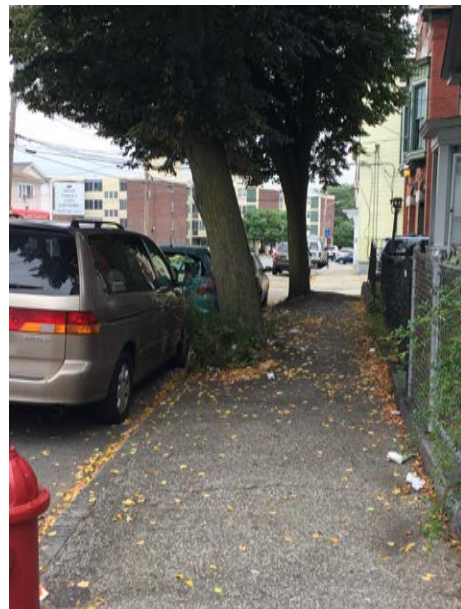
In general, the sidewalk widths along High Street are adequate. The walking surface is generally even with the exception of the upended panels near the mature trees on the east side of the street. The concrete sections of sidewalk are in much better condition than those sections paved in asphalt.

*Trees along this sidewalk have made this section impassable for those with limited mobility or strollers*

- Repair/replace sidewalk panels in dire need of repair, such as near the mature trees

- Replace all sidewalk panels in need with concrete sidewalks
- Ensure that all ramps are compliant with ADA standards and add detectable warnings and level landings
- Raise curbs to provide 6" reveal between the roadway and the sidewalk
- Reduce the extensive curb cuts leading to businesses and surface parking along the west side of High Street
- Paint the "Ls and Ts" to delineate parking spaces and bus stops on the roadway

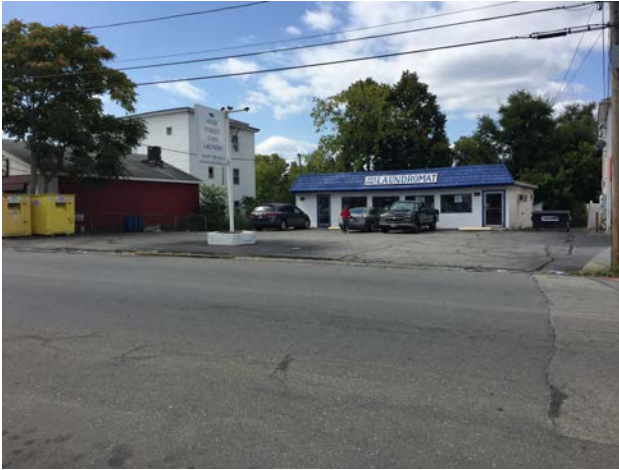
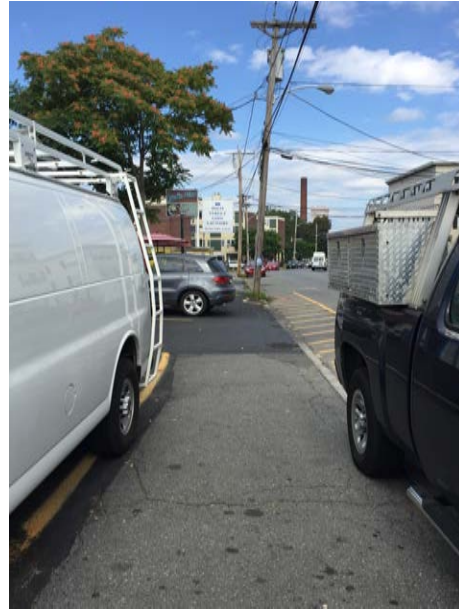
There are long stretches of curb cuts and some depressed curbs particularly on the west side of High Street. Cars park in these areas interrupting the pedestrian pathway and forcing people to walk in the street. The entry and egress from the parking areas is also confusing. The Lowell Planning Department has been working with the Asados Dona Flor restaurant at 175 High Street to redesign their parking lot and seating areas.

*Businesses along the western side of High Street between Andover and Chestnut have allowed parking and wide curb cuts to take over the sidewalk*

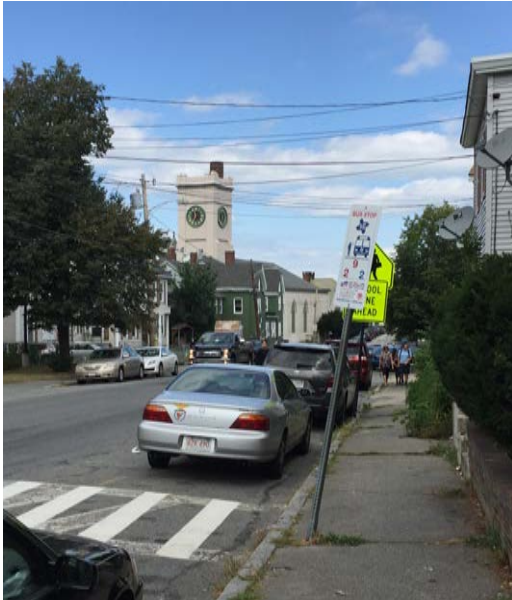
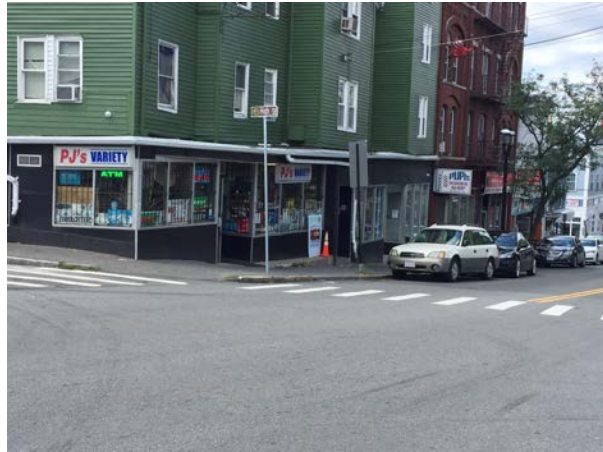
Parked cars can present a challenge for people trying to cross a street safely. Cars parked too close to an intersection, or too close to a mid-block crossing, prevent pedestrians from seeing oncoming traffic and drivers from seeing pedestrians who want to cross. High Street has examples of both of these conditions – at the E Merrimack Street, Chestnut Street and Andover Street intersections, and at the mid-block crossing in front of Norton Family Manor. Cars are not legally parked if they are within 25 feet of an intersection or crosswalk. Furthermore, cars are parked on the sidewalk on the north side of Chestnut Street between High and Fayette Streets significantly reduce the width of the sidewalk making it difficult for those in wheelchairs or using strollers.

*Cars parked too close to crosswalks and intersections block visibility for both pedestrians and drivers*

- Enforce parking regulations – issue tickets to those in violation
- Paint diagonal lines indicating no parking zones at intersections and near mid-block crossing
- Install No Parking signs
- Install curb ramps to access mid-block crossing in front of the Norton Family Manor
- Consider installing flex posts to delineate no parking zone near mid-block crossing

- Install curb bump outs at the mid-block crossing in front of the Norton Family Manor
- Consider installing a Rectangular Rapid Flashing Beacon (RRFB) in front of the Norton Family Manor

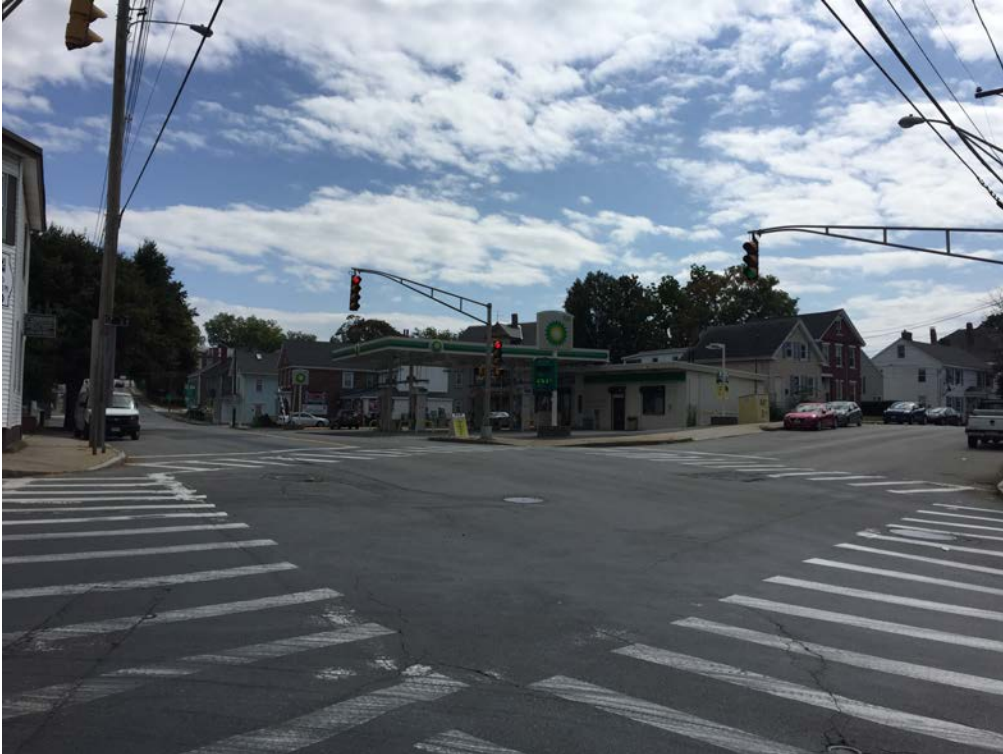
The traffic signal at the High Street/Andover Street intersection has an exclusive pedestrian phase, which gives pedestrians adequate time to cross one leg of the intersection, and almost enough time to cross diagonally. Given the length of time it takes for the signal complete its full phase before the WALK light is illuminated, it is worth considering extending the WALK time to accommodate diagonal crossing. It may also be prudent to add a couple seconds to the all RED phase to ensure the intersection clears. This may reduce the number of left-hand turn crashes in the intersection.

*View of the Andover/High Street intersection traffic signals and crosswalks*

One theory that may be a contributing factor in the number of rear-end crashes at the High Street/Andover crossing is that eastbound traffic on Andover Street can not see the traffic signal. Upgrades to the signal itself and warning signage could improve visibility.

- Extend the pedestrian phase so pedestrians can cross the intersection diagonally
- Consider adding additional time to the all RED phase to allow cars to clear the intersection
- Install signage or flashing red beacon on Andover Street as the road inclines up from the Concord River to alert drivers that there is a red traffic signal ahead.
- Place a back plate on the traffic signals to make them more visible
- Consider instituting No Right Turn on Red at the intersection to reduce crash rates and protect pedestrians in the crosswalk from right turning vehicles.
