Liberty Heights Walk Assessment
Area around Carew Street/Liberty Street intersection
Springfield, MA

September 26, 2017

Walk Assessment Overview

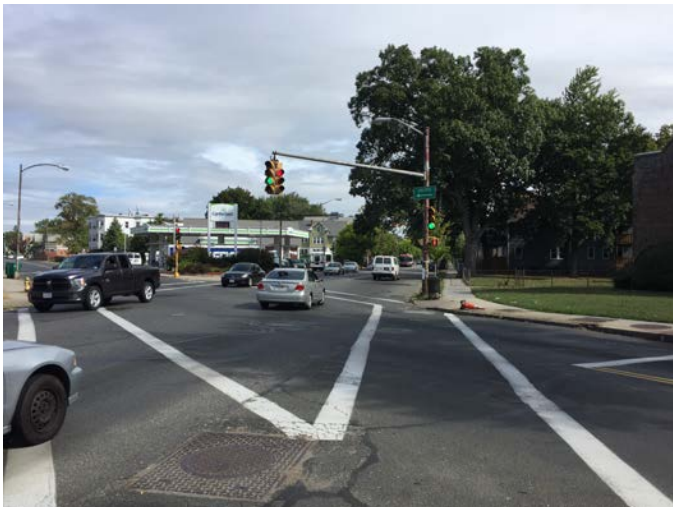
When the study team observed vehicle operations at Carew St/Liberty St intersection at 11 am on Friday, September 22, vehicles appeared to obey traffic signals and did not run red lights. The traffic signal cycle is very long, approximately 120 seconds. To receive a WALK signal, pedestrians must push a button and wait up to 115 seconds, which is almost two minutes for a WALK. The study team observed that many pedestrians did not wait for a WALK, but ran across the intersection with gaps in traffic.

Once the WALK signal is illuminated, the amount of time to cross one leg of the intersection is sufficient: 7 seconds of WALK time and 20 seconds of Flashing Don't Walk time. However, given the elongated nature of the diagonal crossing, there is not enough time for pedestrians to cross more than one leg of the intersection. Therefore, if someone wants to cross both legs of the intersection, it could take over four minutes.

View of Carew Street/Liberty Street intersection from southeast corner of Brunton Terrace

- Adjust signal phasing, possibly by shortening the signal cycle to 90 seconds, to prioritize the pedestrian phase to limit wait times for pedestrians; concurrent signals are not recommended given the high volumes of fast-moving traffic on Liberty and Carew Streets

- Upgrade pedestrian signals to include countdown clocks and accessibility accommodations
- Consider moving the crosswalks back from the intersection to shorten crossing distances – would require construction of new curb ramps, repainting crosswalks, stop lines and right-turn lane arrows

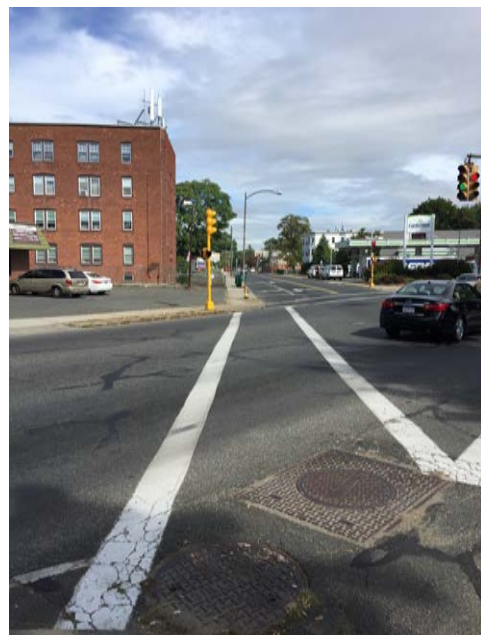
Due to the diagonal alignments of Carew and Liberty Streets, the crossing distances are long, measuring between 77' and 92' on Google maps. Although the signal phasing provides adequate walk time to cross one leg of the intersection, efforts need to be made to shorten the distances. Both Carew Street and Liberty Street are bus routes, so shortening curb radii or adding curb bump-outs may be difficult.

Diagonal crosswalks increase length of crossing distances.

- Repaint crosswalks with new City standard continental design with next scheduled maintenance

- Consider moving crosswalks back from diagonal alignment of the intersection – shorten crossing distances. Add new curb ramps.

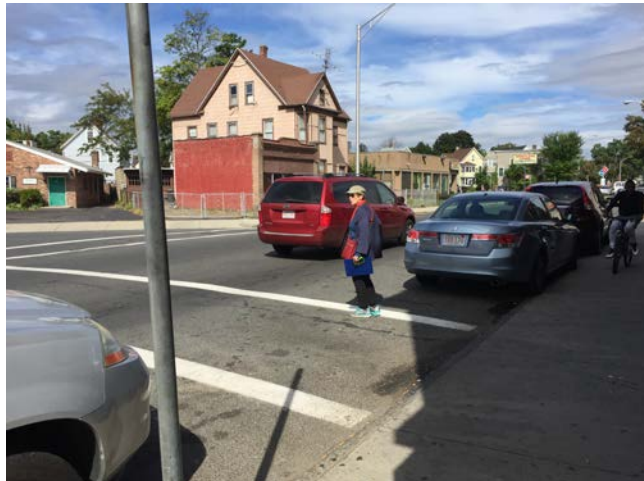
Cars are parked too close to the crosswalks, particularly on the east side of the street in front of the mini-mart. Drivers cannot see pedestrians that want to cross, and pedestrians cannot see oncoming traffic. Curb ramps and crosswalk signage are also missing from the Liberty Street crossings. Inexpensive improvements, such as pedestrian crossing signage and no parking signage and pavement markings, could enhance the safety of these crossings.

Pedestrians can't see oncoming traffic and drivers can't see pedestrians waiting to cross at the Cleveland Street intersection

- Repaint crosswalks with new City standard continental design with next scheduled maintenance
- Install advance crossing signage and curbside crosswalk signage with arrows at crosswalk location
- Consider placement of in-street pedestrian crossing sign in crosswalk across Liberty St
- Install no parking signs
- Paint diagonal lines or install flex posts within 25' of crosswalk to discourage parking
- Install curb ramps where they are missing along Liberty Street

- Install curb bump outs to shorten crossing distance and prevent cars from parking too close to the crosswalk

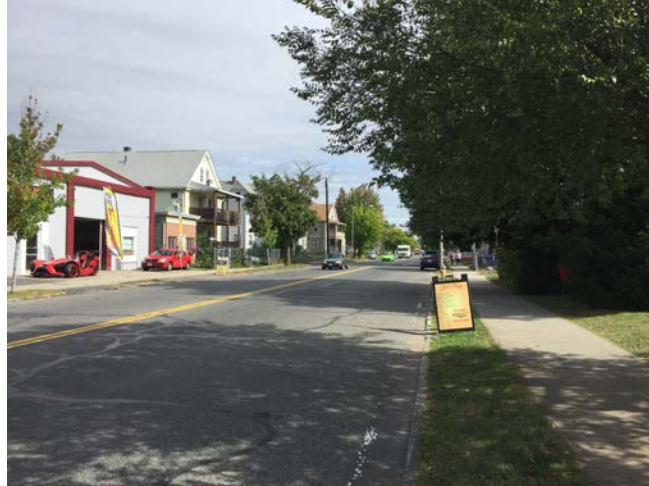
Carew Street is a relatively wide street measuring approximately 40 feet wide using Google maps. The only pavement markings on Carew Street, other than the yellow centerline, are faded fog (or edge) lines along the curb. Parking is allowed along much of the corridor, except at bus stops, although there are no pavement markings indicating either bus stops or parking spaces. Narrowing travel lanes with paint is known to reduce traffic speeds. If the maintenance cost of painting the “Ls and Ts” of parking spaces along the corridor are too steep, using a solid line marking a 10 to 11 foot travel lane would delineate room for a parking lane and driving lane.

Carew Street corridor is a urban arterial with wide lanes and few pavement markings.

- Paint lines to narrow travel lanes and delineate parking areas on Carew Street
- Trim vegetation along Carew Street
