Pearl Street Walk Assessment Somerville, MA

November 7, 2014

Massachusetts Department of Transportation
Bicycle and Pedestrian Safety Program

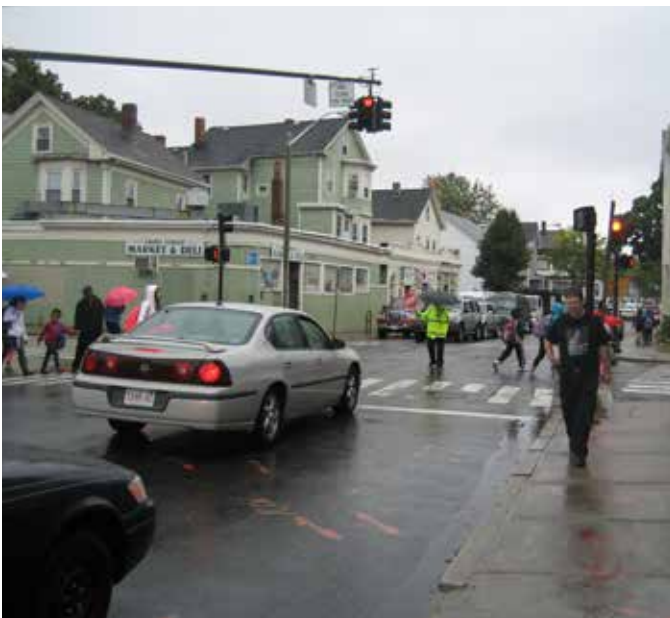
ESCS dismissal at the Cross/Pearl Street intersection

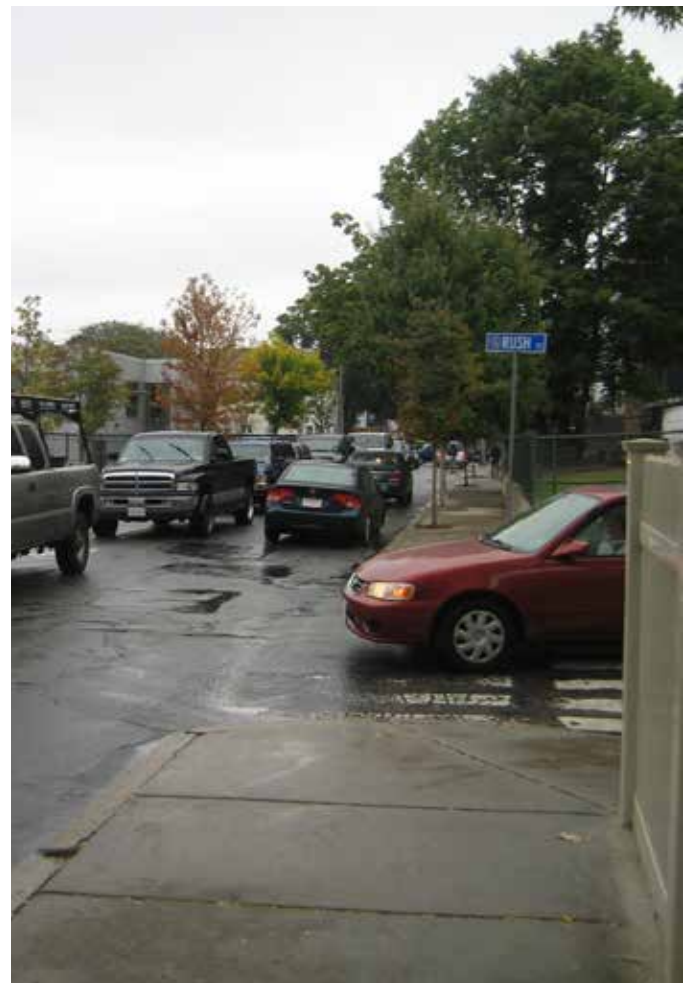
Vehicles waiting to turn left block this crosswalk

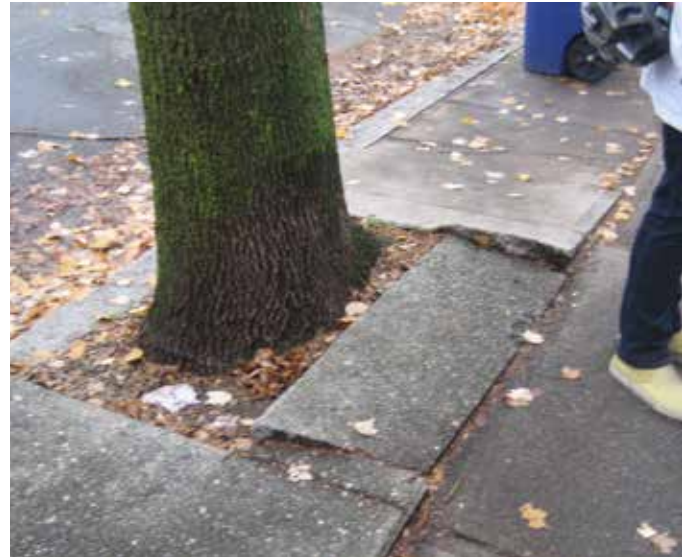
- Sidewalks are not uniformly accessible; missing curb ramps and detectable warning strips (some curb ramps have been upgraded on the south side of Pearl between Walnut and Medford); narrow openings between trees and edge of sidewalks; heaving concrete panels
- Limited visibility from driveways and at intersections along Pearl Street compromises pedestrian safety
- Crosswalks are faded and not perpendicular to curb line; “piano key” design but skewed to reach curb ramps or accommodate other road conditions

Heaving concrete panels around trees are tripping hazards.

- Repair curb ramps and install detectable warning strips to meet ADA accessibility requirements
- Widen sidewalks through selective tree removal; preserve trees where possible; replace or repair concrete panels to eliminate tripping hazards
- Study location of on-street parking as it relates to driveways and intersections; consider prohibiting parking in those locations where visibility is compromised
- Evaluate location of crosswalks and repaint those that are faded
- Evaluate signal phasing to determine if a concurrent phase is possible. Before switching to a concurrent phase, evaluate the red light compliance and crash data. Add leading pedestrian interval (LPI) with concurrent phase, if appropriate.

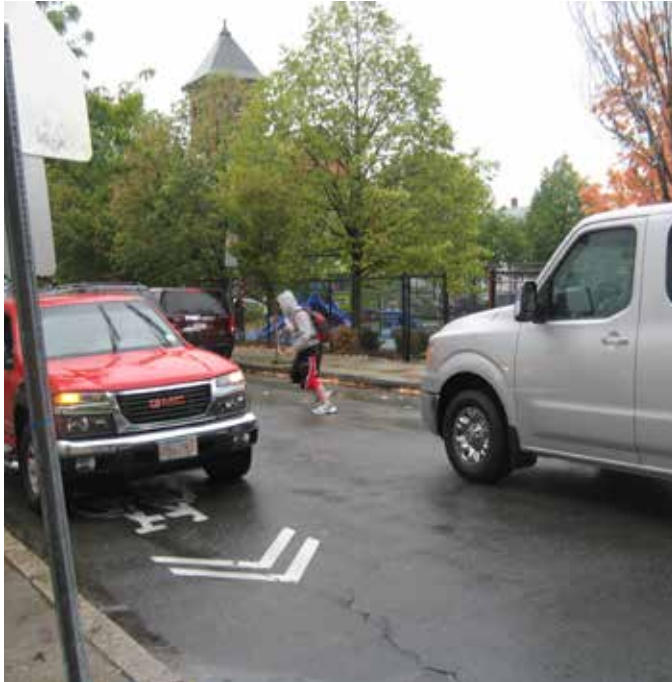
- Double parking along Cross Street
- Parking in the MBTA bus stop preventing the bus from pulling over and causing traffic to back-up
- U-turns on Cross Street either before or after students were dropped off
- Students crossing (primarily with their parents) between parked cars and mid-block rather than using the signalized intersection staffed with a crossing guard
- Posted ESCS staff member in the school bus lane to prevent cars from entering the exclusive lane; if he left his post to manage other traffic infractions on Cross Street, cars would drive into bus lane almost immediately (according to staff member)

An ESCS student darts across the street

The assessment team recommends that a comprehensive study of the arrival and dismissal patterns and policies be reviewed to determine the best course of action to improve pedestrian safety around ESCS. The study should include interviews with the school principal, crossing guards, and other staff members assisting in arrival and dismissal. Transportation surveys should be administered to all families and mapped to better understand where students are coming from, and how they are reaching the school campus.

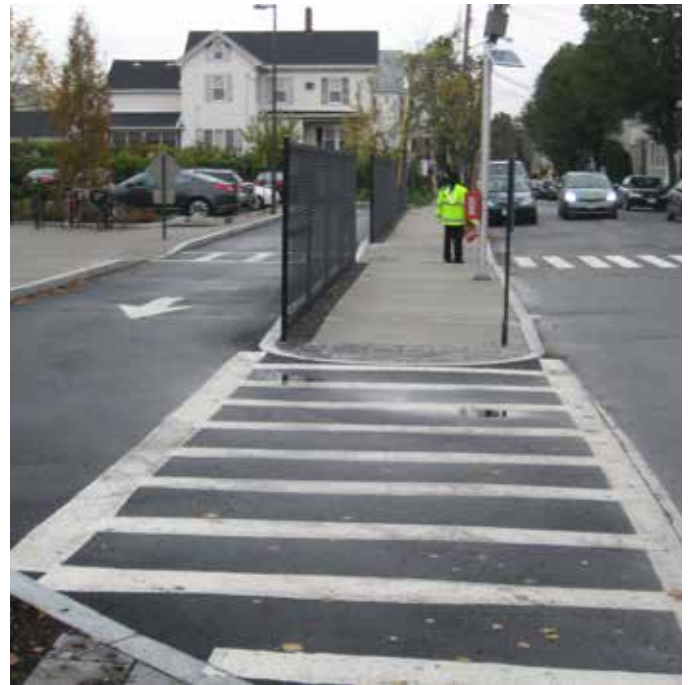
Well-marked crosswalk and a separated drop-off lane increase the safety of this dangerous zone. However, most students are dropped off on the Cross Street side of the school.

- Determine if there are drawbacks to using the Glen Street drop off zone and work with the City of Somerville Traffic and Parking Offices to alter traffic patterns, if needed
- Work with the Somerville Police Department to periodically enforce parking restrictions and other traffic laws during arrival/dismissal times
- Flip the vehicle drop-off zone on Glen Street with the bus drop-off zone on Cross Street, if possible

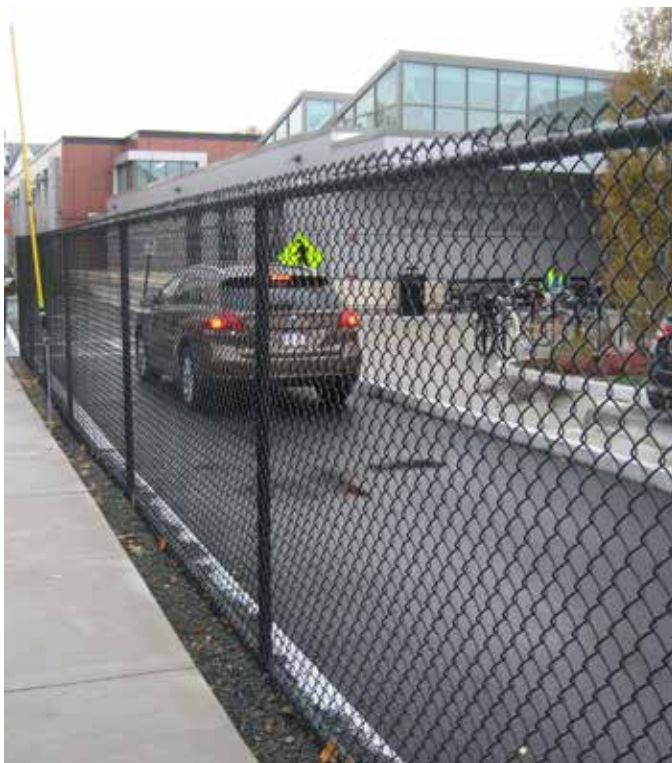
A fence separates this sidewalk from the car drop-off lane on Glen Street

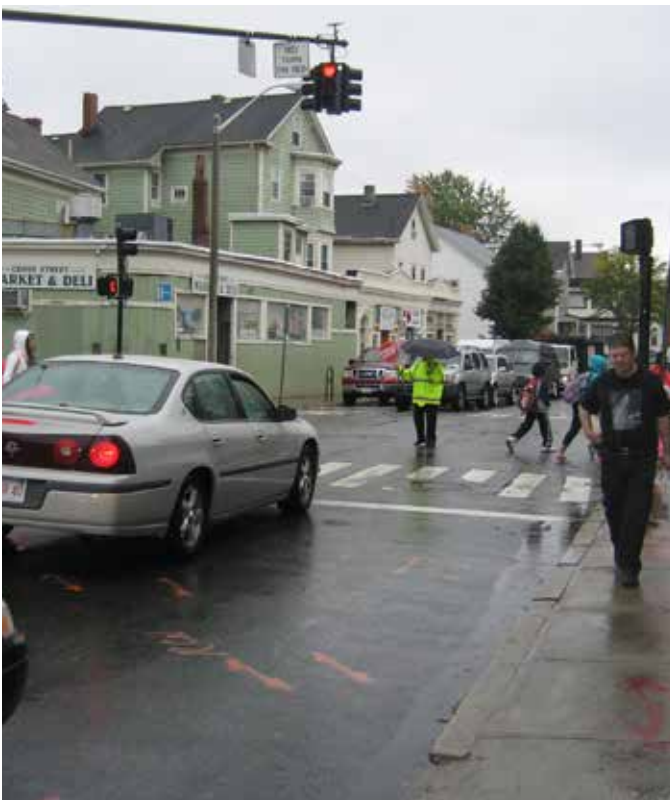
The intersection of Pearl and Cross Streets is the center of pedestrian activity near the East Somerville Community School

- No lane markings on Cross Street: double yellow or parking lanes
- Flashing school zone beacon is not functioning
- Missing curb ramps
- Pedestrian traffic signal is misaligned and is not facing pedestrians in crosswalk
- MBTA bus stops on the north side of Pearl Street on both sides of Cross Street pinch the intersection (northbound bus on the far side of the intersection; southbound bus on the near side of the intersection)

- Repair or replace flashing school zone beacon; evaluate other approaches to school for adequate school zone signage and pavement markings
- Install accessible curb ramps and detectable warning strips on all corners
- Realign pedestrian traffic signal head so that it faces oncoming pedestrians
- Work with MBTA to determine if southbound bus stop could be moved to the far side of the Pearl/Cross intersection to provide more right-of-way for other travel modes

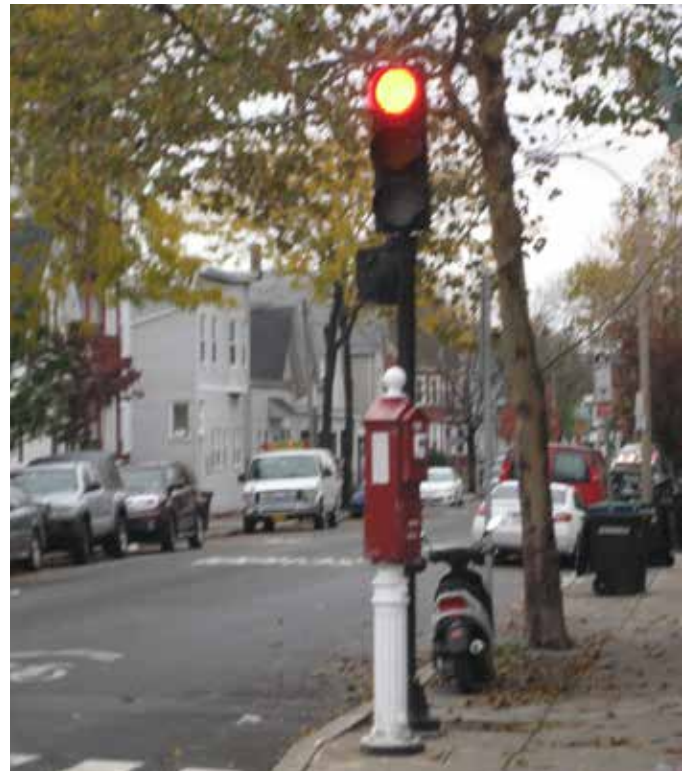
The pedestrian crossing signal is facing the wrong direction at the Cross/Pearl intersection

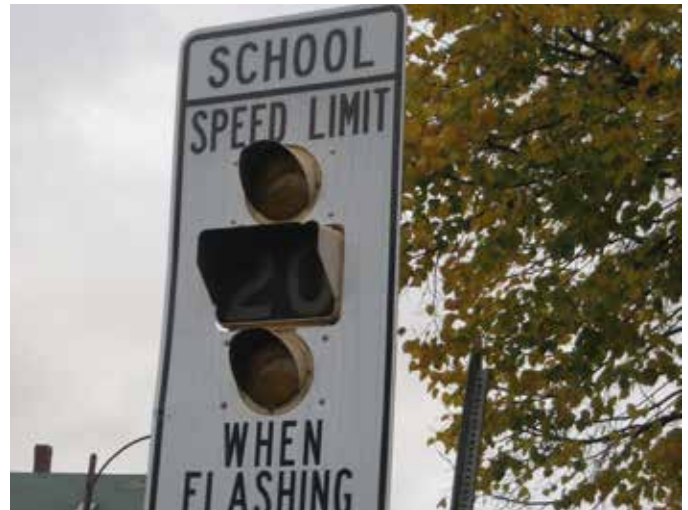
The school zone beacon at the intersection of Pearl and Cross Streets is not functioning

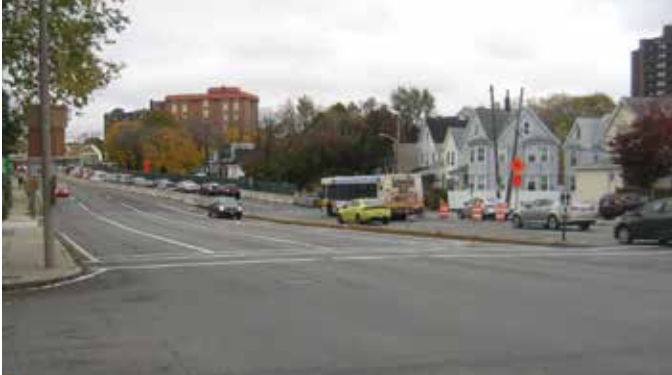
McGrath Highway, looking south

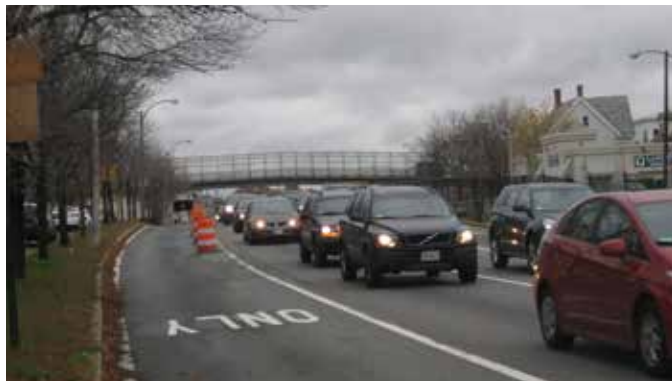
McGrath Highway, looking north

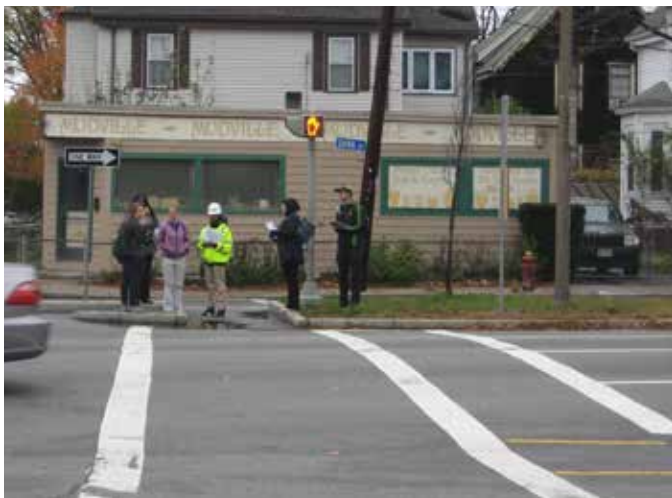
Crosswalk at Pearl Street and McGrath Highway

- Auto repair shop on SW corner of intersection has extensive curb cuts and minimal separation between driveways and sidewalks
- Pedestrian phase of traffic signal seems short considering pedestrians are crossing six lanes of traffic (timed at 22 secs)
- Long crossing distance across McGrath Highway; no pedestrian refuge island
- Pedestrian traffic signals are not countdown signals
- Crosswalk pavement markings are minimal; two parallel lines
- No Right Turn on Red Signs (RTOR) are easily missed; may not be posted for traffic traveling westbound on Pearl Street at the McGrath intersection or for traffic on McGrath Highway turning onto Pearl Street
- Missing detectable warning strips on all curb ramps

- Install pedestrian countdown signals
- Enhance crosswalk pavement markings to zebra, ladder or continental design to raise awareness of crossing point and discourage drivers from stopping beyond the stop line

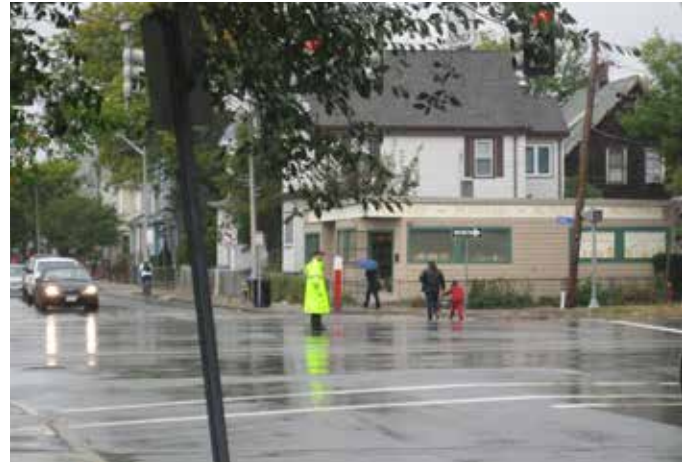
Crossing guard helps students and families cross McGrath Highway during school dismissal

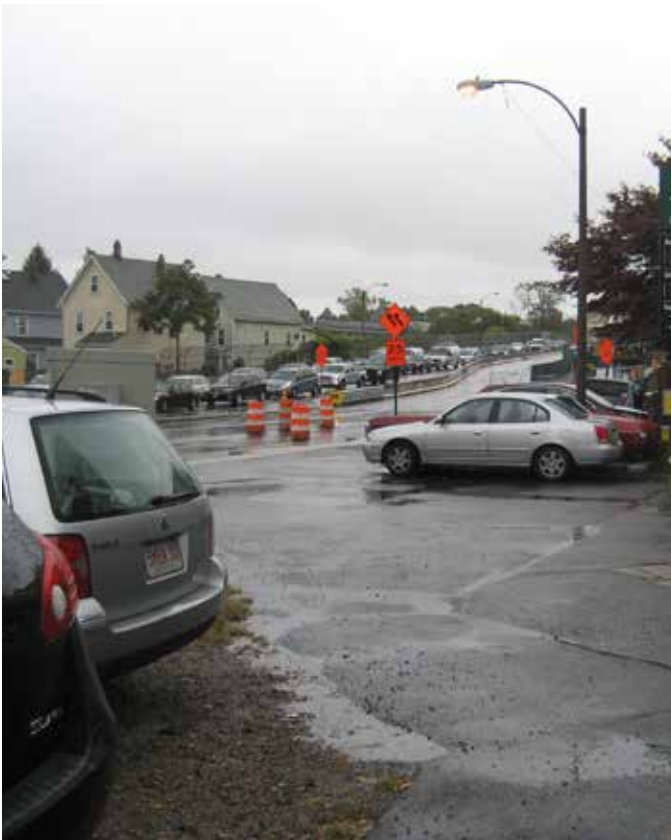
The parking lot of the auto repair shop on the southwest corner of McGrath Highway/Pearl Street intersection blends with the sidewalk compromising the pedestrian zone

- Work with auto repair shop owner to delineate pedestrian zone from parking and driveway areas
- Evaluate pedestrian phase of traffic signal to ensure that there is adequate time for pedestrians to cross and clear the intersection

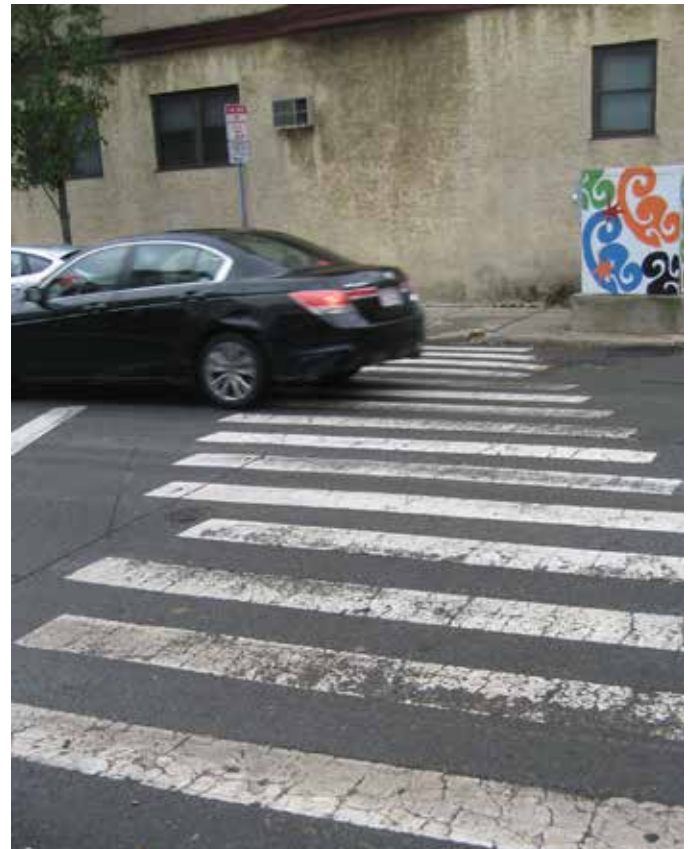
- Exclusive pedestrian phase on traffic signal; wait time seems long given one-way traffic pattern; not a countdown signal
- Crosswalks are not parallel to the curb lines; connect to curb ramps while avoiding traffic signal equipment and control boxes
- Crosswalks are faded
- Curb ramps are missing detectable warning strips
- Traffic moves quickly down Walnut Street sometimes speeding through Pearl/Walnut intersection

Crosswalk at Pearl and Walnut Streets

- Evaluate signal phasing to determine if a concurrent phase is possible. Before switching to a concurrent phase, evaluate the red light compliance and crash data to be sure motorists typically comply with existing signal. Add leading pedestrian interval (LPI) with concurrent phase, if appropriate.
- Evaluate crosswalk locations on all approaches; determine if they can be regularized to improve experience for visually impaired and increase proper use of crosswalks
- Repaint faded crosswalks
- Install detectable warning strips and evaluate all curb ramps to ensure they meet ADA accessibility standards
- Consider installing curb bump-outs on Walnut Street to slow traffic speeds and increase visibility of pedestrians and shorten crossing distances

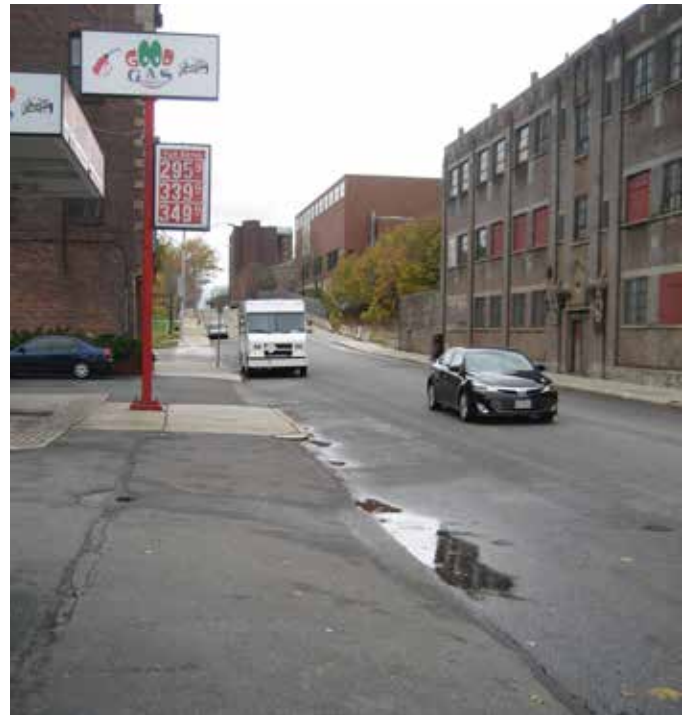
Medford Street looking toward Pearl Street Intersection

- Crossing distance on Pearl Street is long; curb radius at the northeast corner is wide
- Traffic moves quickly northbound on Medford Street
- Few marked crossings on Medford Street; only at signalized intersections
- Pavement markings are minimal and worn; no consistent road centerline on Medford Street, faded crosswalks and stop line
- Curb ramps are new, but curbs and traffic control equipment crowd the ramps

- Consider installing curb bump-outs on Pearl Street to shorten crossing distances and tighten curb radii
- Implement traffic calming strategies on Medford Street
- Evaluate number of crossings on Medford Street and determine if additional crossing points are needed; proposed Gilman Square green line station will likely generate more pedestrian traffic and may require a marked crossing at this intersection
- Repaint pavement markings: centerline on Medford Street, parking lane or edge lines on Pearl Street, crosswalk on Pearl Street, and stop line
- Evaluate curb ramps to determine if they meet ADA accessibility standards

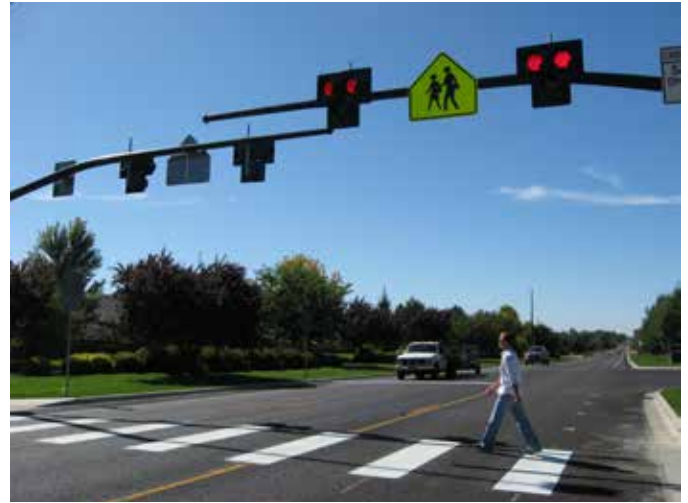
A HAWK beacon (High-Intensity Activated crossWalk beacon) is a traffic signal used to stop road traffic and allow pedestrians to cross safely. It is officially known as a Pedestrian Hybrid Beacon (PHB). The purpose of a HAWK beacon is to allow protected pedestrian crossings, stopping road traffic only as needed. Where standard traffic signal 'warrants' prevent the installation of standard three-color traffic signals, the HAWK beacon provides an alternative.

Walker crosses roadway after activating the HAWK beacon
Source: <http://www.achdidaho.org/Projects/Images/NewHawkSignal092209%20014.jpg>

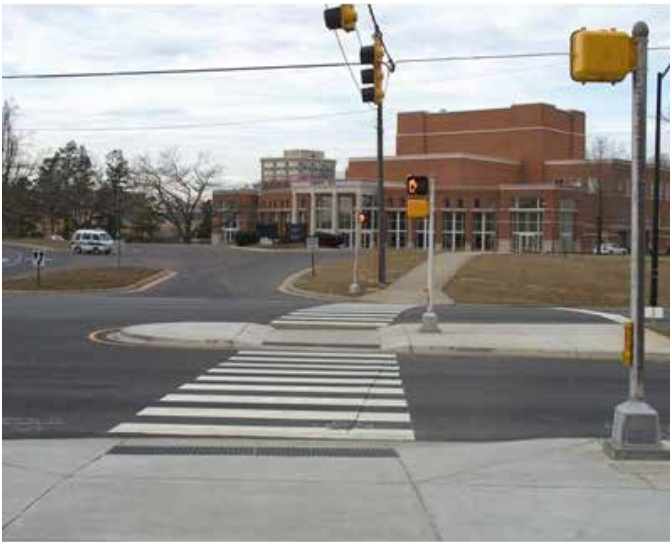
Pedestrian refuge islands are protected areas where people may safely pause or wait while crossing a street. Pedestrian refuge islands are particularly helpful as resting areas for seniors, persons with disabilities, children, and others who may be less able to cross the street in one stage. At signalized intersections, they allow slow moving pedestrians to cross in two phases. At unsignalized locations, they simplify the act of finding a gap in traffic to cross since vehicles from only one direction must be reckoned with at a time.

Pedestrian refuge island at a signalized crossing
Source: <http://safety.fhwa.dot.gov/intersection/resources/fhwasao6o16/images/fig95.jpg>
