South End Neighborhood Walk Audit New Bedford, MA

October 19, 2016

Purpose of the Assessment

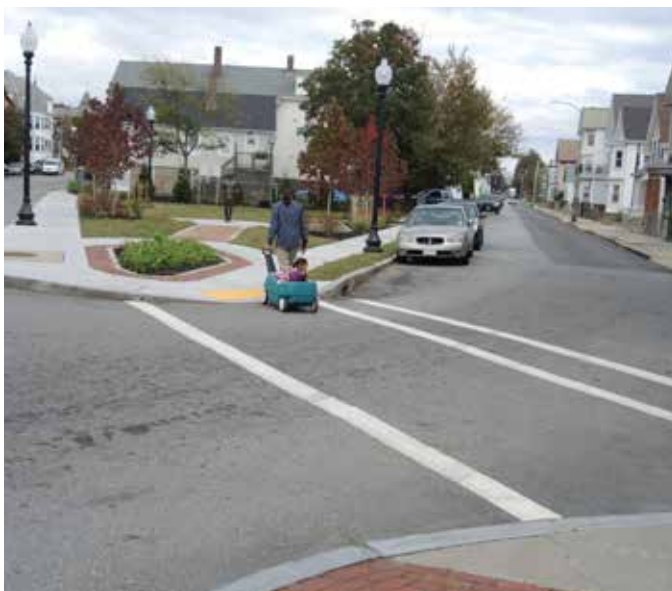
Recent intersection improvements at S 6th Street, Grinnell and County Streets

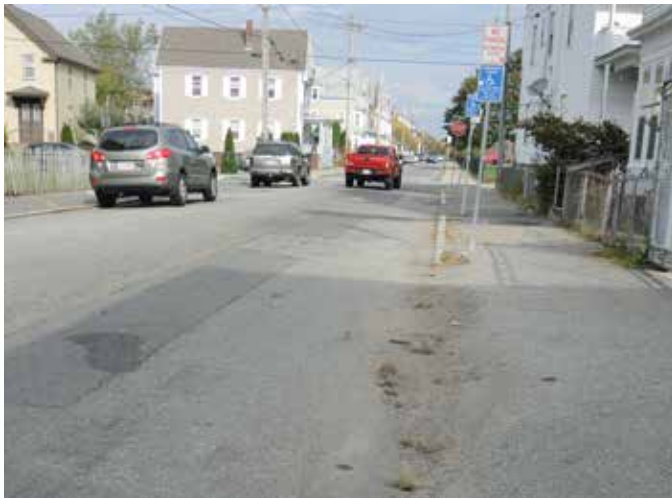
The majority of the sidewalks along the route are concrete. However, the section of sidewalk on South 2nd Street between Rivet Street and Potomska Street is asphalt. Asphalt is also occasionally used to patch the concrete sidewalks throughout the neighborhood. While smooth asphalt is better than broken concrete, asphalt is not as high quality material and can convey a lower investment in the neighborhood.

Asphalt sidewalk on along S 2nd Street between Rivet and Potomska Street

- Replace sidewalk panels disrupted due to tree roots. New Bedford Department of Public Infrastructure (DPI) has a short-term fix that preserves the tree and provides a smoother sidewalk
- Replace asphalt sidewalk between Rivet Street and Potomska Street with an concrete sidewalk
- Motivate residents and property owners to trim vegetation and pick up litter/trash on sidewalks near their property. Neighborhood organizations, faith-based institutions, schools or social service organizations can be good partners in these efforts
- Activate sidewalks with activity along high volume pedestrian corridors – could include temporary installations or pop-up parks; consider installation of parklets – temporary seating areas placed in parking spaces in front of businesses to provide outdoor gathering spaces

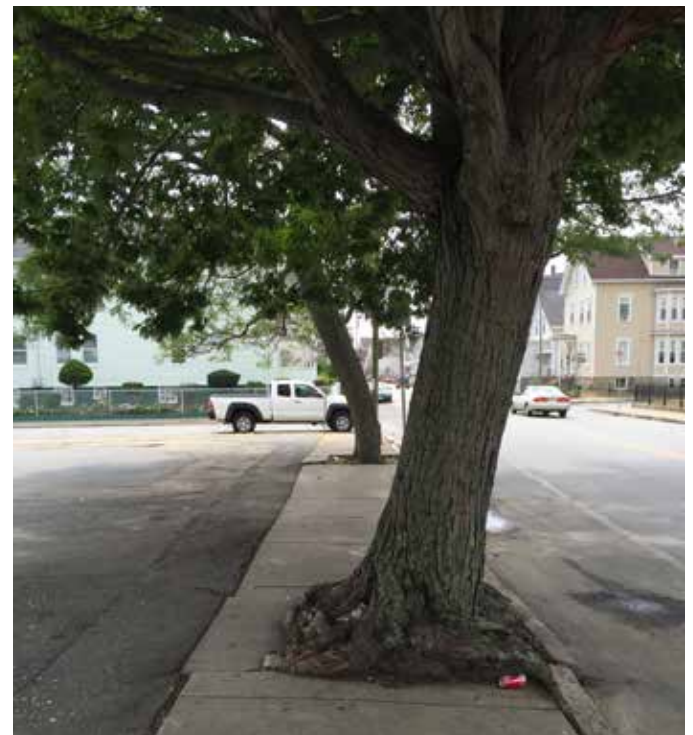
- Cracked or heaving panels due to tree roots or freeze/thaw cycles
- Narrowing due to overgrown trees or proximity to fences and building edges
- Lack of maintenance – trash, litter-filled; overgrown vegetation

Trees overtaking the sidewalk along County Street

- Participate in the planning and design of South End road reconstruction projects to ensure adequate sidewalk width and connectivity

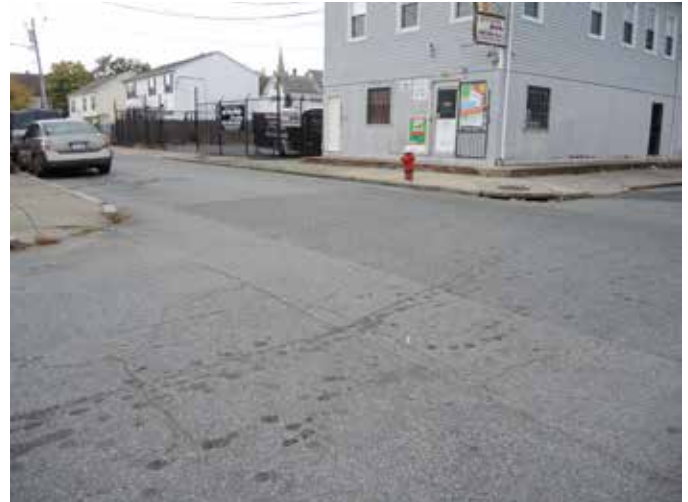
There are no marked crosswalks at the intersection of Grinnell Street and Acushnet Avenue despite the presence of a convenience store on the corner. Curb ramps and detectable warning panels are also missing.

- Develop a crosswalk painting plan that prioritizes highly utilized pedestrian corridors and walk to school routes
- Paint new high visibility crosswalks at high priority locations; continue with lower priority locations as funding and time allows
- Repaint existing crosswalks with high visibility crosswalks
- Install school zone beacons and signage along South 2nd Street near the Gomes and Renaissance Schools
- Hold community design charrette/workshop to rethink the connection between the neighborhood and the Gomes/Renaissance Schools at Grinnell Street

- Install ADA-compliant curb ramps and detectable warning panels on all approaches to all intersections and mid-block crossings
- Identify partnership and funding opportunities to implement new gateway concept at Grinnell Street/South 2nd Street intersection

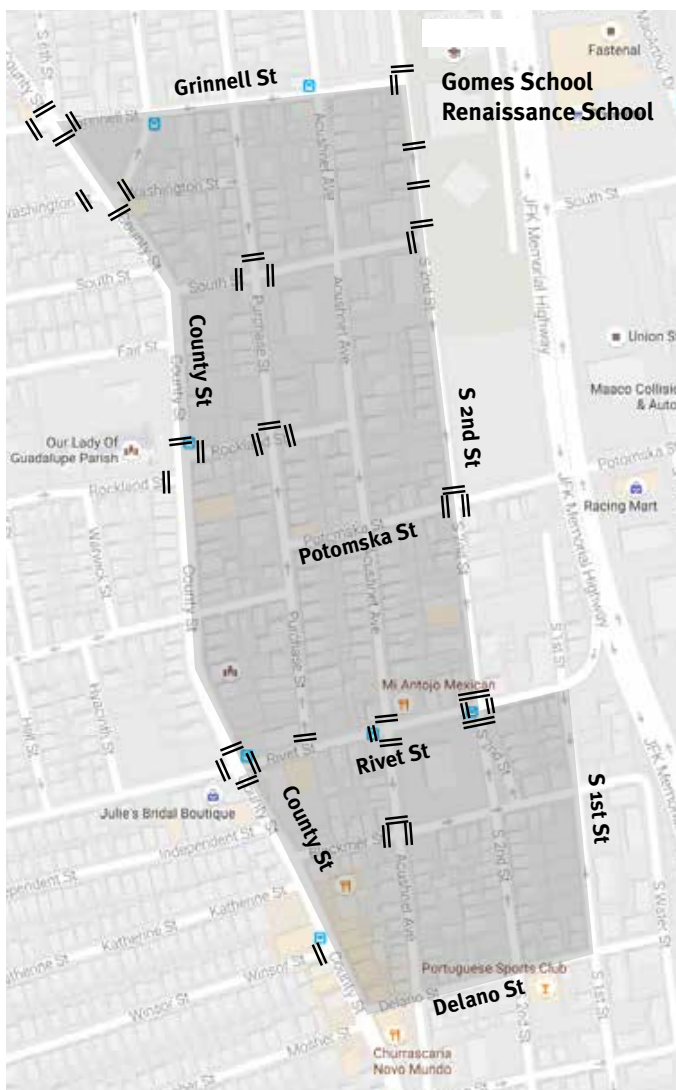
The map below indicates locations where crosswalks are painted. Of the 37 intersections in the study area, only 3 intersections have marked crosswalks on all four approaches. Only 14 of the 37 intersections have a marked crossing across one or more approaches, excluding the 3 complete intersections. Furthermore,

Map of existing marked crosswalks in the study area

the pattern of marked crossings does not appear to relate to walking corridors or street hierarchies. This seemingly random approach to installing marked crosswalks is not advisable given the dense, residential neighborhood with two elementary schools, senior housing, neighborhood parks and retail districts, churches, and other community assets within short walking distances.

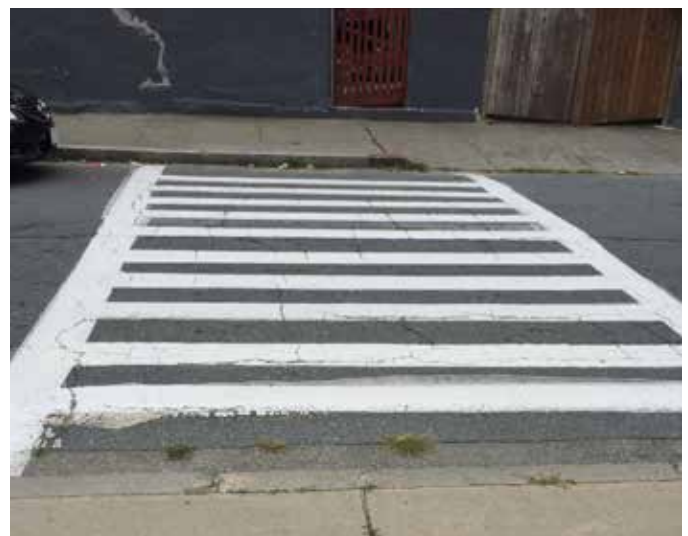
This high visibility crosswalk near the Gomes School has no curb ramps or detectable warning panels.

The crosswalks at priority locations near the Gomes and Renaissance Schools – primarily across South 2nd Street – use high visibility pavement markings. However, curb ramps are missing from the majority of the crossings and no detectable warning panels are present. Furthermore, parking restrictions, which limit parking within 20 feet of a crosswalk, are not enforced. Children trying to cross the street cannot see beyond parked cars, and drivers traveling down South 2nd Street cannot see children waiting to cross. Diagonal lines painted in a hatched pattern next to crosswalks can discourage parking adjacent to them.

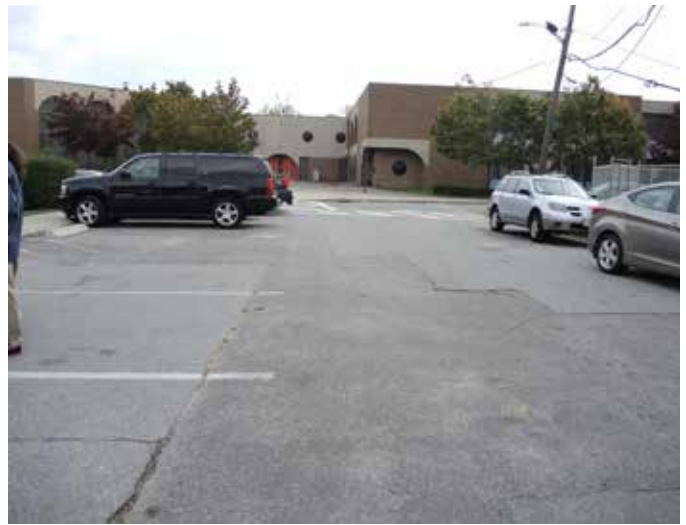
Parking area at the intersection of Grinnell and S 2nd Street could be transformed into a gateway between the neighborhood and the school buildings

Several participants identified the intersection of Grinnell and South 2nd Street as an opportunity area to rethink the neighborhood connection to the elementary schools. Currently, the intersection terminates in a parking lot for the housing complex, which lies between the schools and the neighborhood. There are continuous sidewalks that lead to South 2nd Street along Grinnell, but they do not follow pedestrian desire lines. The space is large enough to provide more green space, direct pedestrian connections and maintain vehicle access if it were redesigned as a welcoming gateway to the neighborhood.

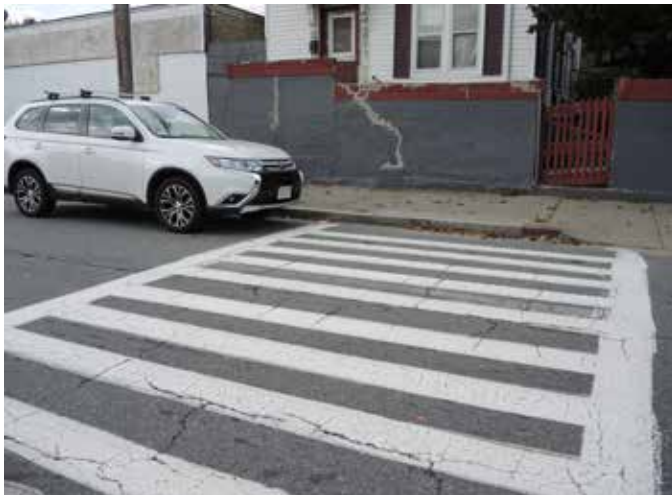
Cars parked directly adjacent to crosswalks block the view of oncoming traffic for people crossing

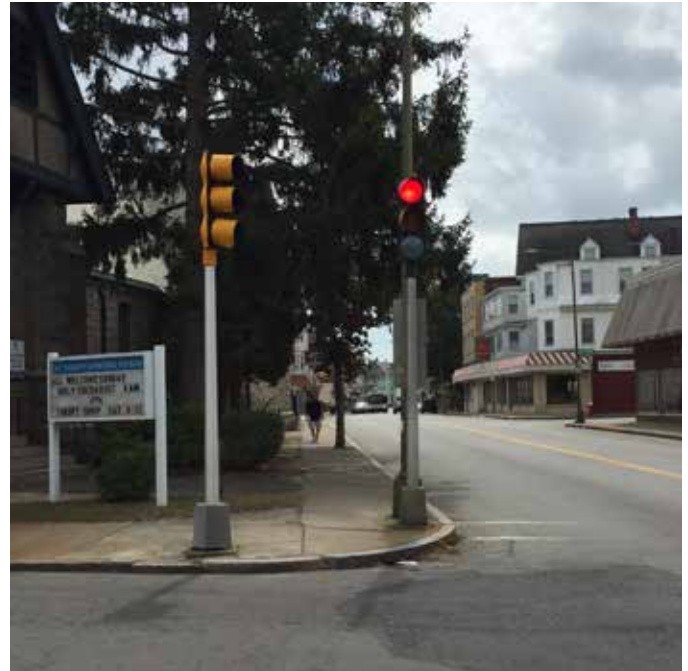
The traffic signal at Rivet and County Streets is the only signalized intersection within the study area. There are no pedestrian signals at this intersection. People driving north on County Street are prohibited from turning right on red which gives pedestrians crossing some protection. Traffic driving south on County or in either direction on Rivet Street have no turning restrictions.

Traffic signal at Rivet/County has no pedestrian signals

- Install No Right Turn on Red signs on all approaches at the Rivet/County Street intersection to provide some protection for pedestrians crossing without a pedestrian signal
- Engage the City in a conversation regarding the use of concurrent and exclusive signal timing. Concurrent signal timing has been shown to increase pedestrian compliance and shorten overall cycle times for all users. WalkBoston recommends concurrent signals except when signals are located within school zones or in areas with high numbers of seniors

- Install pedestrian traffic signals at the Rivet/County Street intersection

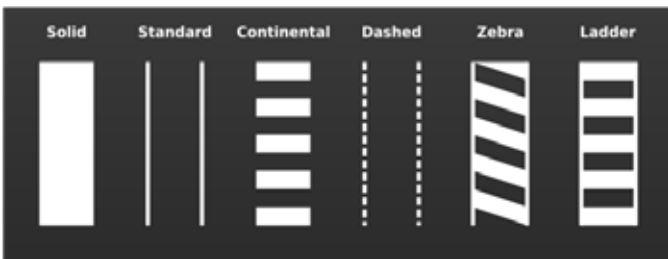
Crosswalks can be painted in a variety of ways, some of which are more effective in warning drivers of pedestrians. Crosswalks are usually accompanied with stop lines. These lines act as the legally mandated stopping point for vehicles, and discourage drivers from stopping in the middle of the crosswalk.

Crosswalk patterns
Source: USFHA

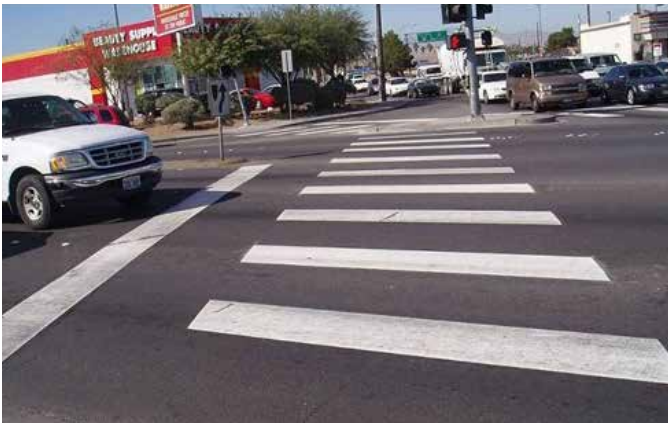
Crosswalk and stop line
Source: http://safety.fhwa.dot.gov/ped_bike/tools_solve/ped_scdproj/sys_impact_rpt/images/fig16.jpg

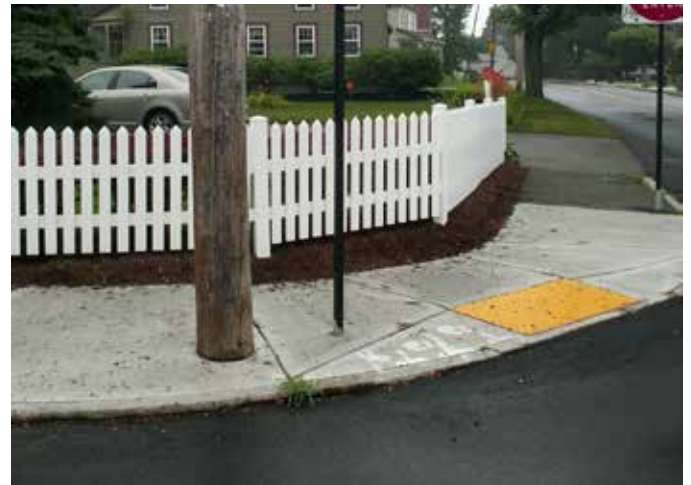
Curb ramps provide access from the sidewalk to the street for people using wheel chairs and strollers. They are most commonly found at intersections. While curb ramps have improved access for wheelchair-bound people, they are problematic for visually impaired people who use the curb as an indication of the side of the street. Detectable warning strips, a distinctive surface pattern of domes detectable by cane or underfoot, are now used to alert people with vision impairments of their approach to streets and hazardous drop-offs.

Curb ramp and detectable warning strip

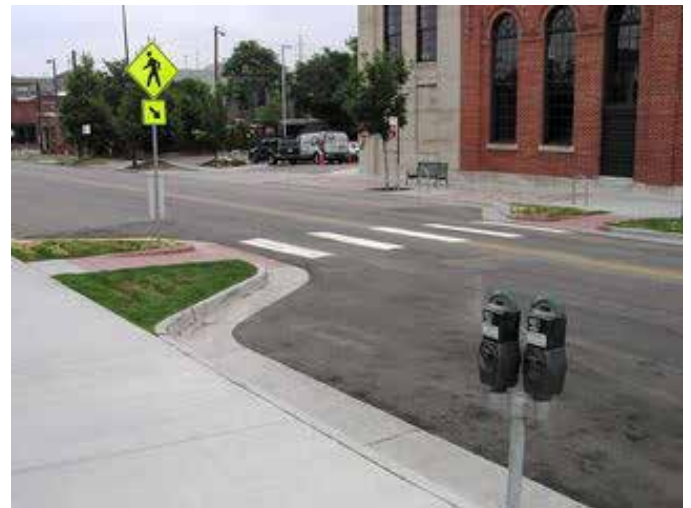
A sidewalk extension into the street (into the parking lane) shortens crossing distance, increases visibility for walkers and encourages eye contact between drivers and walkers.

Curb extensions are often associated with mid-block crossings

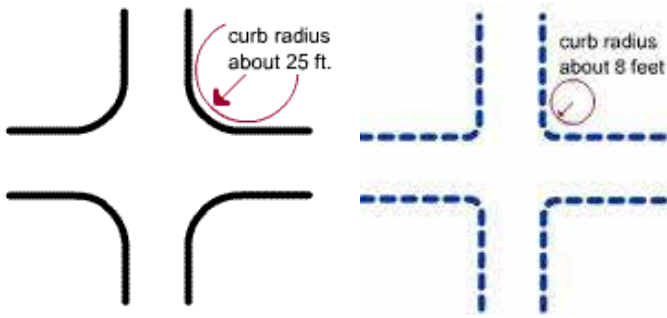
A longer curb radius (on the left in figure below) allows vehicles to turn more quickly and creates longer crossing distance for pedestrians. A shorter curb radius (on the right in the figure below) slows turning speeds and provides pedestrians shorter crossing distances.

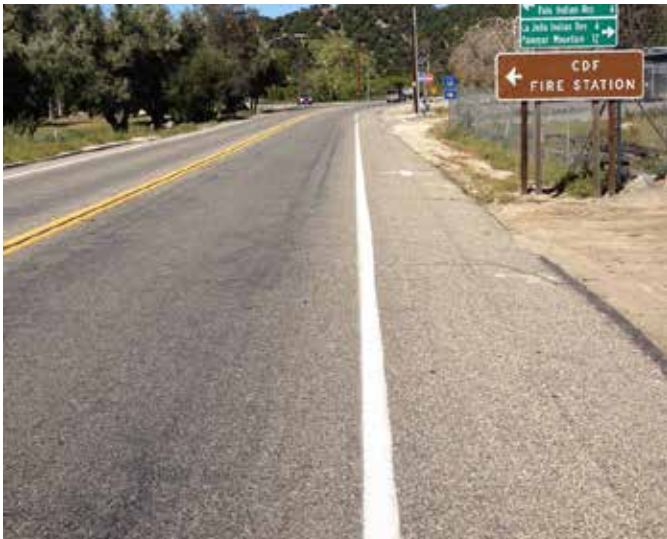
A fog line is a solid white line painted along the roadside curb that defines the travel lane. It narrows a driver's perspective and helps to slow traffic speeds. Fog lines are used in urban, suburban and rural locations.

Fog lines delineate the vehicular driving zone on wide roadways.

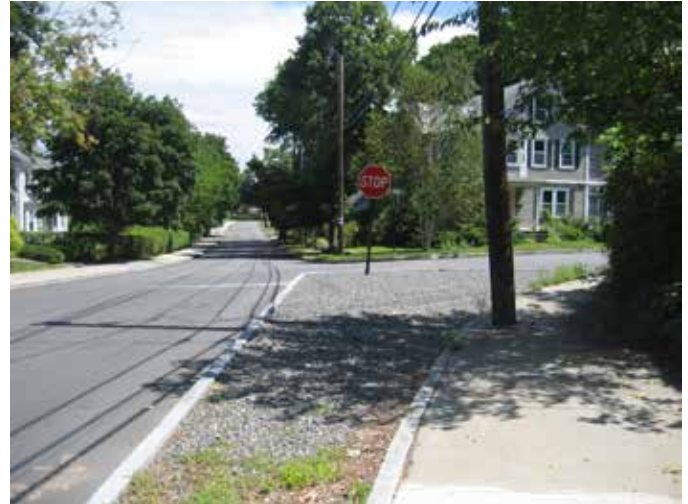
There are two excellent examples of the shortening of curb radii in Woburn, MA. The first (A) is a low-cost solution using a gravel-filled zone between the original curb line and the newly established road edge. The second is a higher-cost solution using grass and trees and extending the sidewalks to the new curb. Both work to slow traffic.

(A) Gravel-filled curb extension

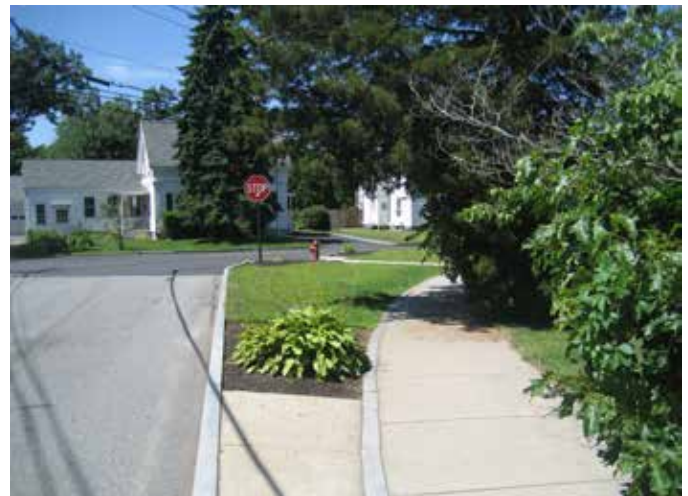
(B) Grass, trees and extended sidewalk in curb extension

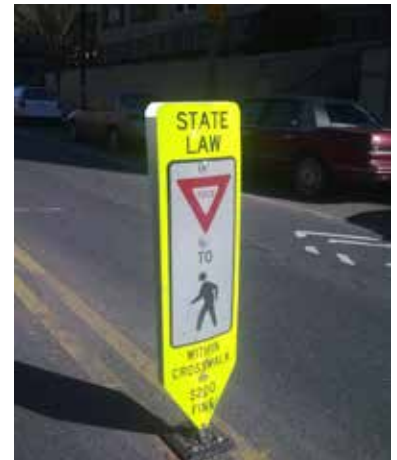
In-street pedestrian crossing signs are used at the road centerline within crosswalks to increase driver awareness of pedestrians in the area. These signs are a relatively low-cost, highly effective tool in slowing traffic by the narrowing travel lanes. They are popular with road maintenance departments since they can be easily moved for snow removal.

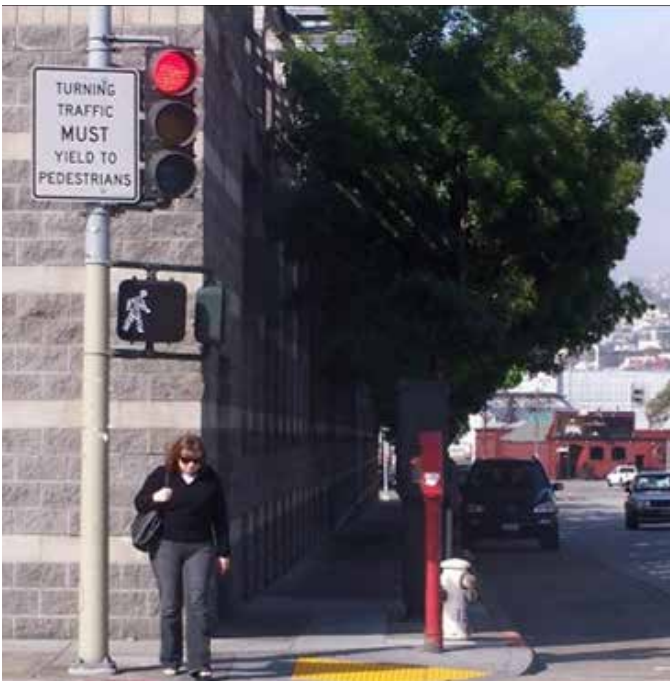
Source: http://safety.fhwa.dot.gov/ped_bike/tools_solve/ped_scdproj/sys_impact_rpt/images/fig34.jpg

A leading pedestrian interval gives pedestrians an advance walk signal before motorists get a green signal, giving the pedestrian several seconds to start walking in the crosswalk before a concurrent signal is provided to vehicles. This makes pedestrians more visible to motorists and motorists more likely to yield to them. Typical LPI settings provide 3 to 6 seconds of advance walk time.

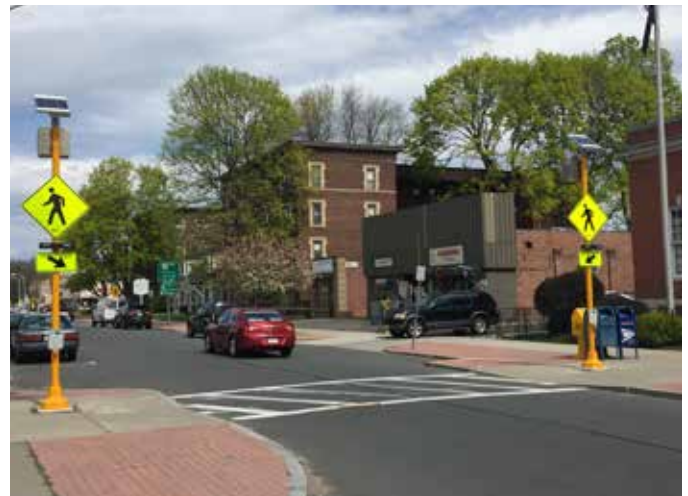
RRFBs are user-actuated flashing lights (amber LEDs) that supplement pedestrian warning signs at unsignalized intersections or mid-block crosswalks. They can be activated by pedestrians manually by a push button or passively by a pedestrian detection system. RRFBs use an irregular flash pattern that is similar to emergency flashers on police vehicles. RRFBs may be installed on either two-lane or multi-lane roadways.

Rectangular Rapid Flash Beacon (RRFB) in West Springfield
