Walk Assessment Haverhill, MA

October 8, 2014

Massachusetts Department of Transportation
Bicycle and Pedestrian Safety Program

Haverhill Walk Assessment

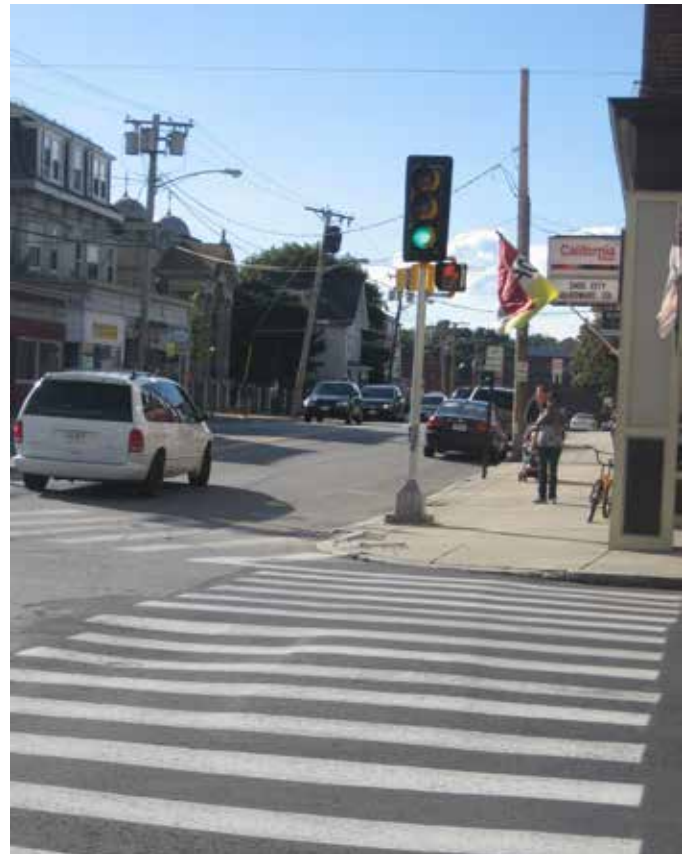
- “No Right Turn On Red (RTOR)” signs are outside of drivers’ visibility and therefore most drivers do not see the sign until they have proceeded into the crosswalk
- Missing curb ramps and non-ADA compliant curb ramps on southeast corner of the intersection
- Missing stop line on the southbound side of White Street
- Trucks turning onto Winter Street from White Street are cutting the corner and damaging the sidewalk panels on the northwest side of the intersection
- Traffic signal is too close to travel lane in the northwest corner of the intersection; both the pedestrian signal and traffic signal appear to have been struck by oncoming traffic; few options for locating a signal pole and accommodating pedestrians on this corner

At the Winter/White intersection, the traffic signal obstructs the curb ramp; the sidewalk concrete has been damaged by turning trucks; and signal phasing does not prioritize the pedestrians

- Signal timing does not prioritize pedestrians: takes a long time for the phase to change to WALK, and the WALK phase itself seems too short. No RTOR should allow concurrent phasing with a leading pedestrian indicator (LPI)
- Pedestrian signal equipment is antiquated and in poor condition – appears to have been struck

- Relocate the No RTOR signs so that they are adjacent to the traffic signal heads
- Install ADA-compliant curb ramps where they are missing and upgrade those curb ramps that do not meet requirements
- Repaint stop line on southbound side of White Street
- Evaluate the turning radii on the northwest corner of the intersection; needs to accommodate truck traffic and should discourage (or prevent through design) the practice of driving on the sidewalks
- Evaluate possibility of moving/upgrading the traffic signal on the northwest corner of the intersection to provide additional gathering space

- Consider changing the signal timing so that pedestrians wait less time for WALK phase; evaluate the vehicle volumes to see if concurrent phasing with a leading pedestrian indicator (LPI) is possible
- Upgrade the pedestrian signal heads to a countdown signal

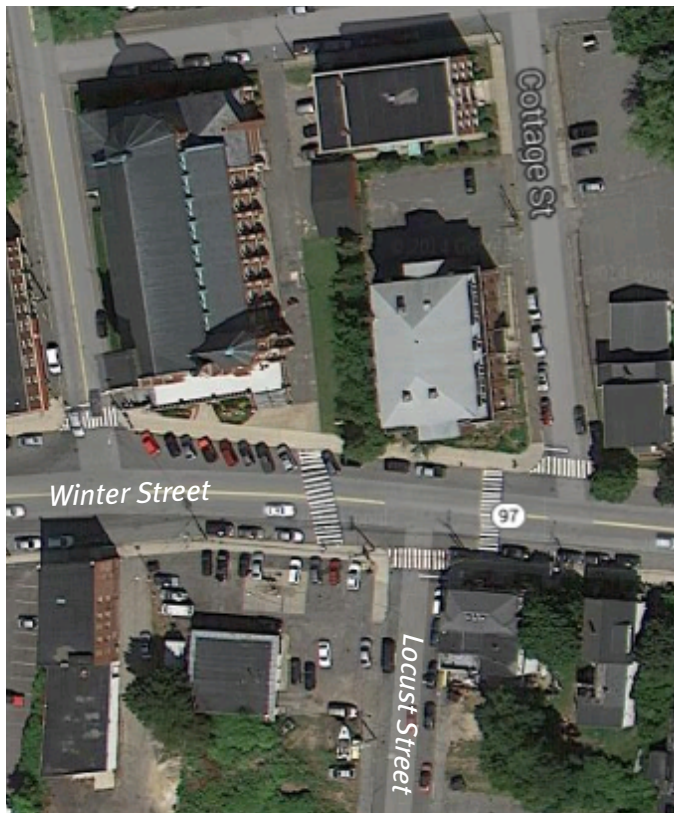
Aerial view of the Cottage/Winter and Winter/Locust intersections

The staggered alignment of Cottage Street and Locust Street contributes to the inconsistent location of crosswalks near the Winter/Locust Street intersection. On-street parking near this intersection varies from parallel parking to angled parking. In some cases, parking contributes to the limited visibility issues at this intersection. The sidewalks on Locust Street between Winter Street and Walnut Street are in poor condition.

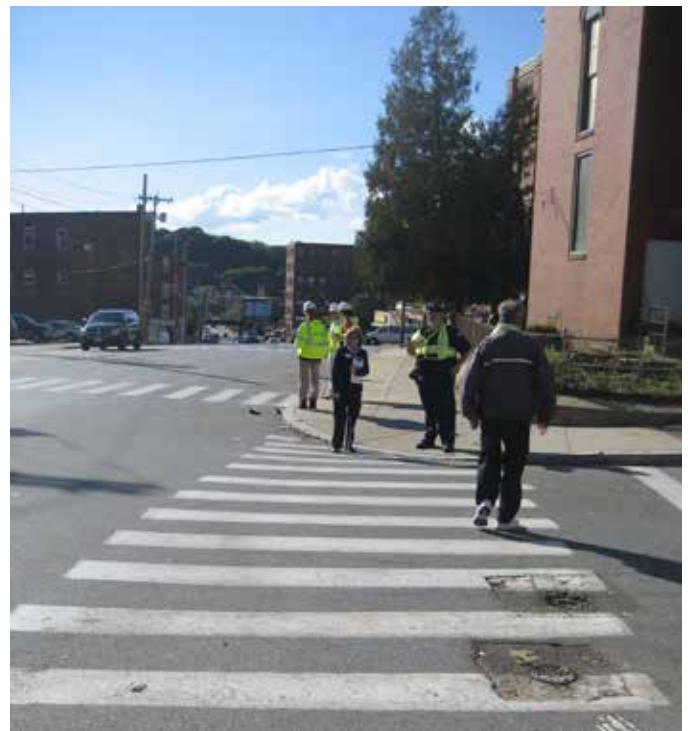
- Crosswalks are not uniform in their location at the intersection or in their direction – one is on a diagonal and another runs perpendicular to the roadway; crosswalks are close together at unsignalized intersection
- Cars are parked within 20' of the crosswalk and the intersection

Street view of multiple crosswalks

- Review need for both crosswalks on Winter Street near Locust Street intersection; consider installing curb extensions or raising the intersection to increase visibility of pedestrians and reduce crossing distances, if pedestrian volumes warrant it
- Remove pavement markings that allow parking within 20' of crosswalk and install markings that prohibit parking; consider prohibiting on-street parking along Winter Street near the intersection to increase pedestrian visibility; relocate signs that obstruct sight lines
- Add signage to alert drivers to the presence of pedestrians – advance crosswalk signs, "yield to pedestrian" signs, and in-street pedestrian sign
- Paint edge lines and or parking stalls where appropriate to better define lanes and encourage slower speeds

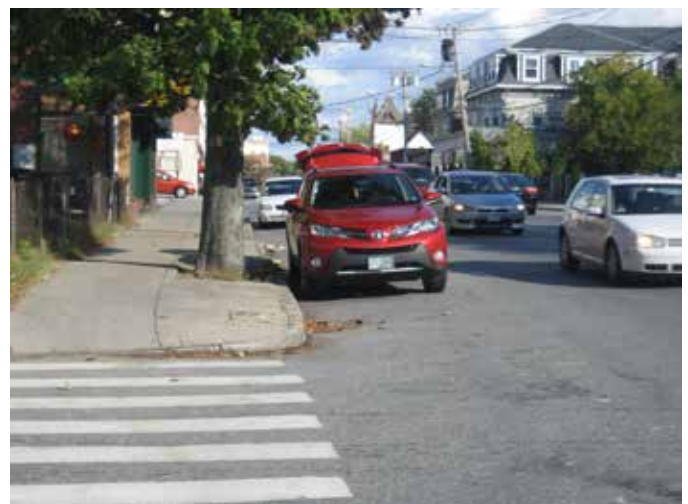
Parked cars on Winter Street contribute to limited visibility issues

- Site visibility constraints: signs and buildings close to the road's edge block motorist views of crosswalk; parked cars also limit sightlines
- No "yield to pedestrian" or advance crosswalk signs to alert drivers to the possibility of pedestrians crossing
- Travel lanes seem wide; no edge lines or painted parking stalls
- Sidewalks on Locust Street between Winter and Walnut Streets are in bad condition – missing curb ramps and detectable warning strips, narrow and crumbling asphalt and concrete

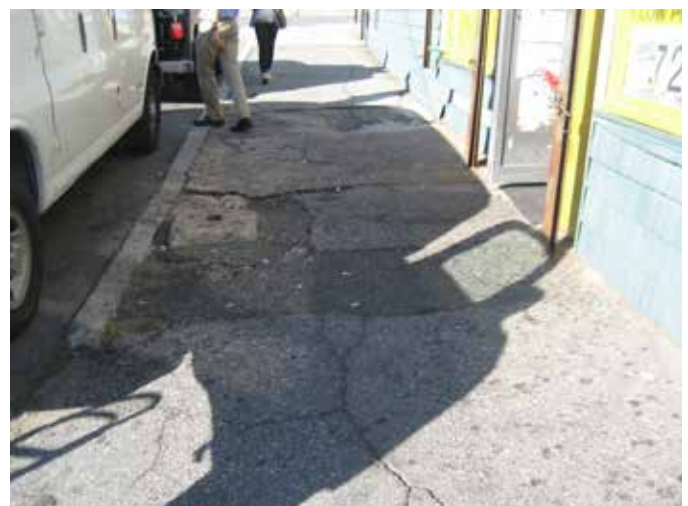
Sidewalks on Locust Street are in poor condition

- Repair and replace sidewalks on Locust Street between Winter and Walnut Streets

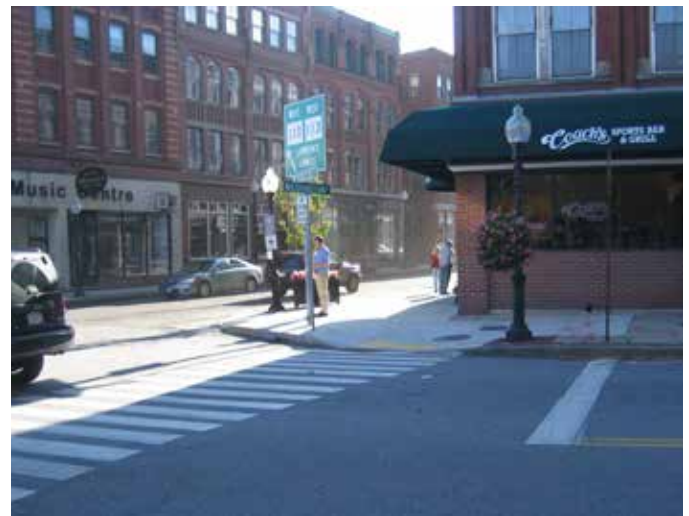
Essex/Washington Street intersection is unsignalized; drivers must inch into crosswalk to see oncoming traffic beyond building edges

- Site visibility constraints: buildings close to the road's edge block motorist views of crosswalk when turning onto Essex from Washington traveling in both eastbound and westbound directions
- Crosswalk is set back from the pedestrian desire line; crossing distance is long due to wide travel lanes on Essex Street
- Stop line, located behind the crosswalk, is far from intersection and motorists must advance to see oncoming traffic
- Curb ramp on the northwest corner does not meet ADA requirements

- Consider installing curb extensions (bump-outs) to address site visibility constraints and shorten the pedestrian crossing distance

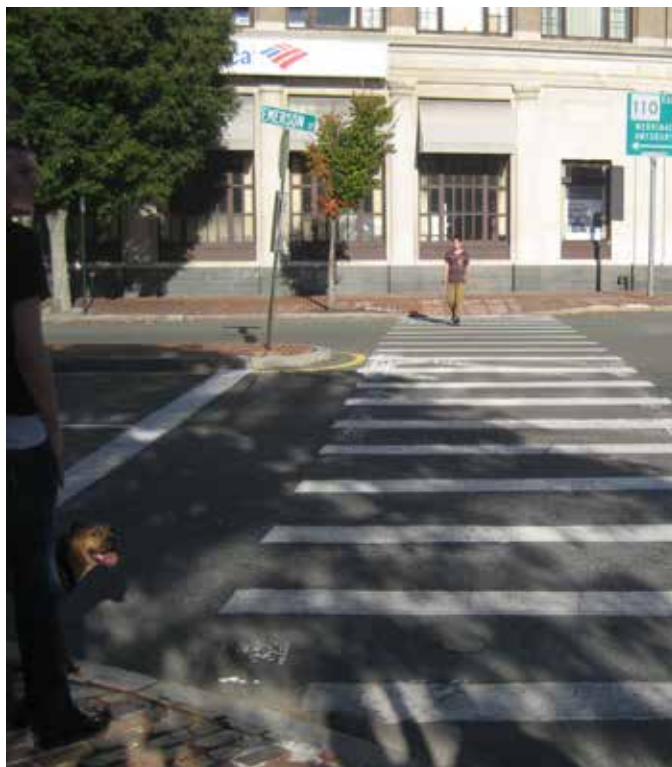
Median helps to define lanes, but does not provide adequate protection for pedestrians waiting to cross

- Intersection is very wide with long pedestrian crossing distance
- Site visibility constraints: buildings close to the road's edge block motorist views of crosswalk when turning onto Emerson from Washington
- Stop line, located behind the crosswalk, is far from intersection and motorists must advance to see oncoming traffic
- Median helps to narrow and define travel lanes on Emerson Street; however, the median is ineffective as a pedestrian refuge island – it does not reach across the crosswalk and is relatively narrow
- Curb ramps do not meet ADA requirements; missing detectable warning strips

- Consider installing curb extensions (bump-outs) to address site visibility constraints and shorten the crossing distance
- Consider adjusting location of crosswalk and stop line to improve visibility
- Explore possibility of redesigning median as a pedestrian refuge island with protection on both sides of the crosswalk of sufficient width
- Install ADA-compliant curb ramps and detectable warning strips

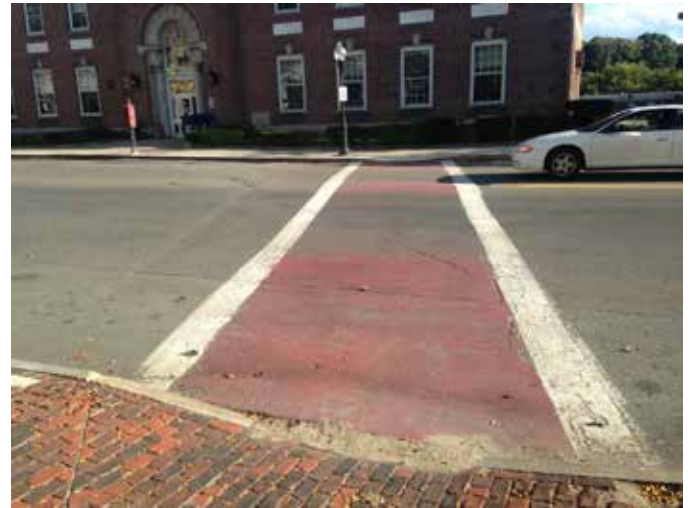
Mid-block crossing leading to the Post Office

The Post Office and the MVRTA bus depot generate a lot of foot traffic across Washington Street. On a busy Saturday morning, it is difficult to find a parking space and motorists park on the crosswalk, as well as within the 20-foot buffer zone required adjacent to crosswalks. According to the municipal representatives and Haverhill residents, drivers behave unpredictably in this area while searching for parking, and pedestrians do not use the marked crosswalk. The marked crossing is long and pedestrians often cross the street in other places in order to shorten their trip. The Washington Street right-of-way is extremely wide between the Post Office and the public open space at Washington Square.

- Washington Square right-of-way is extremely wide; currently accommodates one lane of traffic in both directions and parking on both sides of the street
- Parking stalls may be painted too close to the crosswalk (should be 20' from crosswalk)

- Crossing distance is long; crosswalk is on a diagonal and is inconsistent with, and not as visible as the newer, continental pavement marking designs in the Washington Square area

- Consider installing a median on Washington Street between Essex and Elliot Streets to minimize illegal U-turns, narrow travel lanes, and provide a pedestrian refuge island
- Evaluate the possibility of using curb extensions (bump-outs) to shorten crossing distance, define parking stalls, and increase visibility of pedestrians

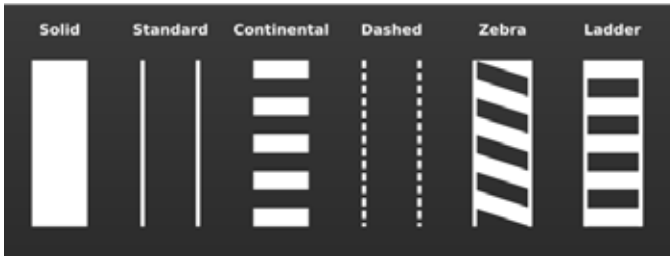
Crosswalks can be painted in a variety of ways, some of which are more effective in warning drivers of pedestrians. Crosswalks are usually accompanied with stop lines. These lines act as the legally mandated stopping point for vehicles, and discourage drivers from stopping in the middle of the crosswalk.

Crosswalk patterns
Source: USFHA

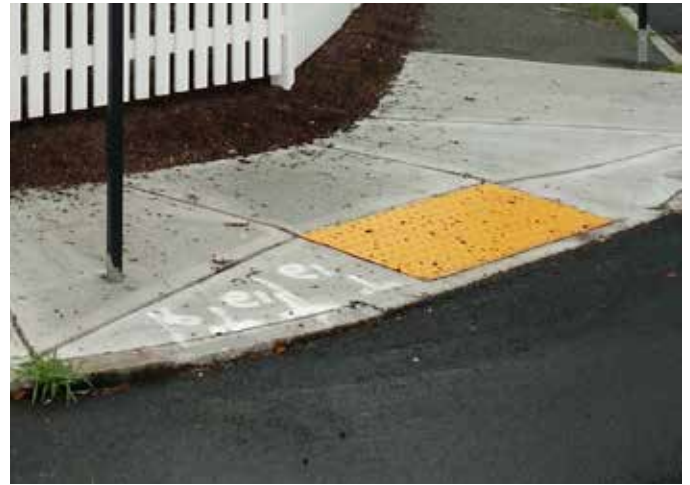
Curb ramps provide access from the sidewalk to the street for people using wheel chairs and strollers. They are most commonly found at intersections. While curb ramps have improved access for wheelchair-bound people, they are problematic for visually impaired people who use the curb as an indication of the side of the street. Detectable warning strips, a distinctive surface pattern of domes detectable by cane or underfoot, are now used to alert people with vision impairments of their approach to streets and hazardous drop-offs.

Curb ramp and detectable warning strip in Woburn, MA

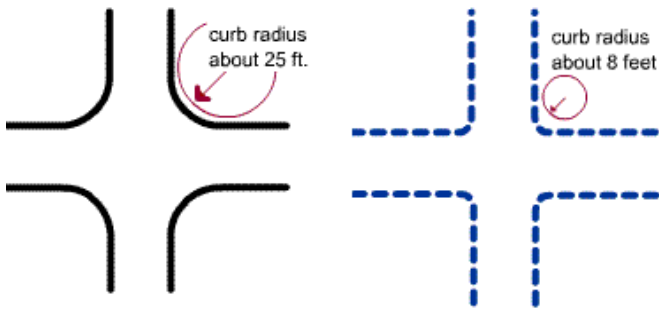
A longer curb radius (on the left in figure below) allows vehicles to turn more quickly and creates longer crossing distance for pedestrians. A shorter curb radius (on the right in the figure below) slows turning speeds and provides pedestrians shorter crossing distances.

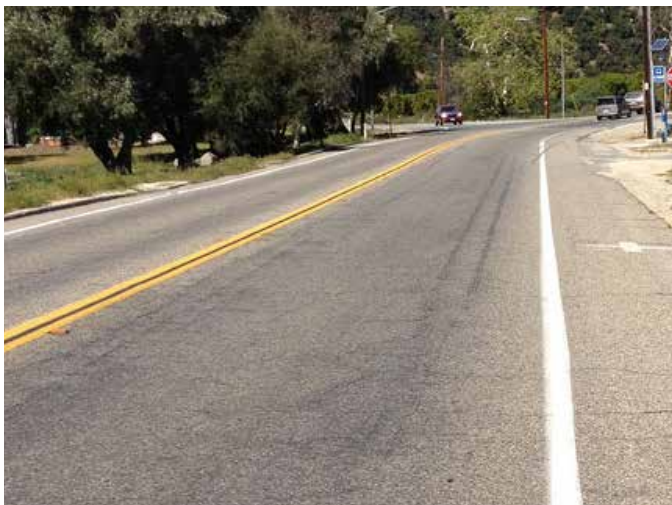
An edge line is a solid white line painted along the roadside curb that defines the driving lane and narrows the driver's perspective. Edge lines are most often used in suburban and rural locations, but may be appropriate in some urban conditions.

Edge lines delineate the vehicular driving zone on wide roadways.

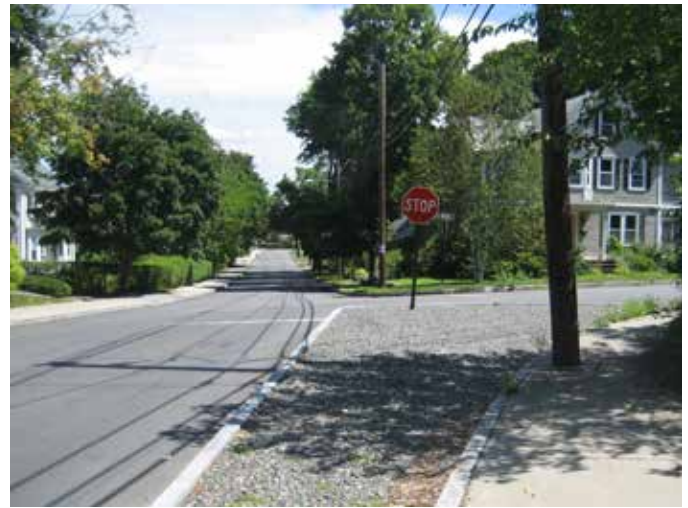
There are two excellent examples of the shortening of curb radii in Woburn, MA. The first (A) is a low-cost solution using a gravel-filled zone between the original curb line and the newly established road edge. The second is a higher-cost solution using grass and trees and extending the sidewalks to the new curb. Both work to slow traffic.

(A) Gravel-filled curb extension

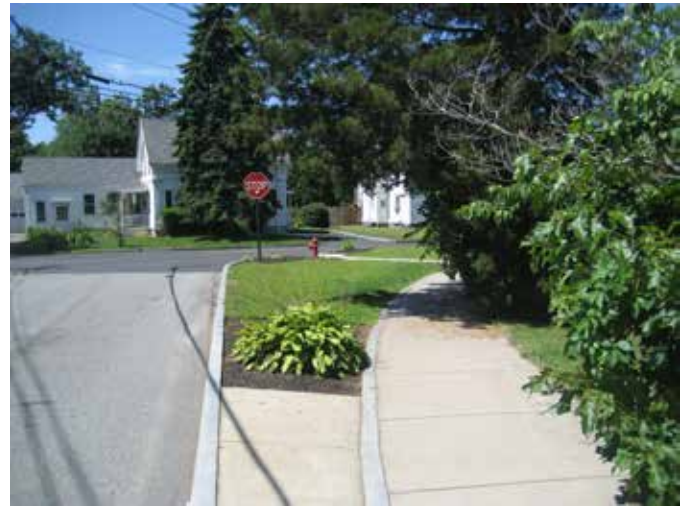
(B) Grass, trees and extended sidewalk in curb extension

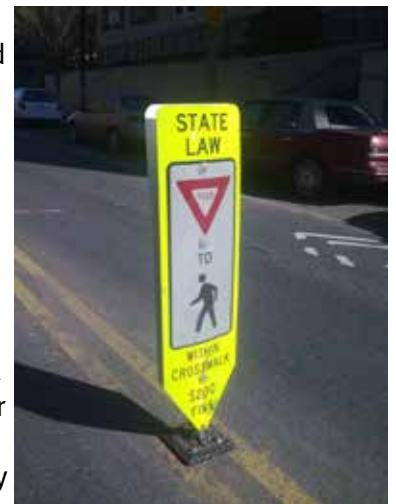
In-street pedestrian crossing signs are used at the road centerline within crosswalks to increase driver awareness of pedestrians in the area. These signs are a relatively low-cost, highly effective tool in slowing traffic by the narrowing travel lanes. They are popular with road maintenance departments since they can be easily moved for snow removal.

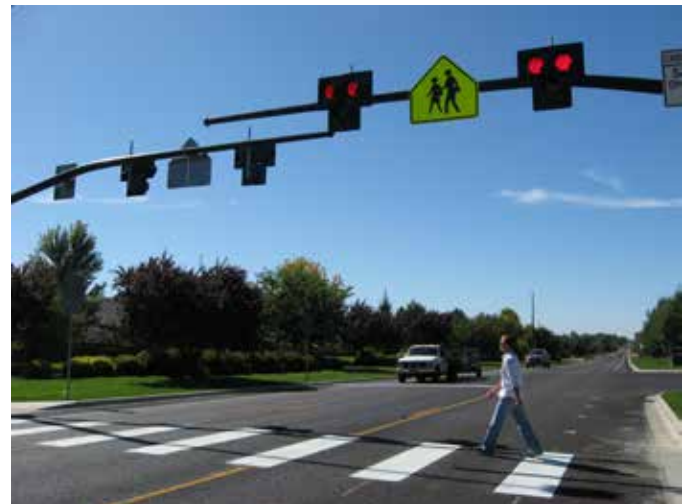
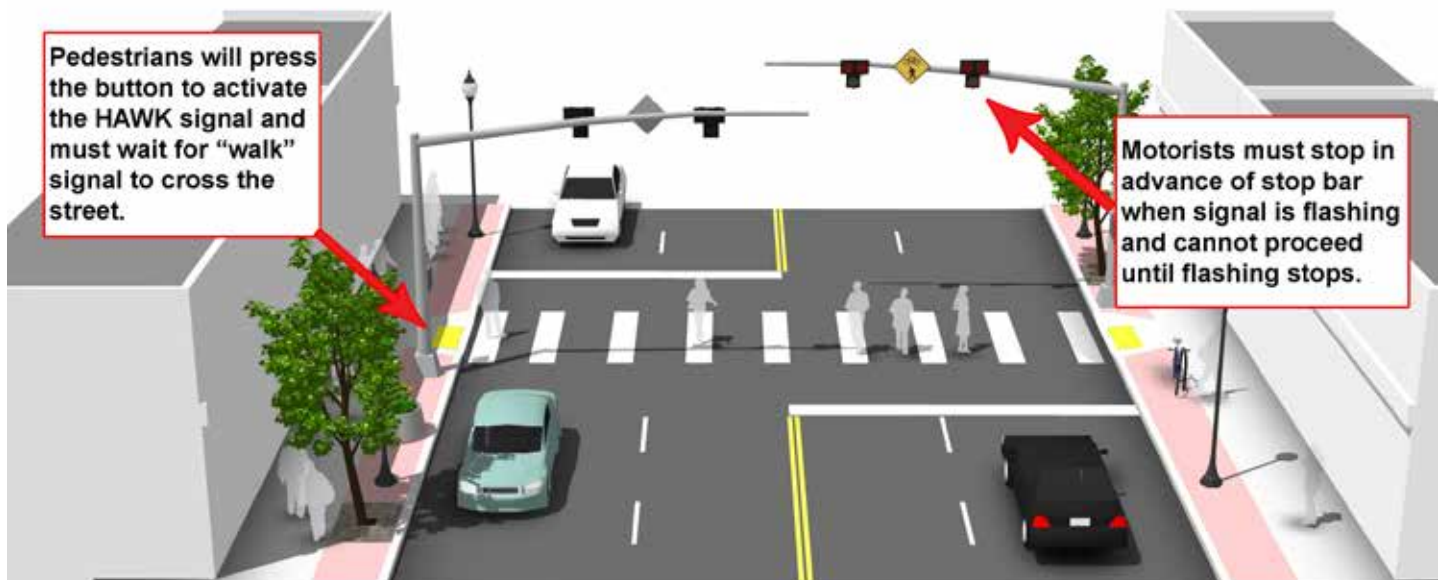
A HAWK beacon (High-Intensity Activated crossWalk beacon) is a traffic signal used to stop road traffic and allow pedestrians to cross safely. It is officially known as a Pedestrian Hybrid Beacon (PHB). The purpose of a HAWK beacon is to allow protected pedestrian crossings, stopping road traffic only as needed. Where standard traffic signal 'warrants' prevent the installation of standard three-color traffic signals, the HAWK beacon provides an alternative.
