Walk Assessment Lynn, MA

October 20, 2014

Massachusetts Department of Transportation
Bicycle and Pedestrian Safety Program

Lynn Walk Assessment

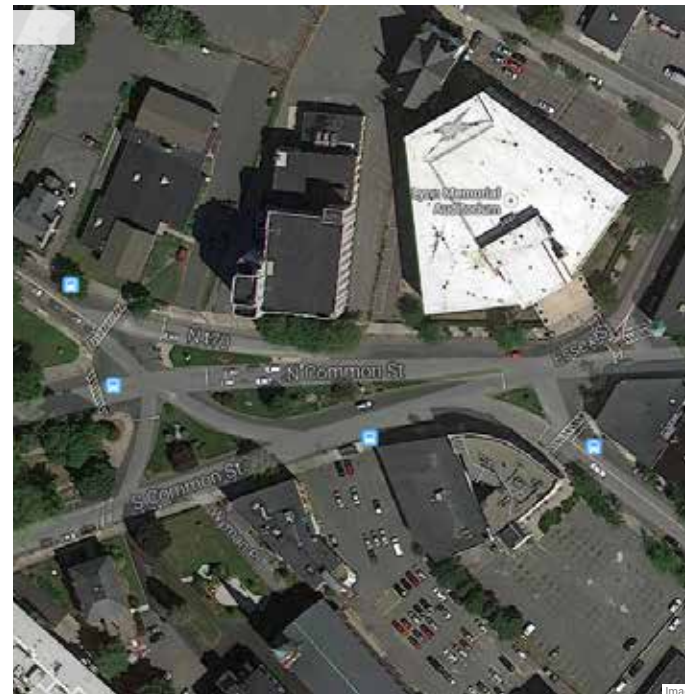
Aerial view of City Hall Square

- Multiple approaches to City Hall Square require drivers to focus on travel lanes instead of looking for pedestrians
- Signal timing has an exclusive pedestrian phase activated by push buttons; pedestrians are not complying with signal
- Pedestrian traffic signal is misaligned; potentially struck by bus or truck
- Pavement markings are worn

- Evaluate traffic patterns in and around City Hall Square for ways to improve pedestrian safety
- Consider a concurrent phase pedestrian traffic signal with a leading pedestrian indicator; one-way traffic patterns should make concurrent phase possible
- Repair pedestrian traffic signal so that it faces the pedestrians using it
- Repaint crosswalks and stop lines

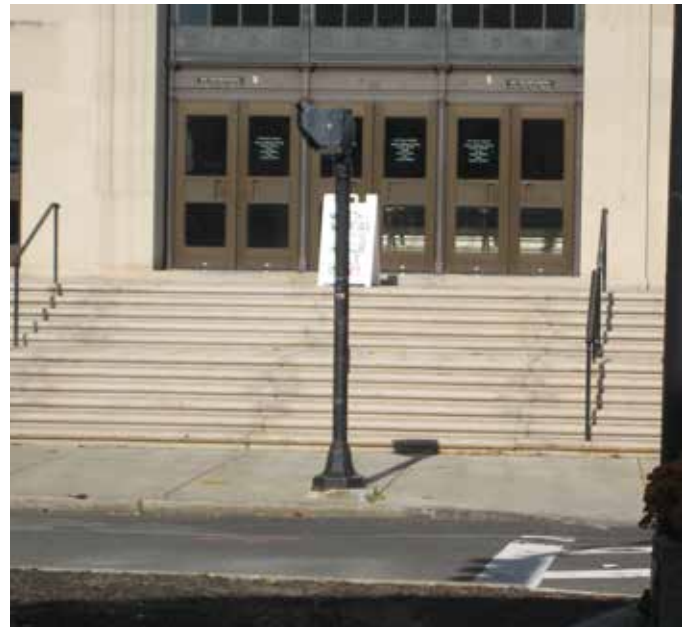
Misaligned pedestrian signal at City Hall Square

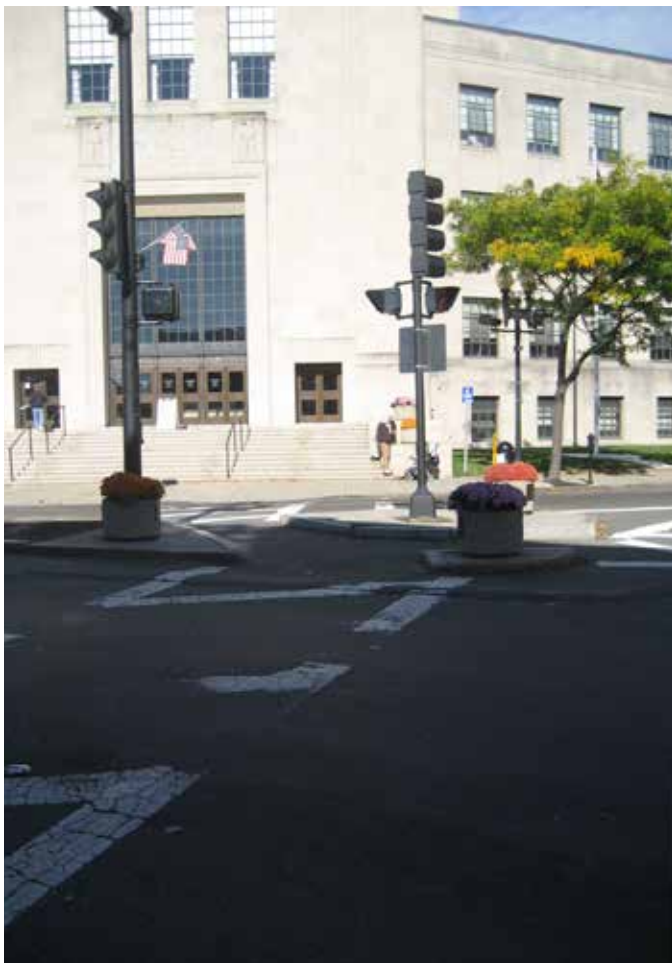
Complicated pedestrian crosswalk at City Hall Square

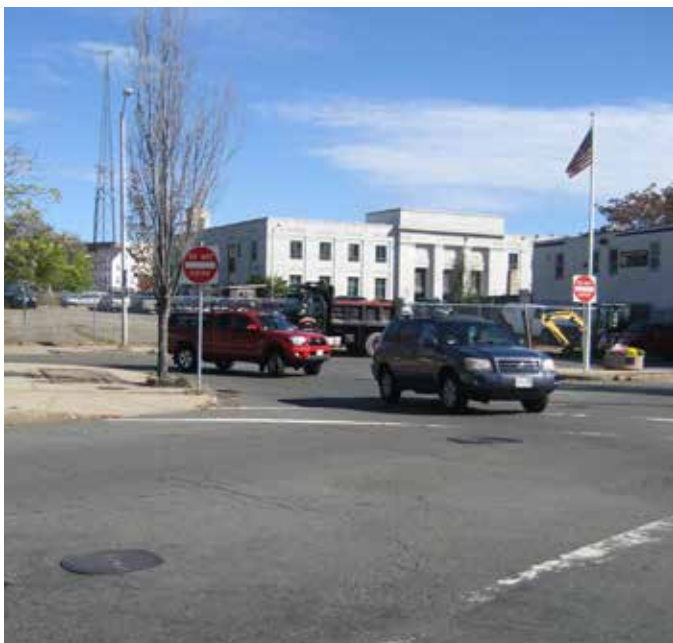
Faded crosswalks near the courthouse on Liberty Street

- Diagonal crosswalks follow pedestrian desire lines, but create long crossing distances
- ADA-compliant curb ramps and detectable warning strips were installed tangent to the curve on Central Avenue at Liberty, but there is no crosswalk connecting the ramps; parked cars block ramps
- Curb radius on northeastern corner seems excessive given traffic is one-way in an eastward direction

- Consider elimination of diagonal crosswalk across Central Avenue
- Paint crosswalk between curb ramps on Central Avenue and limit parking within 20' of crosswalk
- Reduce curb radius on northeast corner of Central/Liberty Street intersection to shorten crossing distance

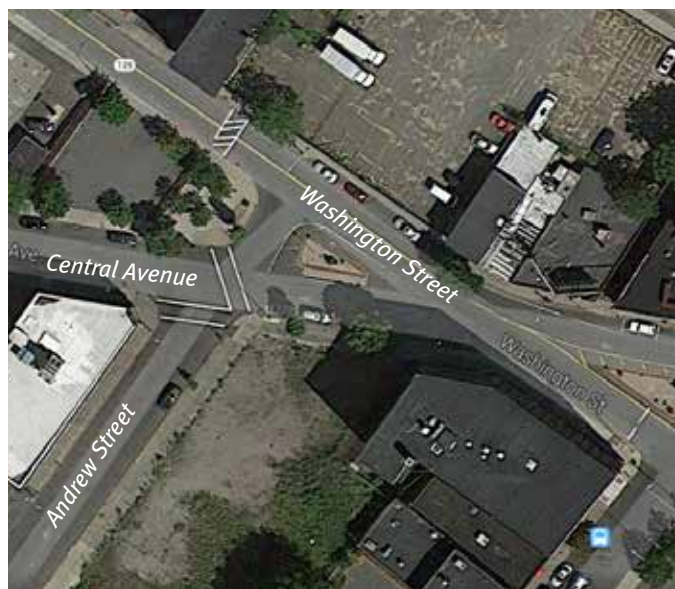
Aerial view of Olympia Square

- Diagonal crosswalk on Central Avenue puts pedestrian in the center of complicated turning movements around traffic island
- Crosswalk pavement markings are minimal and faded
- No stop line at traffic island for traffic turning from Washington Street south onto Andrew Street and the stop sign may not be visible to eastbound drivers
- Pedestrian traffic signals not functioning at intersection of Oxford and Central Ave
- Flashing yellow and red traffic signals at Oxford/Central are ineffective in providing protected pedestrian crossing and in mitigating speeds; no protected crossing for pedestrians
- Missing detectable warning strips and curb ramps (at Oxford and Central)
- Island hopping is prevalent in Olympia Square
- Senior citizen crossing sign posted with no crosswalk

- Remove diagonal crosswalk and relocate along Central Avenue before intersection with Andrew Street
- Paint crosswalks leading to and from traffic island between Washington Street and Central Avenue just east of the Andrew Street intersection
- Paint stop bar with a STOP legend on the pavement and add stop sign to the left side to increase compliance with stop sign
- Repair or replace pedestrian traffic signal at Oxford and Central Avenue
- Consider adding a pedestrian push button-activated pedestrian phase to flashing traffic signal at Oxford/Central to provide a protected crossing phase
- Install ADA-compliant curb ramps and detectable warning strips
- Do a comprehensive review of pedestrian crossings and desire lines
- Evaluate location of senior crossing sign and either remove it or add a crosswalk

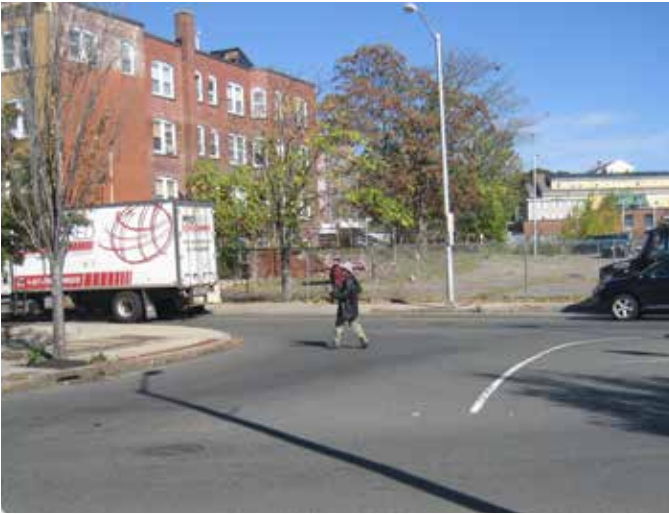
Minimal pedestrian crosswalk markings in Olympia Square

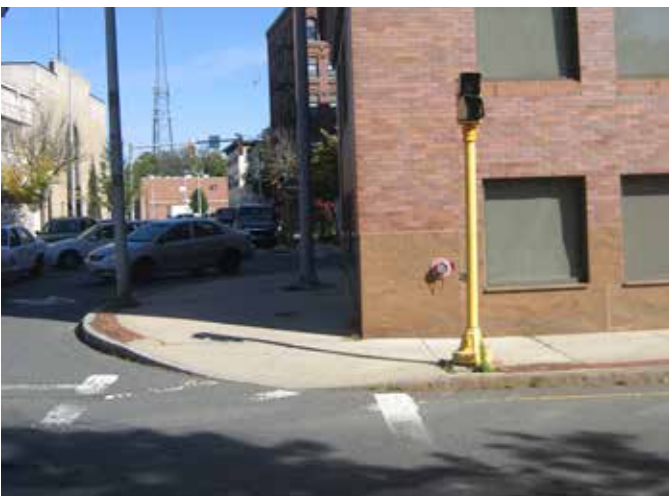
Broken pedestrian signal and faded crosswalks in Olympia Square

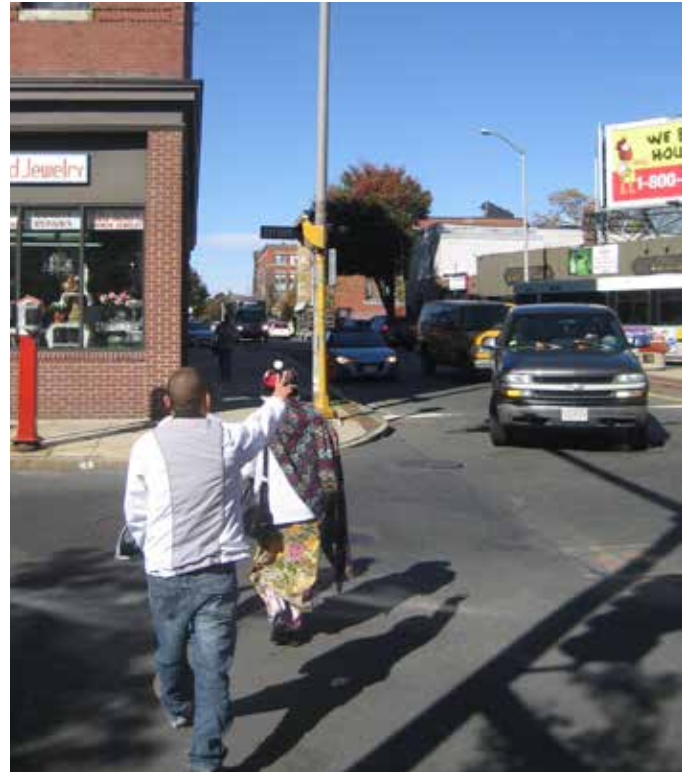
Unprotected pedestrian crossing on Oxford Street

Flashing yellow and red traffic signals at Oxford/Central do not provide protected pedestrian crossing	Consider adding a pedestrian push button-activated pedestrian phase to flashing traffic signal at Oxford/Central to provide a protected crossing phase	Long-term	City of Lynn
Missing detectable warning strips and curb ramps (at Oxford and Central)	Install ADA-compliant curb ramps and detectable warning strips	Mid-term	City of Lynn
Island hopping is prevalent in Olympia Square	Do a comprehensive review of pedestrian crossings and desire lines	Long-term	City of Lynn
Senior citizen crossing sign posted with no crosswalk	Evaluate location of senior crossing sign and either remove it or add a crosswalk	Short-term	City of Lynn

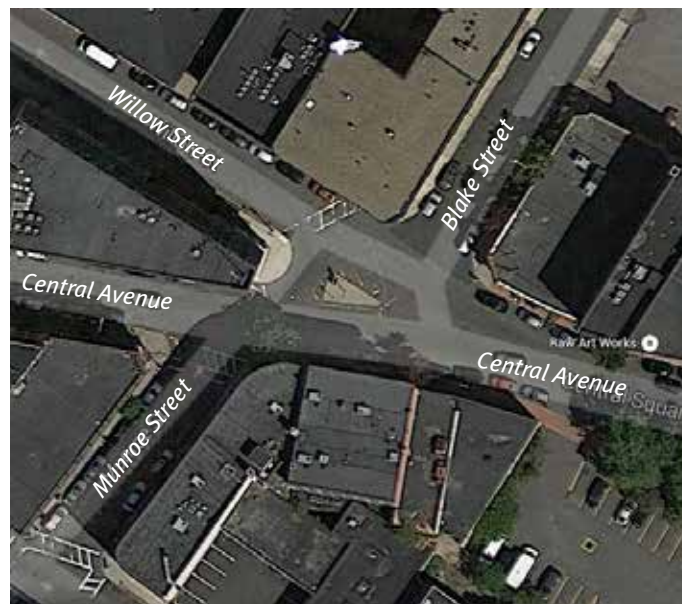
Aerial view of Linnehan Square

- Crosswalks do not follow pedestrian desire lines; no protected crossings in Linnehan Square
- No marked crosswalk across Central Avenue; the closest crosswalks are at Central and Oxford or near the MBTA tracks in Central Square
- Pavement markings are faded
- Motorists cut through Linnehan Square from Monroe Street, traveling the wrong direction on Willow Street, before turning north onto Blake Street (observed this multiple times in the short span we stood at the Square); left hand turn only sign on island is ineffective
- No “yield to pedestrian” signs
- Missing curb ramps and detectable warning strips at some crossings and corners

- Evaluate location of existing crosswalks based on pedestrian desire lines and legal vehicular traffic movements; paint or repaint crosswalks as necessary
- Upgrade traffic island and/or install bump-outs to shorten crossing distances and make pedestrians more visible and movements more predictable in the square; ADA-compliant curb ramps and detectable warning strips may be needed
- Review street network and traffic flows (one-way vs. two-way) to determine if vehicular cut-through behavior can be modified
- Consider installing “yield to pedestrian” signs and in-street pedestrian signs at marked crossings
- Repair or replace curb ramps and detectable warning strips where needed

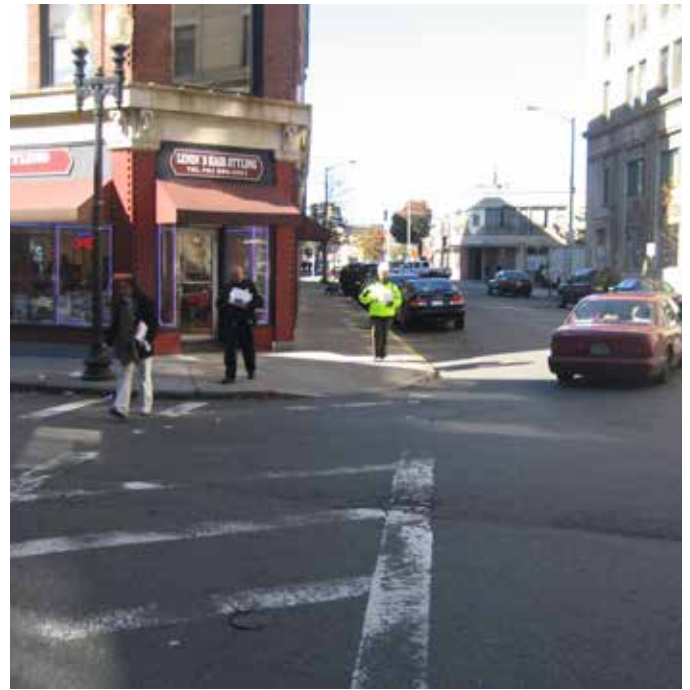
Intersection of Monroe and Central Streets in Linnehan Square

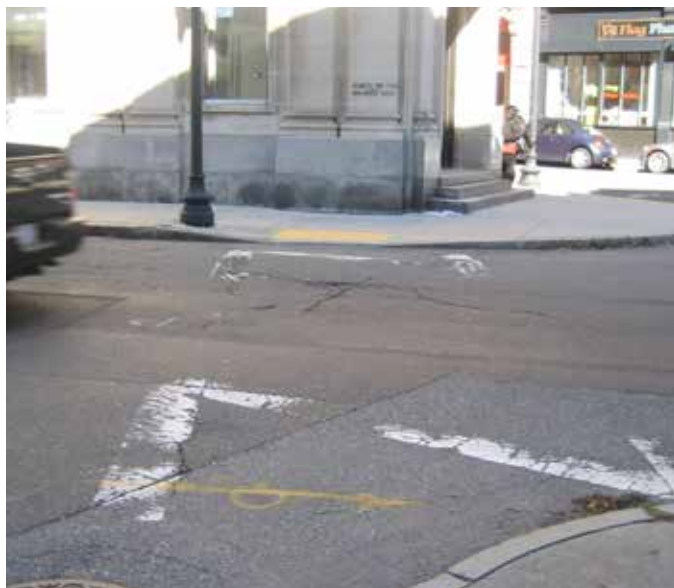
Faded crosswalk in Linnehan Square

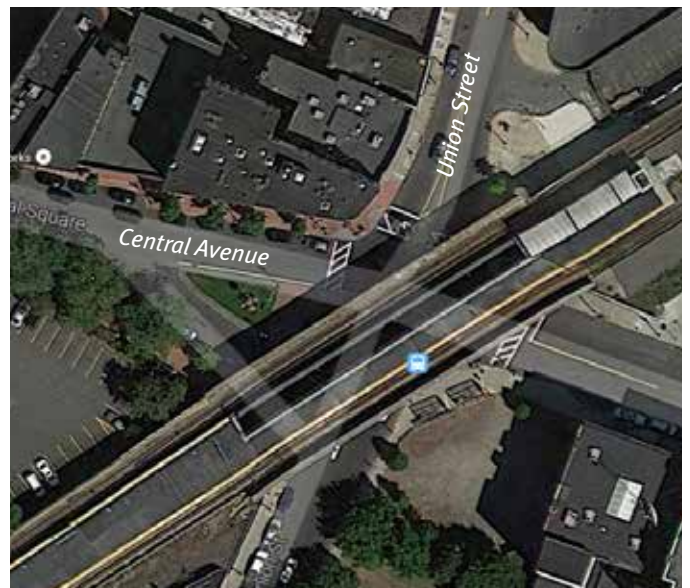
Aerial view of Central Square

- Pedestrians crossing mid-block on Central Avenue where left turn lane from Union Street intersects Central Avenue have no marked crosswalk
- Crosswalks near the train overpass are often in shadow which makes it difficult to see pedestrians
- No “yield to pedestrian” signage or roadside pedestrian crossing signs
- Crosswalk across left turn lane from northbound traffic on Union Street leading westbound on Central Avenue is on the curve and difficult to see; motorists drive quickly around this curve and have difficulty seeing pedestrians in the crosswalk; on-street parking on Union Street contributes to visibility issues
- Lighting under the overpass is minimal
- Curb ramps are missing detectable warning strips

- Evaluate the safety of painting a mid-block crosswalk across Central Avenue between Linnehan Square and Central Square; if crosswalk is painted, use ladder or continental design and consider using an in-street pedestrian crossing sign and installing curb extensions
- Consider installing additional “yield to pedestrian” signs, roadside pedestrian crossing signs and/or in-street pedestrian signs to help alert drivers to presence of crosswalks
- Consider removing on-street parking along Union Street nearest to the curve to improve motorists’ visibility of pedestrians
- Evaluate light conditions under overpass at night and install lighting to improve visibility for drivers and pedestrians
- Install detectable warning strips

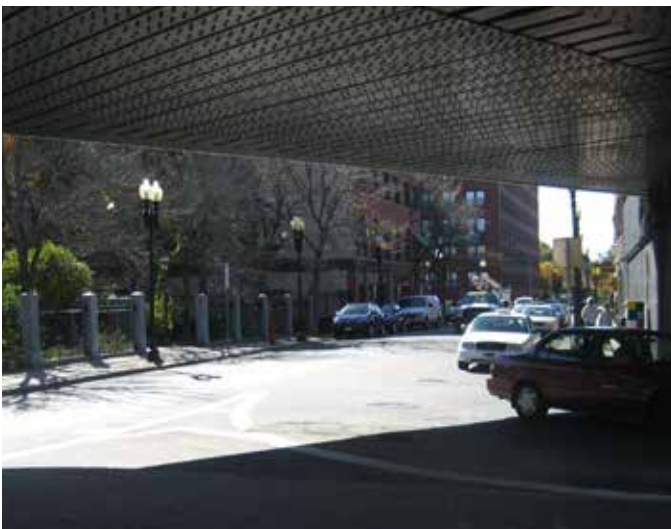
Limited lighting under overpass

ISSUE	RECOMMENDATION	TIMEFRAME	RESPONSIBLE PARTY
Lighting under the overpass is minimal	Evaluate light conditions under overpass at night and install lighting to improve visibility for drivers and pedestrians	Mid-term	City of Lynn
Curb ramps are missing detectable warning strips	Install detectable warning strips	Long-term	City of Lynn

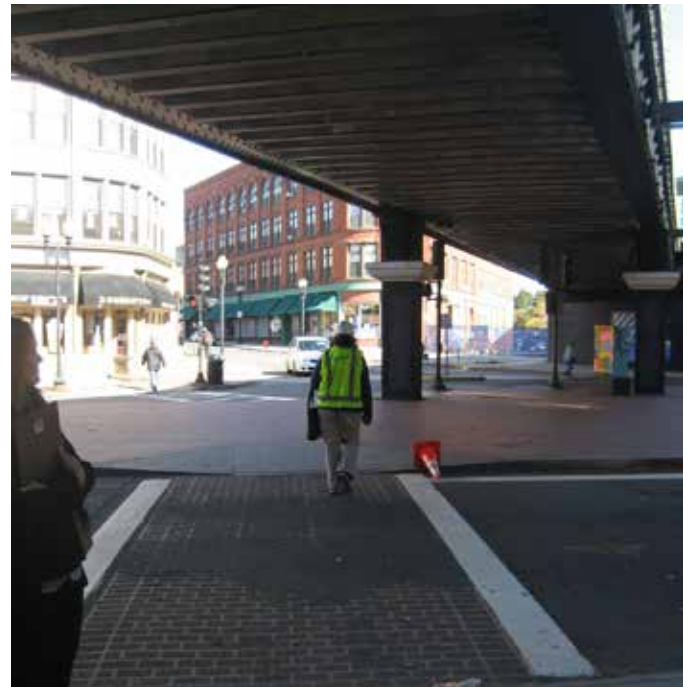
Crosswalk in shadow of overpass

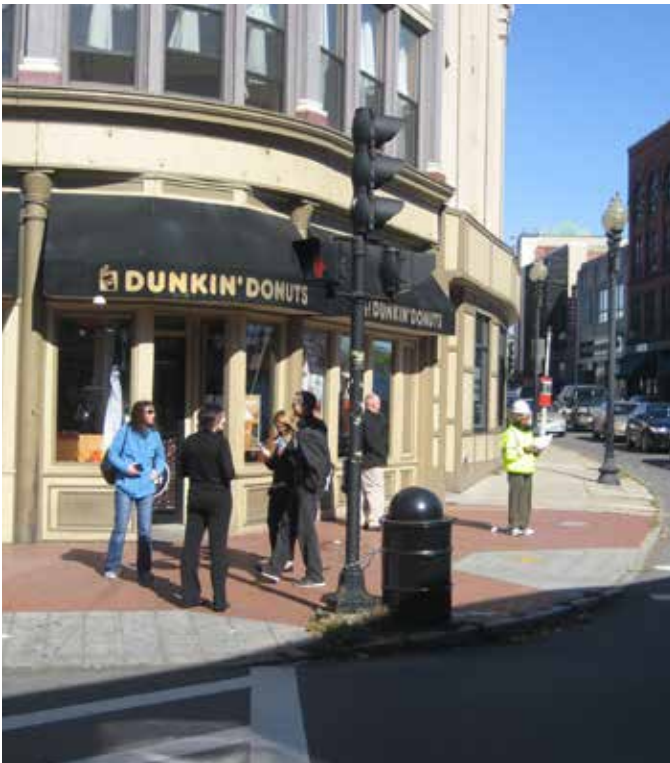
Sidewalks are smooth, wide and well-maintained on this section of Union Street. The Lynn Community Health Center, Greater Lynn Senior Center and other social service agencies generate a lot of pedestrians in this section of the city. An un-signalized, marked crossing at the intersection of Mulberry Street and Union Street provides the only marked crosswalk between Central Square and Freeman Square.

Improved streetscape at intersection of Union Street and Central Avenue

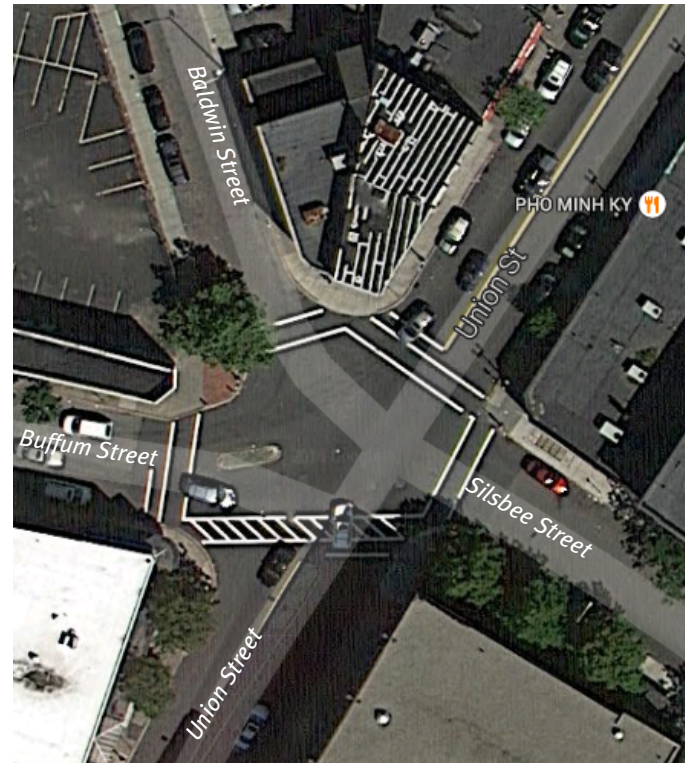
Aerial view of Freeman Square

- Crossing distances are long across Union Street
- Crosswalks have minimal pavement markings (except for one painted using the ladder design)
- Travel lanes seem wide on all approaches; few pavement markings to define roadways
- Traffic islands from previous street configurations do not effectively manage motorists or provide refuge for pedestrians

- Evaluate the location of marked crosswalks; install curb bump-outs to shorten crossing distances
- Paint crosswalks with ladder or continental crosswalk designs
- Use pavement markings to define travel lanes and parking lanes
- Study Freeman Square traffic patterns and redesign square with appropriate pedestrian refuge islands and traffic medians that clarify traffic movements, protect pedestrians at street crossings and improve functionality of vehicular traffic flow

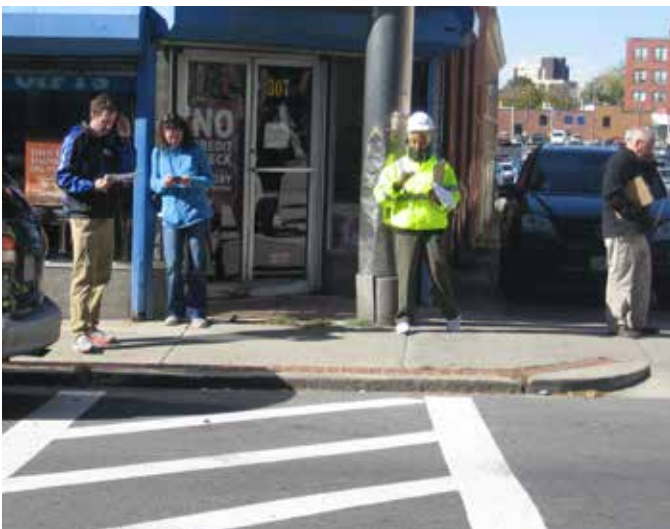
- Missing curb ramps and detectable warning strips at un-signalized marked crosswalk on Union Street

Missing curb ramp at the crosswalk on Union Street

- Install curb ramps and detectable warning strips at un-signalized marked crosswalk on Union Street
- Consider installing curb bump-outs to shorten the crossing distance
- Place an in-street pedestrian crossing sign in the crosswalk to increase its visibility to motorists

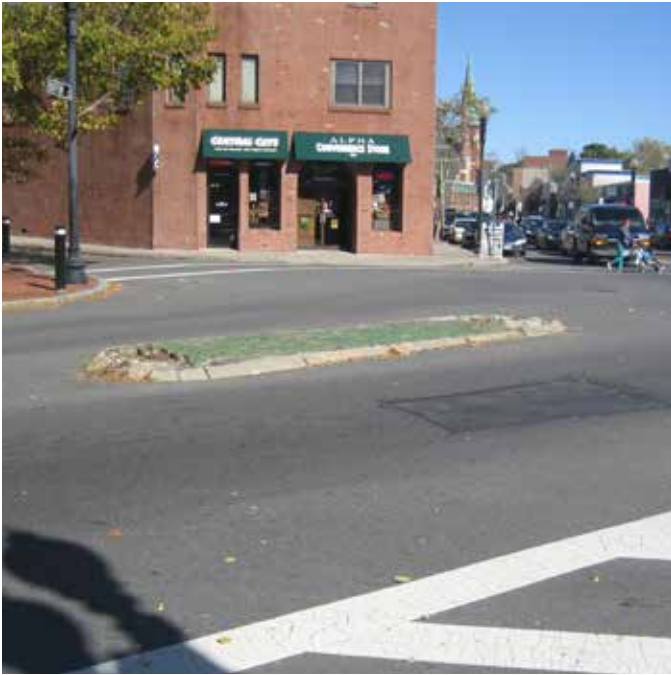
Small traffic island in Freeman Square

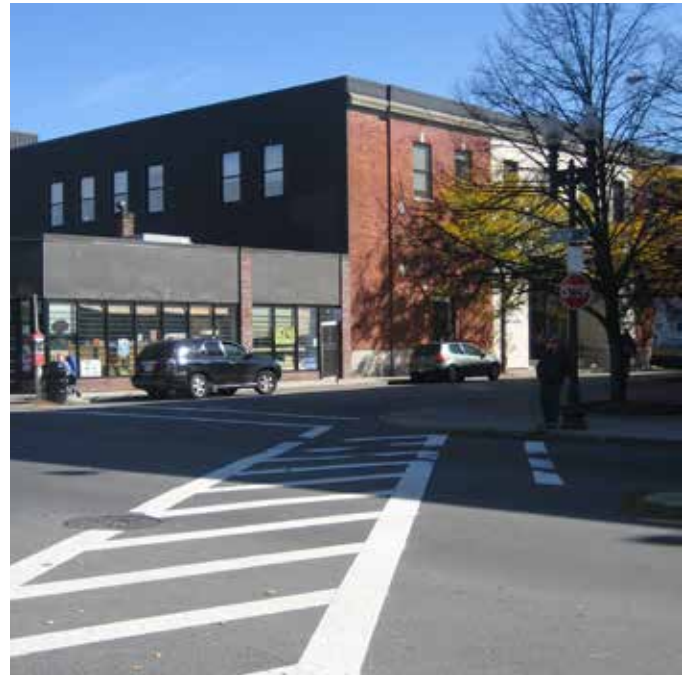
Long crossing distance across Union Street in Freeman Square

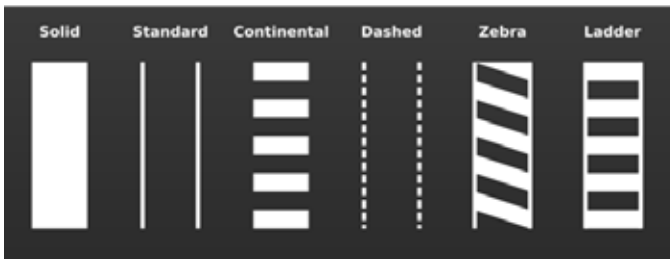
Crosswalks can be painted in a variety of ways, some of which are more effective in warning drivers of pedestrians. Crosswalks are usually accompanied with stop lines. These lines act as the legally mandated stopping point for vehicles, and discourage drivers from stopping in the middle of the crosswalk.

Crosswalk patterns
Source: USFHA

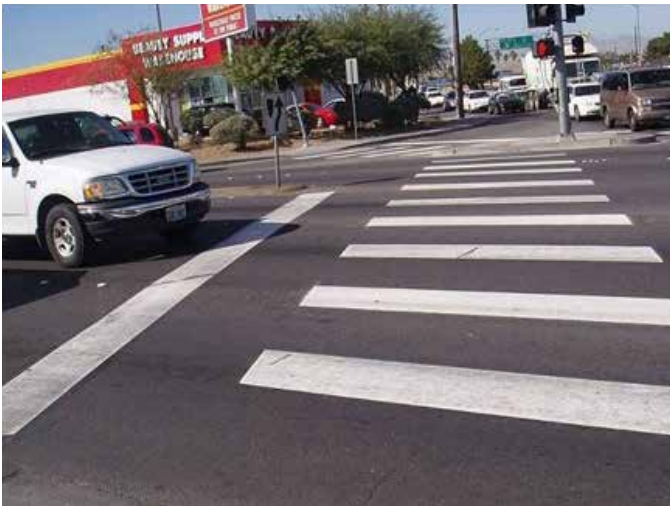
Crosswalk and stop line
Source: http://safety.fhwa.dot.gov/ped_bike/tools_solve/ped_scdproj/sys_impact_rpt/images/fig16.jpg

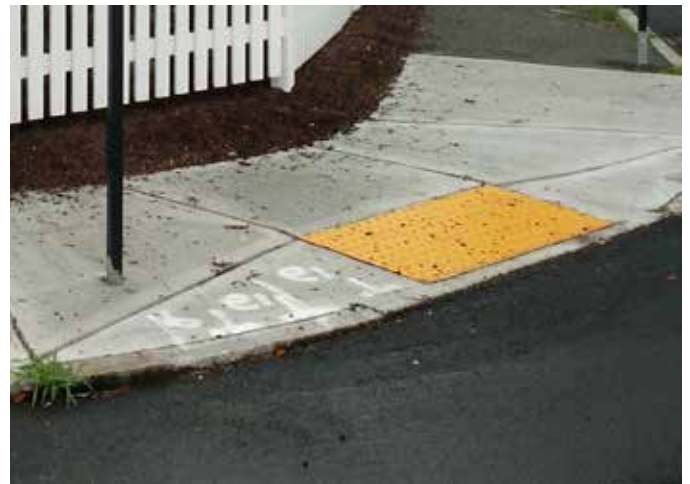
Curb ramps provide access from the sidewalk to the street for people using wheel chairs and strollers. They are most commonly found at intersections. While curb ramps have improved access for wheelchair-bound people, they are problematic for visually impaired people who use the curb as an indication of the side of the street. Detectable warning strips, a distinctive surface pattern of domes detectable by cane or underfoot, are now used to alert people with vision impairments of their approach to streets and hazardous drop-offs.

Curb ramp and detectable warning strip in Woburn, MA

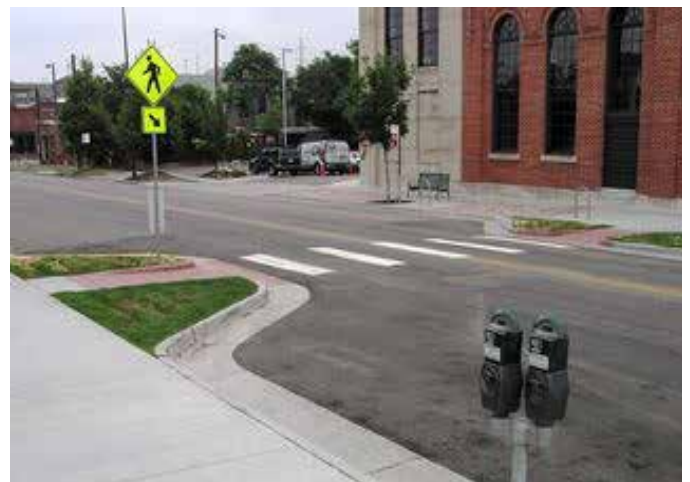
A sidewalk extension into the street (into the parking lane) shortens crossing distance, increases visibility for walkers and encourages eye contact between drivers and walkers.

Curb extensions are often associated with mid-block crossings

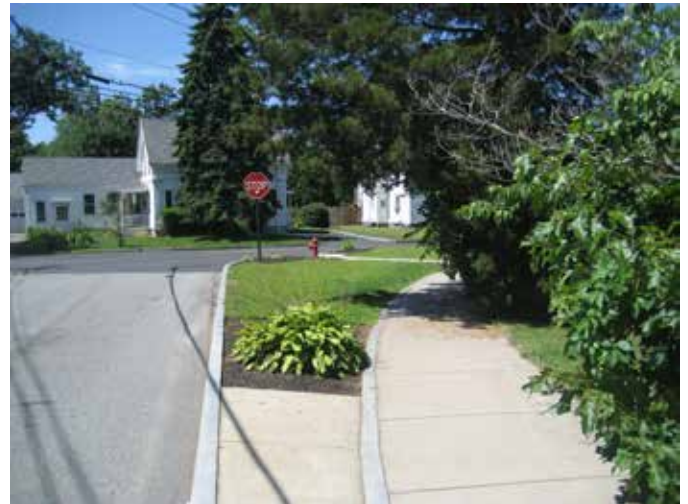
There are two excellent examples of the shortening of curb radii in Woburn, MA. The first (A) is a low-cost solution using a gravel-filled zone between the original curb line and the newly established road edge. The second is a higher-cost solution using grass and trees and extending the sidewalks to the new curb. Both work to slow traffic.

(B) Grass, trees and extended sidewalk in curb extension

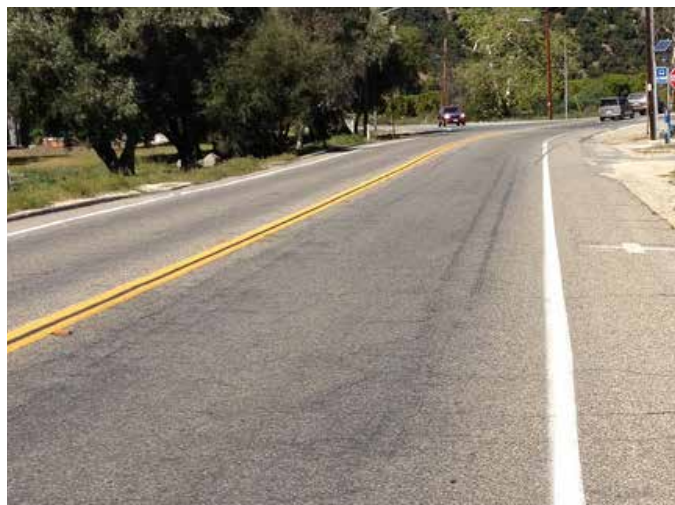
A fog line is a solid white line painted along the roadside curb that defines the driving lane and narrows the driver's perspective. Fog lines are most often used in suburban and rural locations, but may be appropriate in some urban conditions.

Fog lines delineate the vehicular driving zone on wide roadways.

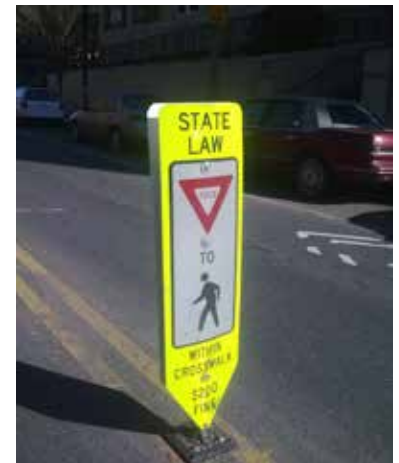
In-street pedestrian crossing signs are used at the road centerline within crosswalks to increase driver awareness of pedestrians in the area. These signs are a relatively low-cost, highly effective tool in slowing traffic by the narrowing travel lanes. They are popular with road maintenance departments since they can be easily moved for snow removal.

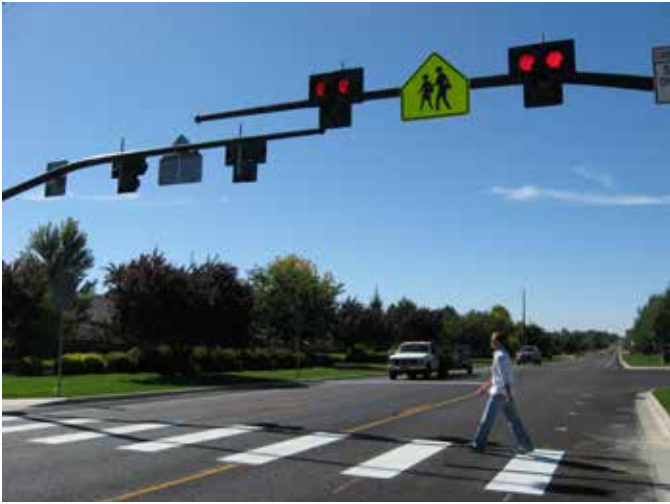
A HAWK beacon (High-Intensity Activated crossWalk beacon) is a traffic signal used to stop road traffic and allow pedestrians to cross safely. It is officially known as a Pedestrian Hybrid Beacon (PHB). The purpose of a HAWK beacon is to allow protected pedestrian crossings, stopping road traffic only as needed. Where standard traffic signal 'warrants' prevent the installation of standard three-color traffic signals, the HAWK beacon provides an alternative.

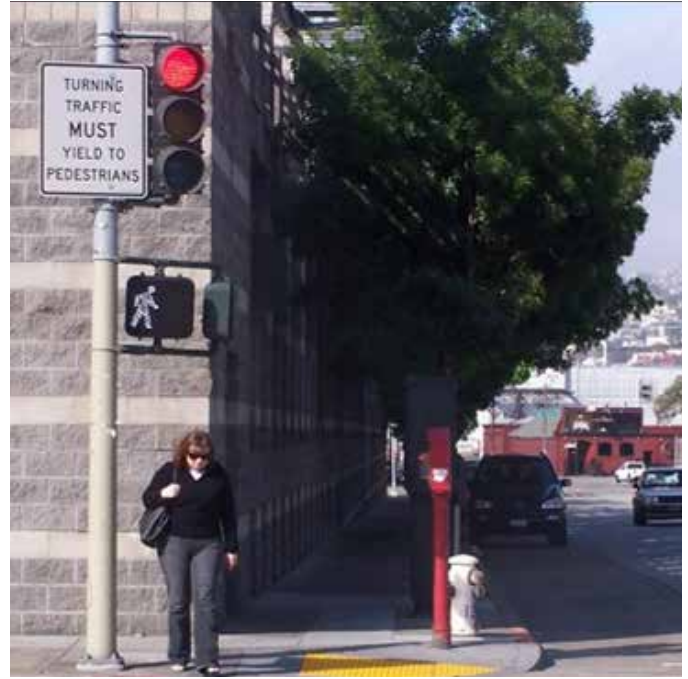
A leading pedestrian interval gives pedestrians an advance walk signal before motorists get a green signal, giving the pedestrian several seconds to start walking in the crosswalk before a concurrent signal is provided to vehicles. This makes pedestrians more visible to motorists and motorists more likely to yield to them. Typical LPI settings provide 3 to 6 seconds of advance walk time.

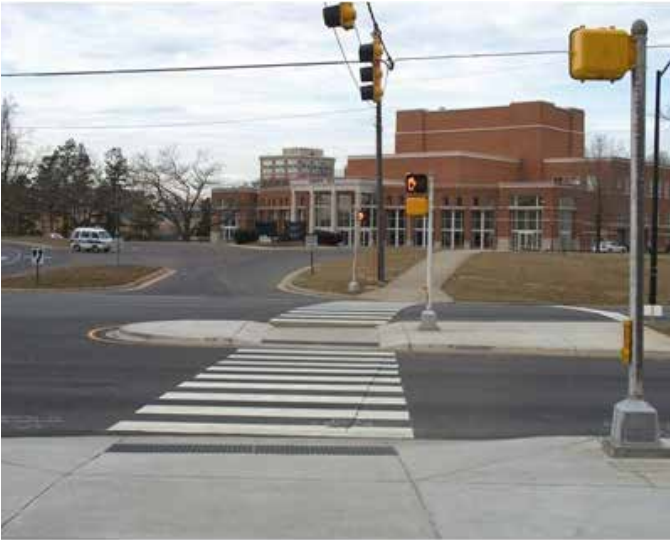
Pedestrian refuge islands are protected areas where people may safely pause or wait while crossing a street. Pedestrian refuge islands are particularly helpful as resting areas for seniors, persons with disabilities, children, and others who may be less able to cross the street in one stage. At signalized intersections, they allow slow moving pedestrians to cross in two phases. At unsignalized locations, they simplify the act of finding a gap in traffic to cross since vehicles from only one direction must be reckoned with at a time.

Pedestrian refuge island at a signalized crossing
Source: <http://safety.fhwa.dot.gov/intersection/resources/fhwasao6o16/images/fig95.jpg>
