## Walk Assessment Watertown, MA

January 14, 2015

Prepared for the Massachusetts Department of Transportation Bicycle and Pedestrian Safety Awareness and Enforcement Program in partnership with the Massachusetts Department of Public Health

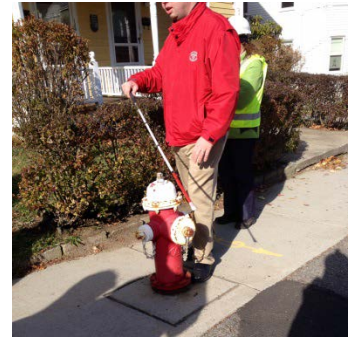
Figure 2: Hydrant in middle of sidewalk on Irving Street.

- Define edge of sidewalk with curbing.
- Define edge of sidewalk adjacent to parking lots with change in material or joint.
- Maintain a hazard-free pedestrian access route of street furniture such as hydrants, utility poles, etc. especially the hydrant on Irving Street near Irving Park.

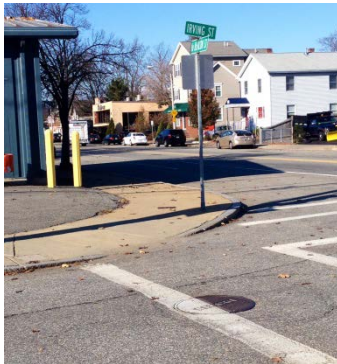
Figure 3: Apex curb ramp.

The assessment team noted that several of the intersections have apex ramps which are difficult for visually-impaired pedestrians to line themselves up at the intersection. It was noted that when the crosswalk and curb ramps are set back at an intersection, visually-impaired pedestrians have difficulty navigating the crossing or, in some cases, are unaware of the presence or location of the crossing and curb ramps. According to the assessment team, the visually-impaired community is taught to not rely on the alignment of the crosswalks or curb ramps rather to adjust their direction based on hearing the direction of vehicular

traffic. The assessment team recommends including ADA-compliant ramps at all crosswalk locations. The assessment team discussed how the visually-impaired community is taught to walk in straight lines including seeing eye dogs are taught to cross within the crosswalk. The assessment team noted that due to these teaching, the crosswalk should be provided in the correct location. Also, it was noted that several of the curb ramps lack detectable warning panels. During the assessment, it was noted that detectable warning panels should be provided within pedestrian crossing islands if the pedestrian is required to activate a pedestrian pushbutton to complete crossing the roadway. This would inform the visually-impaired pedestrians to stop and find the push button to continue crossing the roadway and not to walk out into oncoming traffic.

- Install detectable warning panels at all curb ramps.
- Provide ADA-compliant curb ramps located in a straight path to the crossing for all crosswalks and reduce use of apex ramps when possible.
- Trim vegetation adjacent to sidewalks to maintain pedestrian access route.
- Reduce tripping hazards along sidewalks by repairing raised sidewalk panels or providing smooth transitions with patched segments.
- Maintain a hazard-free pedestrian access route including the detectable warning panels, especially in snow.
- Maintain adequate pedestrian accommodations in work zones.
- Maintain audible pedestrian tones where provided.
- At signalized intersections with concurrent pedestrian phases, consider implementing leading pedestrian phases.
- Repair driveway aprons to fix potholes within the pedestrian path.
- Install vertical separation between parking areas and adjacent sidewalks missing.

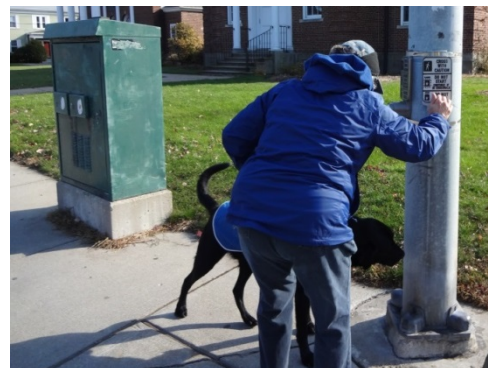
At signalized intersections, the assessment team noted that the pedestrian indications, audible tones, and pedestrian pushbuttons should be in working condition. It was also noted that the audible tones at several approaches to the intersection were similar, making it difficult to distinguish the direction pedestrians may cross. Consideration should be given to using different tones for each intersection crossing. The Town has received complaints about the noise of the

Figure 4: Assessment team member activating the pushbutton.

audible sounds. The Town should consider implementing audible tones that respond to ambient sound levels resulting in a quieter tone being used at night. The assessment team noted that pushbuttons were not always located adjacent to the curb ramps and curb ramps were not always located in a straight path to the intersection.

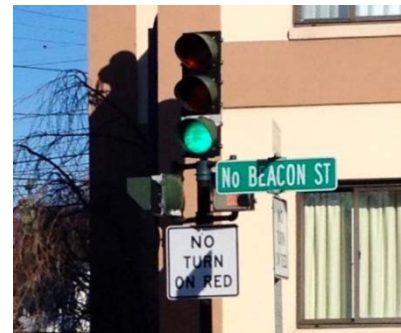
On the northeast corner of the intersection, the street name sign for North Beacon Street blocks the pedestrian indication and the pushbutton does not work. In addition, a member of the assessment team noted that a sign on the northeast corner is mounted too low and is a hazard for pedestrians.

**Figure 5: North Beacon Street name sign blocking the pedestrian indication.**

- Relocate street name sign for North Beacon Street on the northeastern corner as it blocks the walk indication.
- Adjust signage to the correct mounting height.
- Fix the audible signals as they were not functioning properly at the time of the assessment.
- Repaint crosswalks and stop lines; use ladder crosswalk design to increase visibility of crosswalks.
- Evaluate signal timing to ensure adequate crossing time during pedestrian phase. Add into consideration the visually impaired population near this intersection.

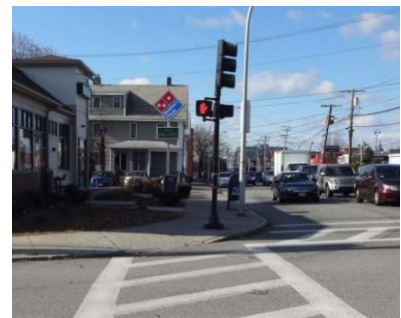
The audible signals were faint and difficult to distinguish the direction to cross. In addition, the curb ramps and pushbuttons are not located properly. Arsenal Street is a wide intersection with undefined space.

Figure 6: Apex curb ramp and pushbutton location at the Irving Street and Arsenal Street intersection.

- Install detectable warning panels.
- Reinstall pavement markings throughout the intersection.
- Adjust signage to the correct mounting height.
- Provide ADA-compliant curb ramps at all crosswalks and reduce use of apex ramps when possible.
- Fix pedestrian indications on the northwest corner as the signal appears to be out at the time of the assessment.
- Fix the pedestrian pushbutton on the northeast corner as it was not working properly at the time of the assessment.
- Fix the audible signals as they were not functioning properly at the time of the assessment.
- Evaluate signal timing to ensure adequate crossing time during pedestrian phase. Add into consideration the visually impaired population near this intersection.

- Consider curb extensions to narrow the roadway width.
- Relocate pushbutton poles to be located adjacent to curb ramps.
- Install pedestrian-scale lighting.
- Relocate the signal cabinet and lighting at the northeast corner to maintain the clear pedestrian access route.

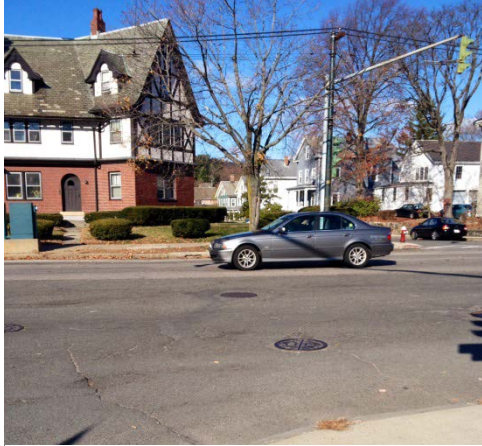
**Figure 7: Missing crosswalk on the eastern side of Mount Auburn Street at Irving Street.**

The assessment team noted that no crosswalk was provided on the eastern side of the intersection. In addition, the assessment team noted there was no curb ramp located on the northern side of the intersection. On the southwest corner of the intersection, there are two pushbuttons on the traffic signal pole. The one signed “BLIND ONLY” was installed in response to neighborhood complaints about the audible signal. If pushed, the audible signal attached to this pole does not operate, while the others in the intersection still sound. The “BLIND ONLY” pushbutton should be removed and the other pushbutton should be located at the appropriate height.

- Evaluate a crosswalk and ADA-compliant curb ramps on the eastern side of the intersection; if added, the crosswalk should maintain perpendicular lines, such as in the ladder design.

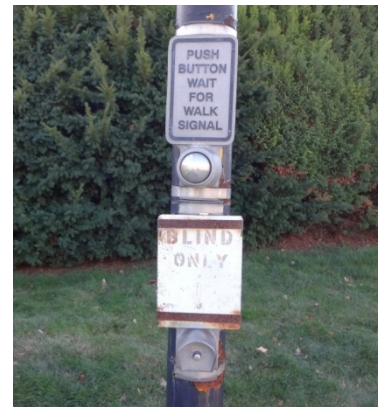
**Figure 8: Separate pushbutton provided at Mount Auburn Street and Irving Street to activate the audible signals.**

- Remove “BLIND ONLY” pedestrian pushbutton.
- Install curb ramp on the northern side of Mount Auburn Street.
- Install detectable warning panels.
- Provide ADA-compliant curb ramps at all crosswalks and reduce use of apex ramps when possible.
- Study the intersection clearance times to ensure vehicles have cleared prior to the pedestrian phase.
- Provide enforcement at the intersection during peak hours.

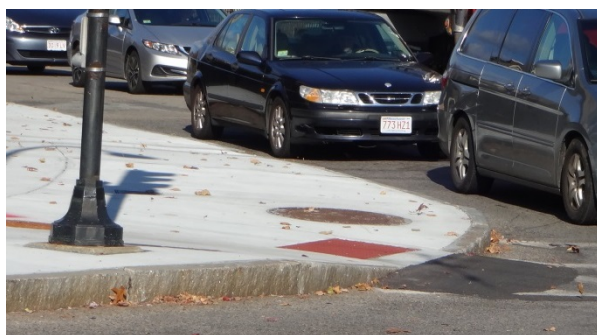
Figure 9: New curb ramp at the intersection of Mount Auburn Street and Common Street.

- Install detectable warning panels.
- Provide ADA-compliant curb ramps at all crosswalks and reduce use of apex ramps when possible.
- Evaluate the addition of a crosswalk and ADA-compliant curb ramps between Parker Street and Common Street.
- Evaluate signal phasing and remove the conflict of vehicles turning onto Parker Street.
- Study adding “NO TURN ON RED” signs at all the intersection approaches.
- Provide enforcement at the intersection during peak hours.

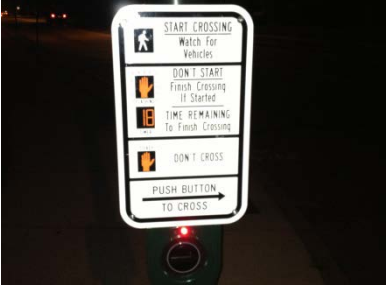
Facility Type	Description	Sample Photo
<p><b>Accessible Pedestrian Signals (APS)</b></p>	<p>Accessible pedestrian signals systems are the components used at a signalized intersection to alert pedestrians when they may cross a roadway. Accessible pedestrian signals include audible feedback during the pedestrian crossing phase, vibrotactile feedback, and locator tones to assist visually-impaired pedestrians.</p>

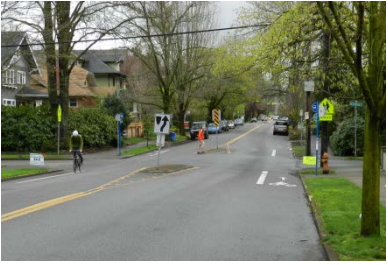
<p><b>Chicanes</b></p>	<p>Chicanes are a traffic calming device that horizontally deflects motor vehicles resulting in reducing vehicular speeds. Chicanes are typically designed by the addition of a median or by shifting on-street parking from one side of the roadway to the other side of the roadway.</p>

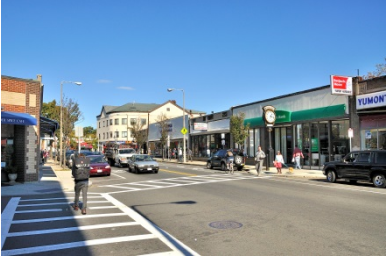
<p><b>Crosswalks</b></p>	<p>Crosswalks indicate to pedestrians the appropriate place to cross the street and inform drivers of potential pedestrian movements in the street. Crosswalk pavement markings may vary in styles; however, must follow the guidelines in the MUTCD. Additional enhancement measures should be used when the speed limit is greater than 40 mph, on multi-lane roadways, or based on engineering judgment.</p>

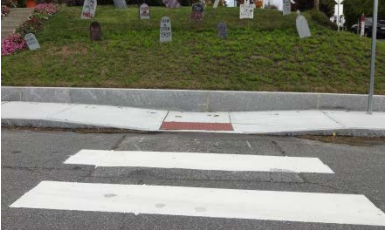
<p><b>Curb Ramps</b></p>	<p>ADA-compliant curb ramps provide ramped access and detectable warning for persons with disabilities. Curb ramps are typically at least 5 feet wide with a level landing pad. Detectable warning panels should be a contrasting color to the adjacent surface.</p>

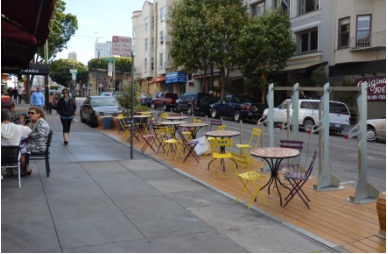
Facility Type	Description	Sample Photo
<p><b>Parklet</b></p>	<p>Temporary gathering area installed in the street adjacent to the curb as an extension of sidewalk space. This is temporary retrofit until a permanent curb extension is installed.</p>

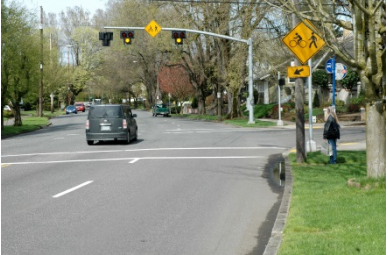
<p><b>Pedestrian Hybrid Beacon</b></p>	<p>An overhead pedestrian activated signal that requires traffic to stop during the pedestrian walk phase. When the beacon is not activated, the signals are dark.</p>

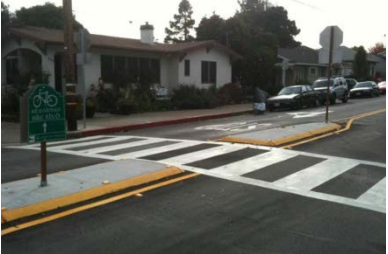
<p><b>Pedestrian Crossing Island</b></p>	<p>Raised median or island that provides in-street refuge at a pedestrian crossing. The island reduces the amount of exposure time for the pedestrian.</p>

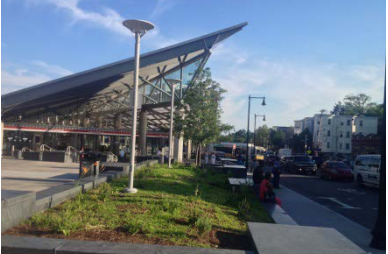
<p><b>Pedestrian-Scale Lighting</b></p>	<p>Light fixtures used to illuminate a sidewalk or pathway typically closer to the ground and placed closer together than roadway lighting.</p>

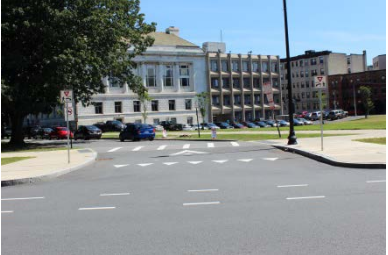
<p><b>Raised Crosswalk</b></p>	<p>A crosswalk raised from street-level to sidewalk-level. This elevated crosswalk increases pedestrian priority and visibility and slows approaching vehicles.</p>
