## Walk Audit Weymouth, MA

July 9, 2014

### **MAKING MASSACHUSETTS MORE WALKABLE**

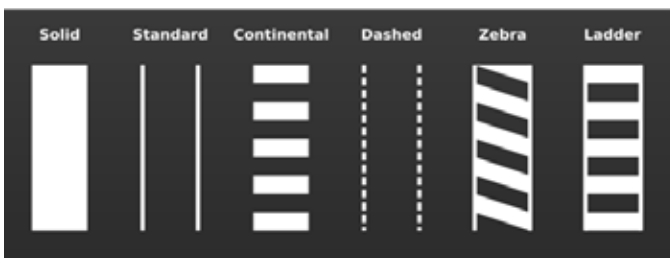
Crosswalks can be painted in a variety of ways, some of which are more effective in warning drivers of pedestrians. Crosswalks are usually accompanied with stop lines. These lines act as the legally mandated stopping point for vehicles, and discourage drivers from stopping in the middle of the crosswalk.

*Crosswalk patterns*  
Source: USFHA

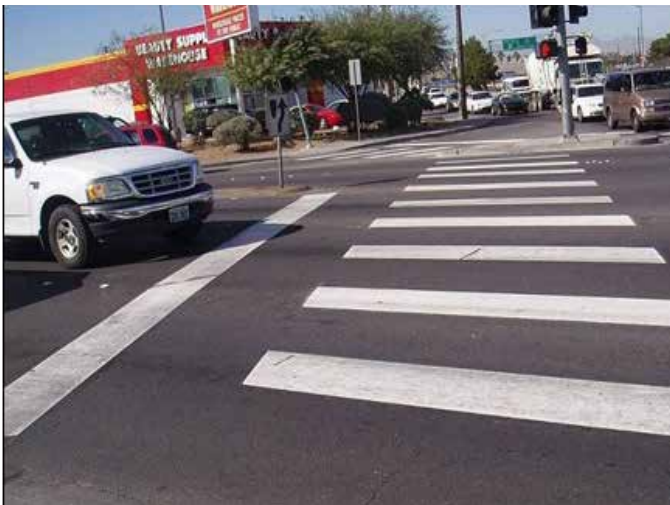
*Crosswalk and stop line*  
Source: [http://safety.fhwa.dot.gov/ped\\_bike/tools\\_solve/ped\\_scdproj/sys\\_impact\\_rpt/images/fig16.jpg](http://safety.fhwa.dot.gov/ped_bike/tools_solve/ped_scdproj/sys_impact_rpt/images/fig16.jpg)

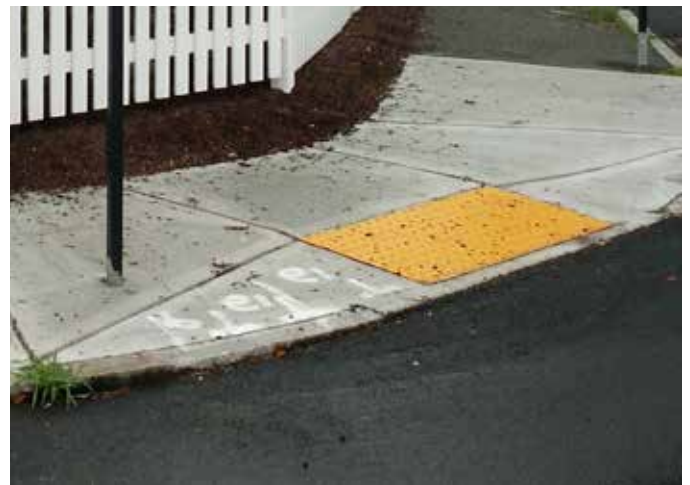
Curb ramps provide access from the sidewalk to the street for people using wheel chairs and strollers. They are most commonly found at intersections. While curb ramps have improved access for wheelchair-bound people, they are problematic for visually impaired people who use the curb as an indication of the side of the street. Detectable warning strips, a distinctive surface pattern of domes detectable by cane or underfoot, are now used to alert people with vision impairments of their approach to streets and hazardous drop-offs.

*Curb ramp and detectable warning strip in Woburn, MA*

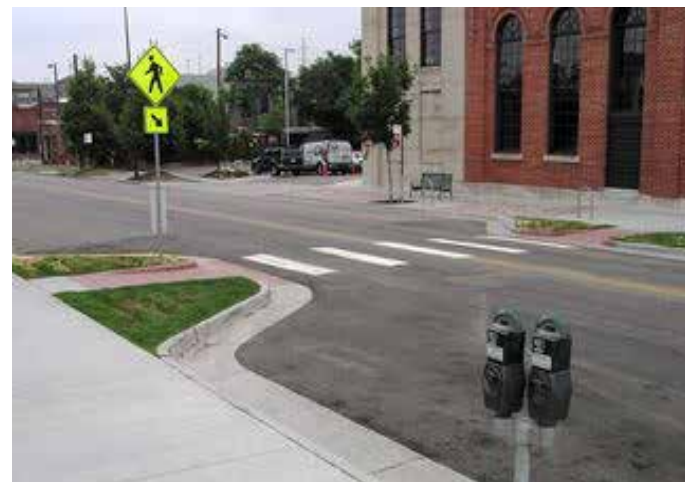
A sidewalk extension into the street (into the parking lane) shortens crossing distance, increases visibility for walkers and encourages eye contact between drivers and walkers.

*Curb extensions are often associated with mid-block crossings*

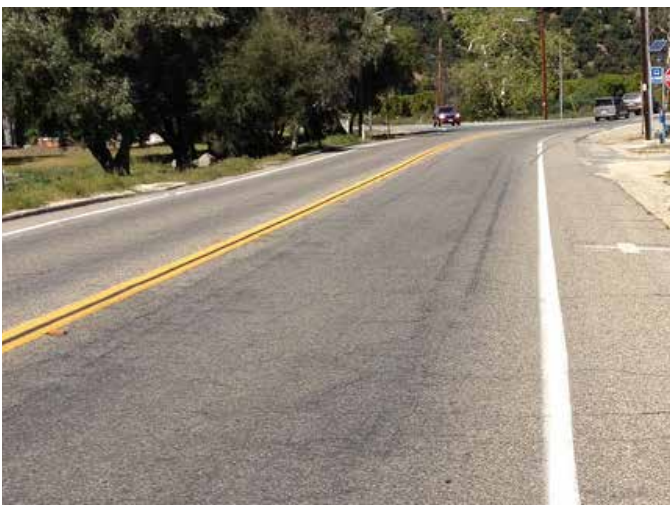
A fog line is a solid white line painted along the roadside curb that defines the driving lane and narrows the driver's perspective. Fog lines are most often used in suburban and rural locations, but may be appropriate in some urban conditions.

*Fog lines delineate the vehicular driving zone on wide roadways.*

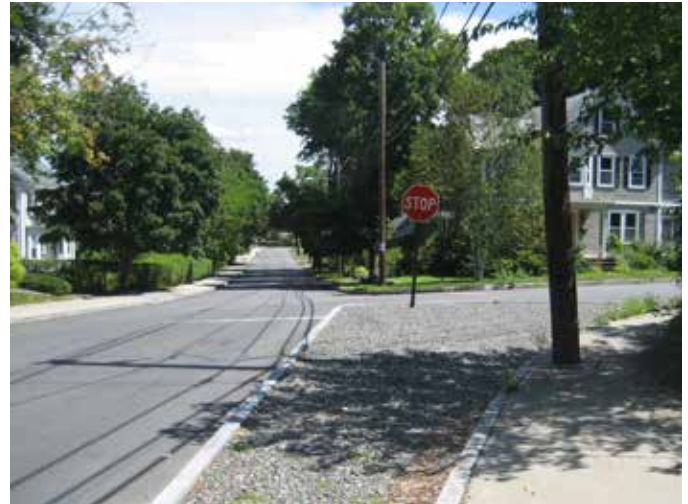
*(A) Gravel-filled curb extension*

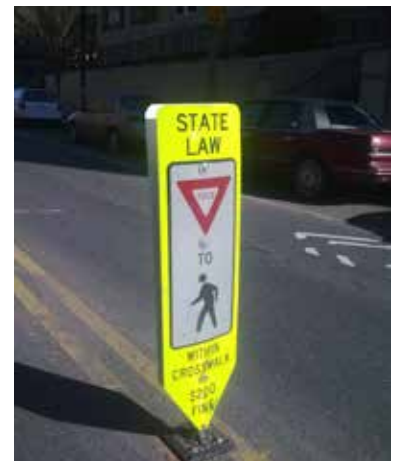
In-street pedestrian crossing signs are used at the road centerline within crosswalks to increase driver awareness of pedestrians in the area. These signs are a relatively low-cost, highly effective tool in slowing traffic by the narrowing travel lanes. They are popular with road maintenance departments since they can be easily moved for snow removal.

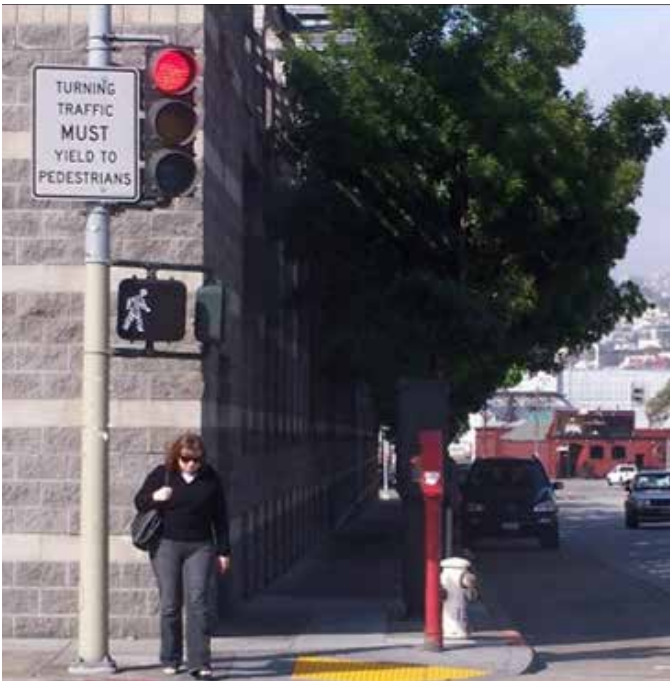
A leading pedestrian indicator gives pedestrians an advance walk signal before motorists get a green signal, giving the pedestrian several seconds to start walking in the crosswalk before a concurrent signal is provided to vehicles. This makes pedestrians more visible to motorists and motorists more likely to yield to them. Typical LPI settings provide 3 to 6 seconds of advance walk time.

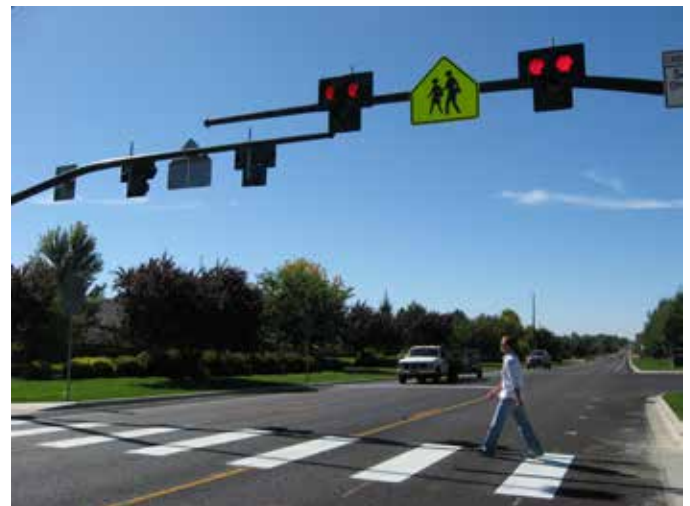
A HAWK beacon (High-Intensity Activated crossWalk beacon) is a traffic signal used to stop road traffic and allow pedestrians to cross safely. It is officially known as a Pedestrian Hybrid Beacon (PHB). The purpose of a HAWK beacon is to allow protected pedestrian crossings, stopping road traffic only as needed. Where standard traffic signal 'warrants' prevent the installation of standard three-color traffic signals, the HAWK beacon provides an alternative.

- Consider adding a pedestrian activated HAWK signal at mid-block pedestrian crossings. (The High-Intensity Activated crossWalk beacon is used to stop road traffic to allow pedestrians to cross safely, stopping road traffic only as needed.)
- Consider eliminating the crosswalk closest to Washington Street (consult with residents of the senior housing beforehand, and coordinate with prior improvements to the crossing at Broad/ Washington)
- Repair sidewalks along Broad Street

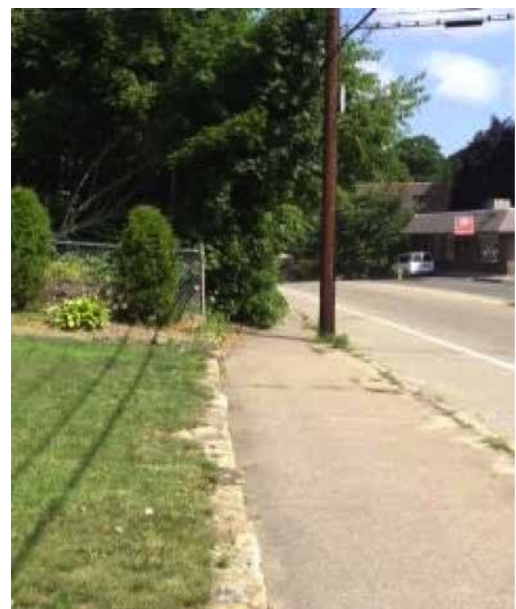
*Overgrown vegetation obstructing sidewalk on Washington Street*

- Trim shrubbery that obstructs the sidewalk at (apparently) publicly owned land on the west side of the street.
- Remove trash from sidewalk
- Narrow curb cut and repair sidewalk in front of

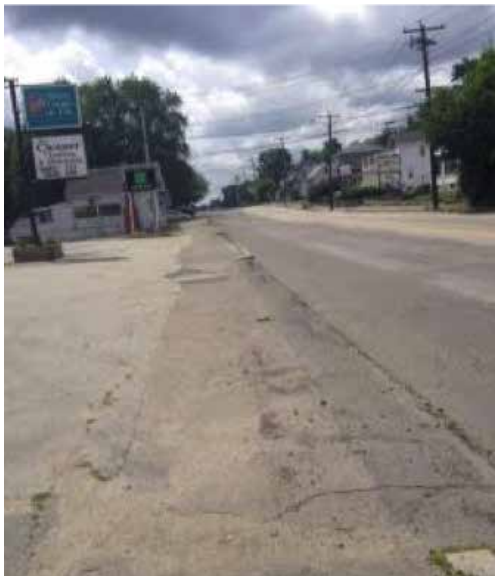
*Extended curb cut on Washington Street*

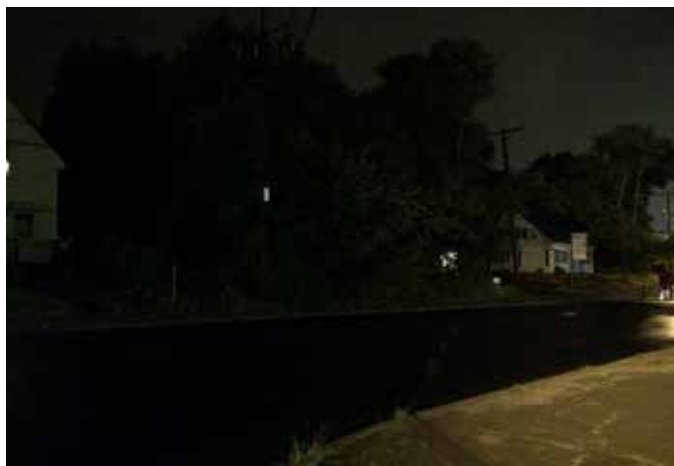
*Limited nighttime visibility on Broad Street*

- Consider adding additional speed limit posting and enforcement on Broad Street for the safety of pedestrians and especially seniors. Changes in the road (such as narrower lanes) would be needed to reduce travel speeds.
- Improve lighting of the sidewalk on the western side of the street where there are some poorly lit areas

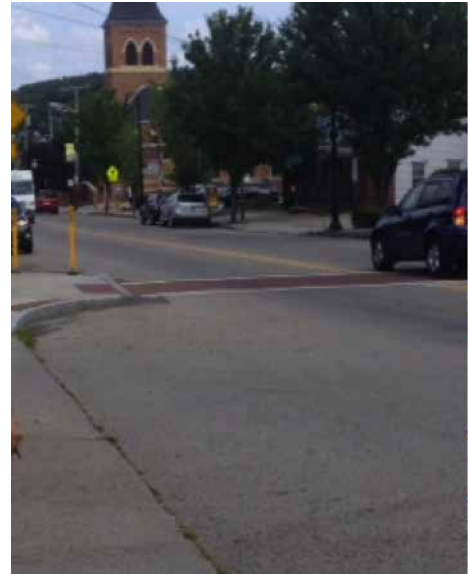
*Pedestrian crossing in front of Post Office on Washington Street*

- Improve the pedestrian crossing in front of the Post Office
  - » Paint the crosswalk with zebra or ladder style markings
  - » Remove the parking space at east end of crosswalk to improve visibility of pedestrians waiting to cross. Several pedestrians were observed at the crossing and each of them experienced difficulties seeing traffic and being seen by drivers.

- Further Improve the pedestrian crossing in front of the Post Office
  - » Construct a bulb-out on the east end of post office crosswalk.
  - » Add pedestrian activated traffic signal.
- Consider adding a mid-block crosswalk with bulb-outs at Richmond Street to connect with the path into Weston Park.
- Fix curb cuts to conform to ADA standards.
- Consider greater posting and enforcement of 30 mph speed limit for the safety of pedestrians and especially seniors. Changes in the road (such as narrower lanes, on-street parking) would help reduce travel speeds.

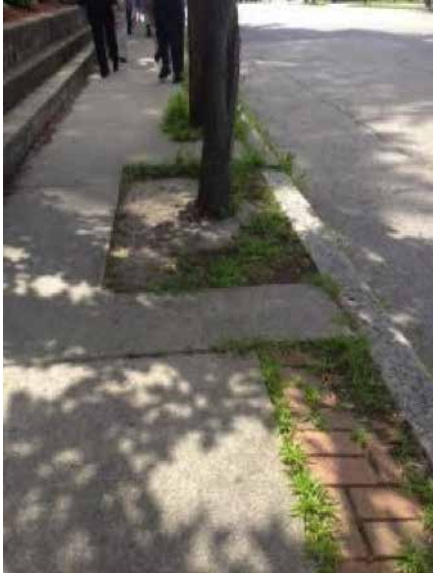
*Tree well on a narrow sidewalk on Washington Street*

- » Repair the sidewalks that are in poor condition.
  - » Encourage additional Washington Street abutters to add planters to brighten the walk for pedestrians, and thank the businesses who already maintain nice plantings for their contribution to the walking environment.

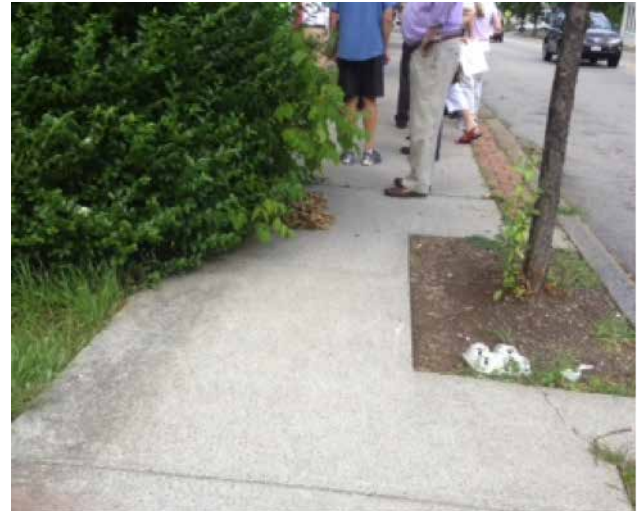
*Overgrown shrubbery near entrance to Weston Park*

- » Trim shrubs now encroaching on the sidewalk at the path to Weston Park.
- » Clean debris from sidewalk.
- » At Eclipse Hair Designs (155 Washington Street, between Broad and Richmond), a sidewalk leading from a driveway into the business has a sloped ramp up to the entrance, un-separated from the sidewalk. This creates a tripping hazard for pedestrians. The Town should work with the building owner to make safety improvements for the entrance.

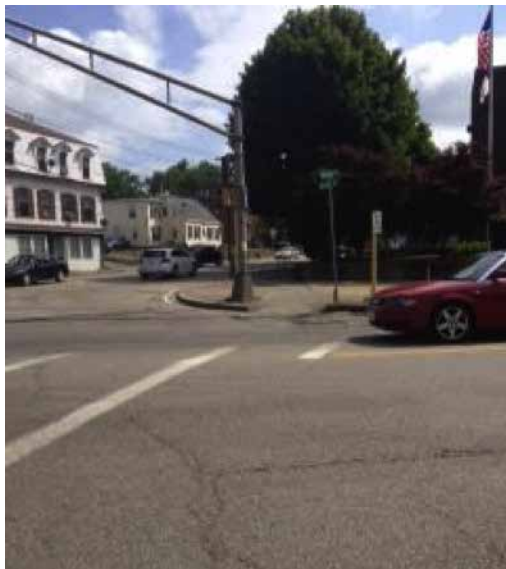
*Pedestrian crossing at Broad and Washington Streets*

- Add signs warning drivers that many seniors cross the street at this intersection.
  - » Add trash containers at the seating area on the southeast corner.
- Longer-term recommendations
  - » Permanently narrow turning radii to slow turning vehicles and shorten pedestrian crossing distances.
  - » Fix all curb cuts to meet current ADA standards and for proper alignment.
  - » Review lane widths to determine if they could be narrowed to reduce speeds and crossing distances.

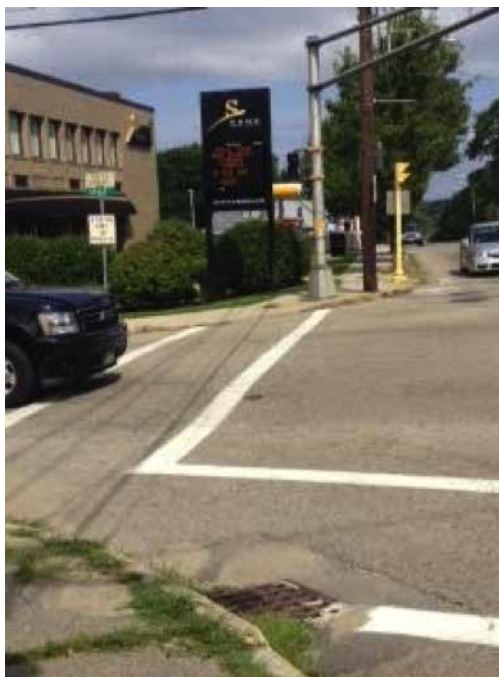
*Long curb radius at Broad and Washington Streets*

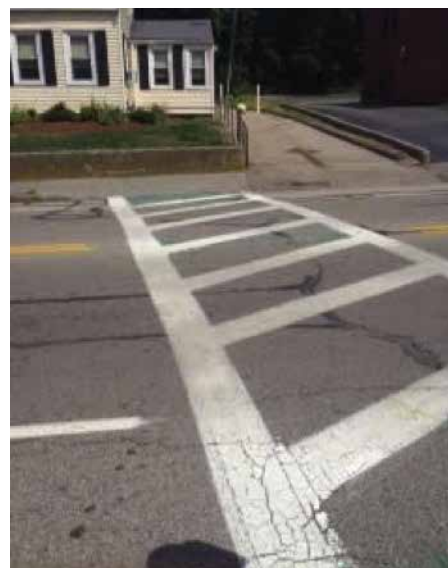
This portion of Broad Street carries heavy, fast traffic and has been the site of several fatal pedestrian accidents. Access between senior housing on the south side of the street and both Jimmy's Broad Street Diner and other destinations on the north side was noted as a particular concern. Two unprotected crosswalks exist, one serving the diner at the corner of Phillips Street, and the second at a mid-block location about halfway between Phillips and Washington Streets. The crosswalk at Phillips Street appears to not meet ADA requirements (of particular importance because of the many seniors with disabilities who use the crosswalk) because the landing on the north side of the street is sloped up toward the sidewalk (between the curb and the property line). While the locations of these two crosswalks are not ideal in terms of sight lines and traffic speeds, they seem to serve pedestrian desire lines.

*Pedestrian crossing near senior housing on Broad Street*

- Add an in-street pedestrian crossing sign at the Phillips Street crosswalk
- Paint the Phillips Street crosswalk with fresh zebra or ladder style striping
- Paint tighter turning radii at Phillips Street to shorten crossing distance
- Add signs warning drivers of an upcoming pedestrian crossing and of large number of seniors using the crossing

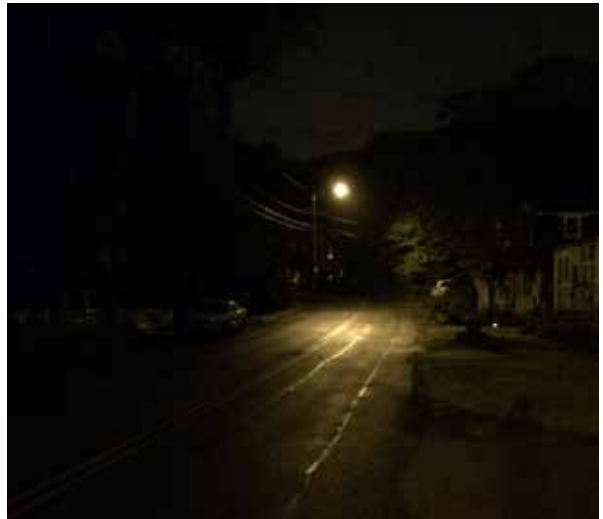
*Poor nighttime visibility on Vine Street*

- Consider reducing curb radii, to aid in slowing traffic at both intersections.
- Consider adding more lighting because Vine Street is poorly lit which is a problem for pedestrians who would not be very visible when walking in the street at night (because there is no sidewalk) night

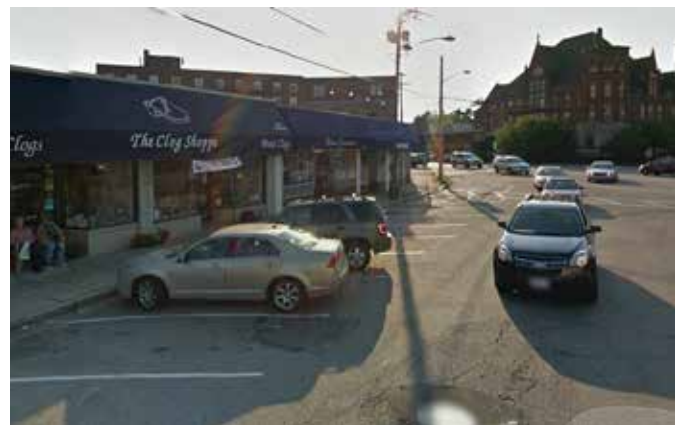
All four approaches to the Square are two-lane streets that widen out substantially into four- or six-lane streets to accommodate turning vehicles within the square. Due to the many turn lanes, the streets are very wide and are difficult for pedestrians trying to cross. In addition, along Union Street just west of Pleasant Street (an area with a number of restaurants) diagonal parking creates a very wide street area (approximately 120 feet) and drivers can't see pedestrians wanting to cross where diagonal parking restricts their view.

*Diagonal parking on Union Street*

- » Improve the lighting and landscaping of the walkway leading from the municipal parking lot to Pleasant Street. Alley from parking to pleasant
- » Add a curb cut to Union Street crosswalk leading to Camelot Way and addition of In-street Pedestrian Crossing Sign in the crosswalk

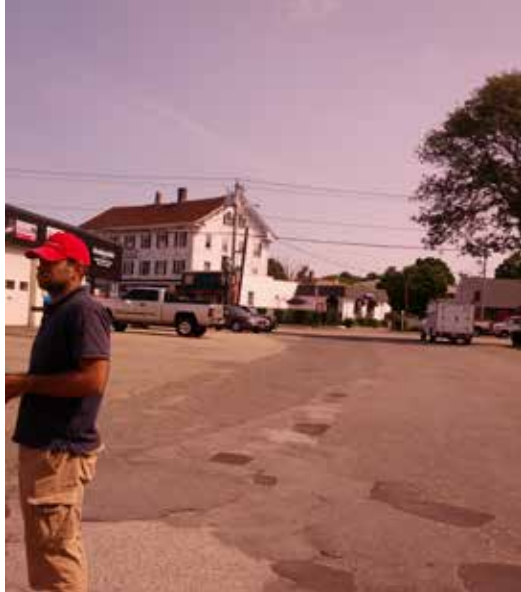
*Walkway to Camelot Way parking lot*

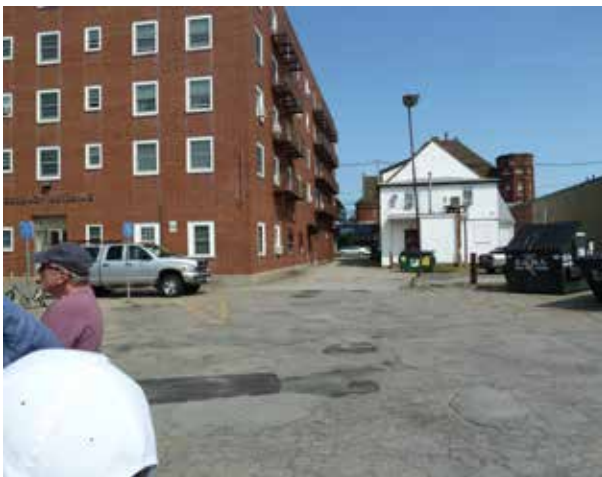
*Alley from parking lot to Pleasant Street*

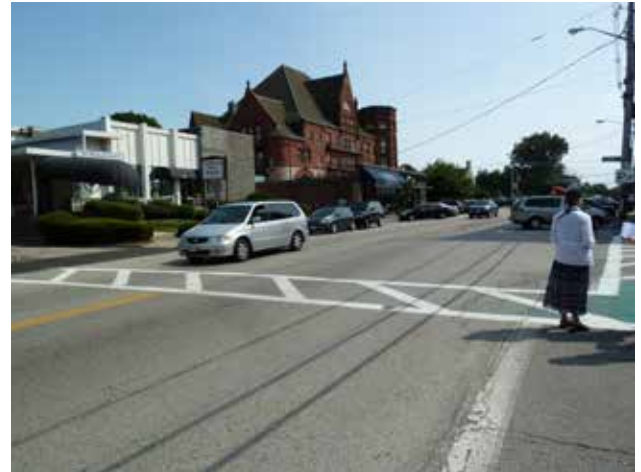
*Poor visibility across Pleasant Street*

- Pedestrian safety improvements are needed for all legs of the Columbian Square intersection. Temporary improvements to explore include:
  - » Create temporary reductions of corner radii, through bollards or barrels, to reduce the speed of turning vehicles
  - » Create temporary bulb outs (with paint and barrels) at the corners to improve visibility for and of pedestrians (this is particularly important for pedestrians crossing Pleasant Street at Torrey Street where vehicles are approaching at high speeds from the northeast)
  - » Add In-street Pedestrian Crossing Signs to crosswalks on Pleasant Street at Torrey, Union/ Columbian and Chauncy Streets

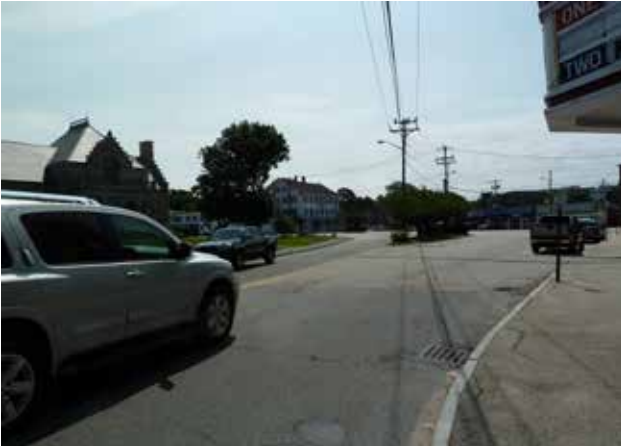
*Wide turning lanes near Colombian Square*

- Provide traffic signals at Columbian Square that provide ample pedestrian WALK time, countdown signals, leading pedestrian indicators, and appropriate phasing to facilitate walking without causing severe traffic delays
- Consider adding a pedestrian refuge island on Pleasant Street at the Torrey Street crossing, as the crossing is wide and there are some visibility issues for drivers.
- Add sidewalks on Camelot Way to serve the street's residents and the municipal parking lot Camelot way
- Review the need for turning lanes on all of the streets approaching Columbian Square and reduce the pavement width wherever feasible. The new street geometry should include tight turning radii and narrow lane widths to reduce crossing distances and moderate traffic speeds in the district.

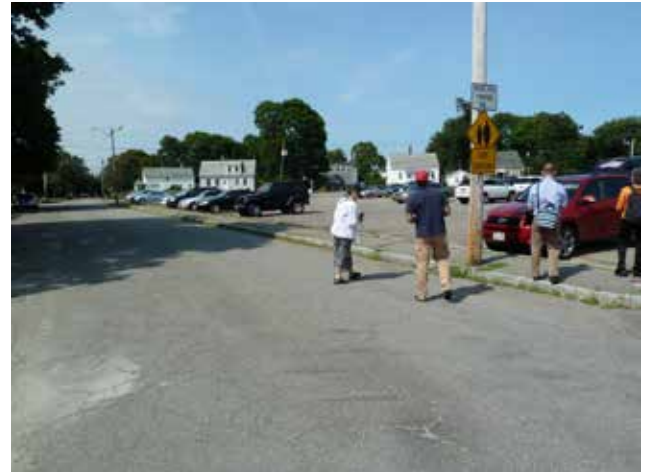
*Municipal parking lot at Camelot Way*

- If the new experimental pedestrian zone on Union Street is successful, add permanent paving, landscaping and street furniture.
- Review the angle parking on both sides of Pleasant Street to determine whether it could also be replaced with a wider, landscaped sidewalk and a more limited number of parallel parking spaces. Angle parking on pleasant
- Add trees and landscaping to the Camelot Way parking lot to make it more attractive to users. Municipal parking Camelot way
- Review need for additional lighting on the Pleasant Street crosswalk at Chauncy Street

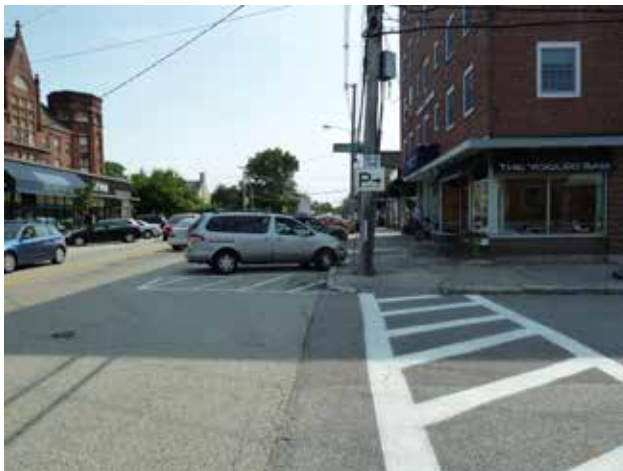
*Angle parking on Pleasant Street*

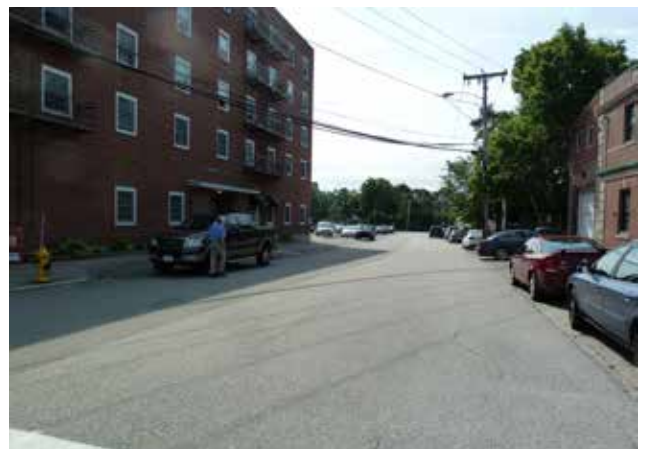
*Walk from parking lot to Chauncy Street*

- Repair the street paving at the Pleasant Street end of Chauncy Street to improve the pedestrian crosswalk
- Consider adding diagonal parking on the half-block of Chauncy Street closest to Pleasant Street to add to the business area parking supply, perhaps by designating Chauncy a one-way street.

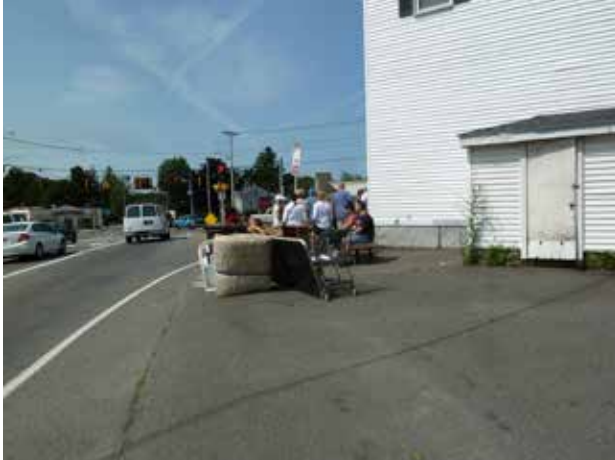
Sidewalks along Pleasant Street vary in width and condition, with some areas inadequate for safe and comfortable walking or to meet ADA standards. In some places where there are no curbs, parked cars occupy a portion of the sidewalk. For example, in front of Snyder Jewelers at 89 Pleasant Street, and at a nearby bicycle repair shop and lock shop the sidewalk is undistinguishable from the street pavement. Near the Main Street intersection (aka Independence Square), there is a significant driveway serving the Pleasant Shops shopping center, and there is no pedestrian walkway marked through the parking lot. At the bus stop on the north side of Pleasant Street near Main, private trash was awaiting pick up and almost completely blocked the sidewalk and bus stop.

*Bus stop with trash along Pleasant Street*

- Repair and reconstruct the sidewalks to meet ADA standards. Particular problem areas are just west of Chauncy Street, at the bike and lock shops, adjacent to the Post Office, and curb cuts at Central and Wilbur Streets.

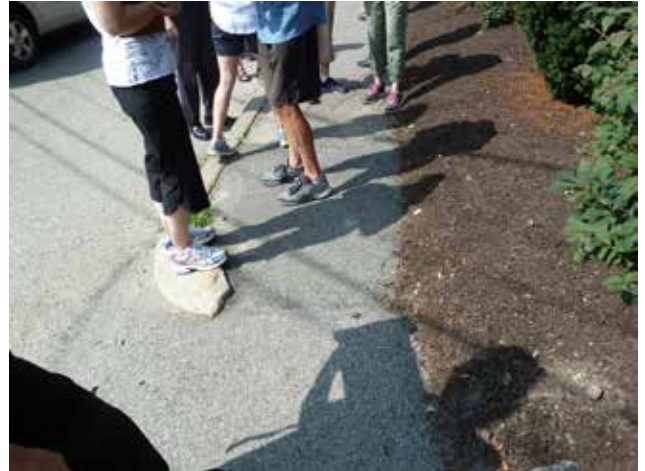
*Inadequate curb ramp on Pleasant Street*

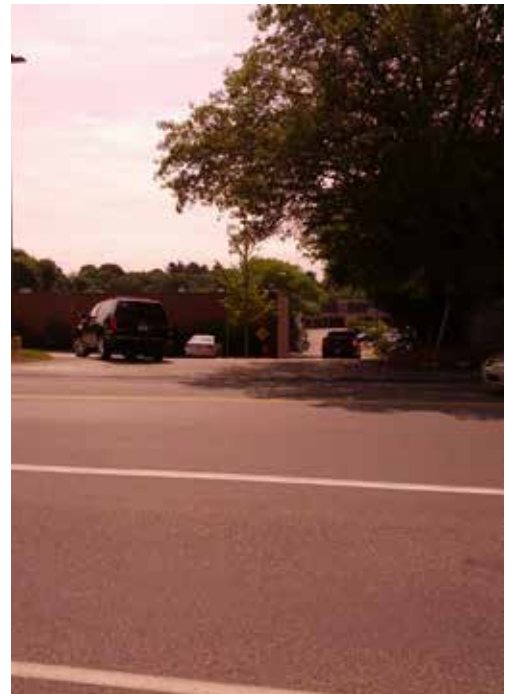
*Shopping center entrance on Pleasant Street*

- Work with Pleasant Shops shopping center owner to improve pedestrian access, including an examination of the slope of the drive which creates a blind spot and the turning radii that encourage fast entry to the site, along with a new pedestrian path.
- Review night light levels and add lighting as needed

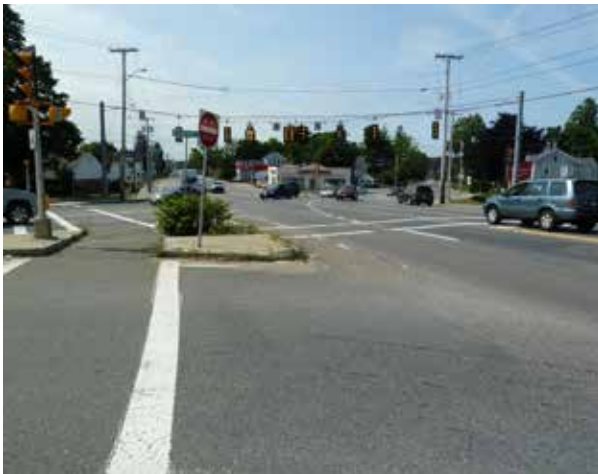
*Intersection of Pleasant and Main Streets*

- Explore re-design of the pedestrian crossings at Independence Square, to reduce crossing distance and improve sight lines through such measures as tightening turning radii and eliminating the free right turn from Pleasant onto Main northbound.

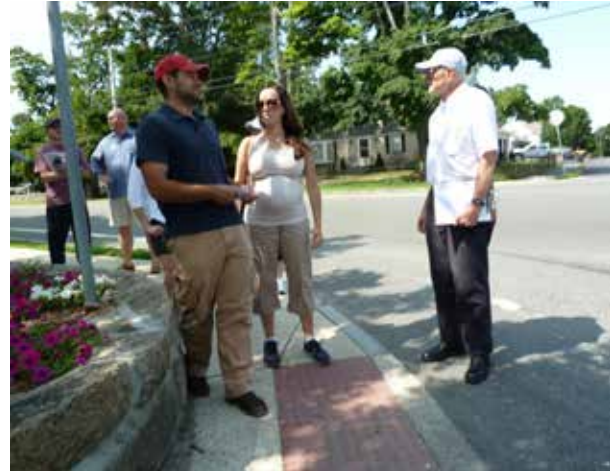
*Skinny curb ramp at Fogg and Main Streets*

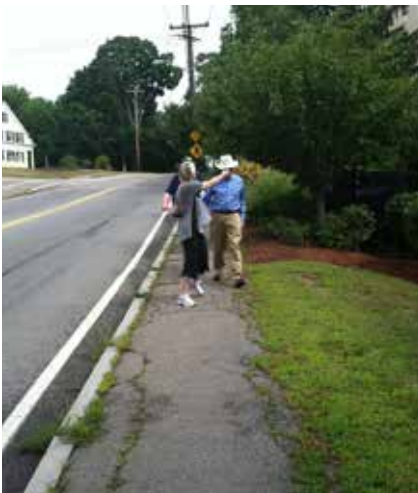
*Narrow sidewalk on Pleasant Street*

- Repair the sidewalks along both sides of Pleasant Street narrow sidewalk on pleasant
- Significantly narrow the continuous curb cut at the Teen Center parking lot
- Fix the sidewalk and curb ramps at the intersection of Pleasant and Water Streets, where the width and angles of the ramps do not meet ADA standards inadequate ramp

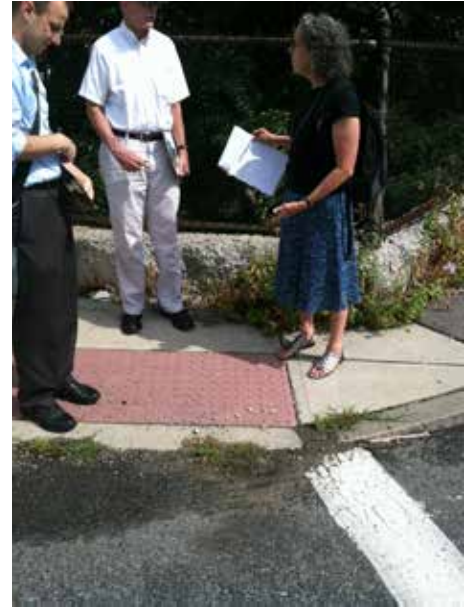
*Inadequate curb ramp at intersection of Pleasant and Water Streets*

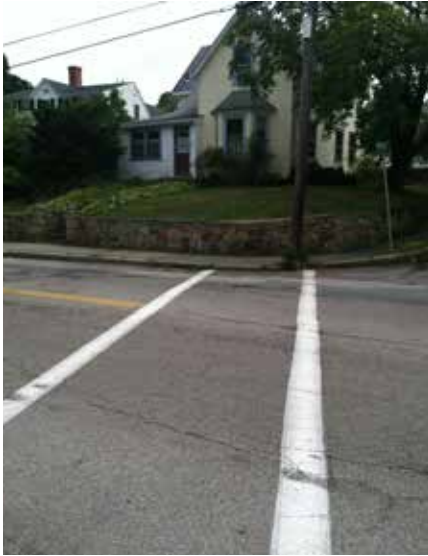
*Crosswalk at Myrtle Street*

- Add fog lines to narrow the travel lanes and help slow traffic speeds
- Trim the overhanging vegetation near the Herring Run Brook overlooks to remove walking obstacles and open up views of the Brook
- Explore ways to improve the safety of the crosswalk to Myrtle Street including addition of an In-Street Pedestrian Sign, zebra or ladder style striping of the crosswalk, and re-alignment of the diagonal crossing Myrtle street crosswalk
- Check the lighting of Commercial Street, especially at the intersection with Water Street, to see if it should be improved for pedestrians.

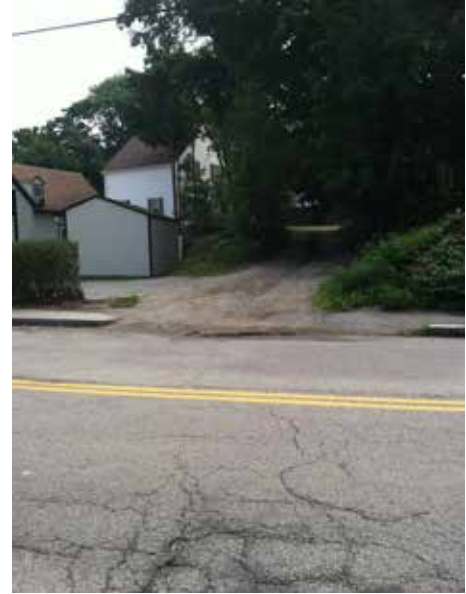
*More damaged sidewalk on Water Street*

- Repair the sidewalks along both sides of Water Street water st sidewalk water st in need of work
- Explore opportunities to enhance landscaping and views of Herring Run Brook
- Narrow the wide curb cuts to businesses along the street water st curb cuts
- Tighten the turning radii at Commercial Street
- Consider narrowing the width of the street which is much wider than necessary, contributing to the speed of traffic

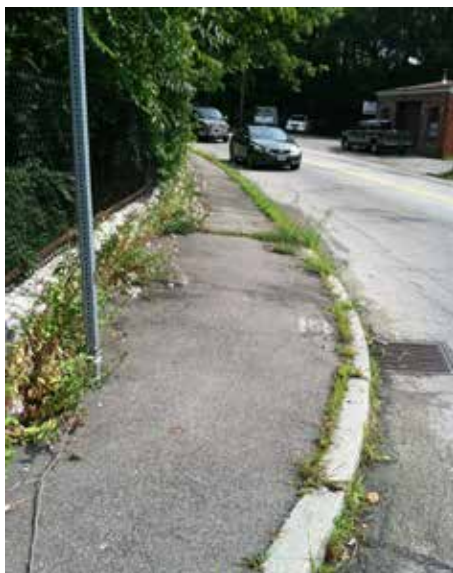
*Sidewalk on Water Street in need of repair*

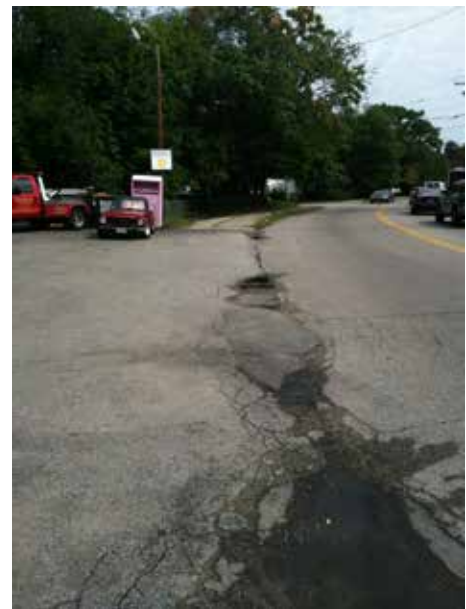
This street includes a large senior apartment block, a number of single family homes, auto repair businesses and small retail at the northern end of the street. Poor sidewalk conditions, wide curb cuts and wide turning radii contribute to the street's poor walking conditions.

*Wide curb cuts on Water Street*

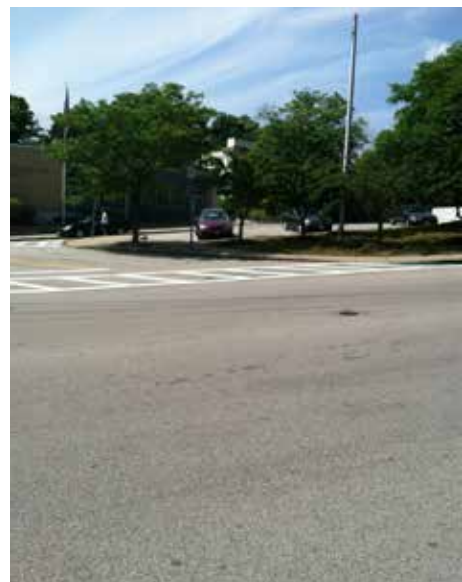
*Wide turning radius on Bridge Street*

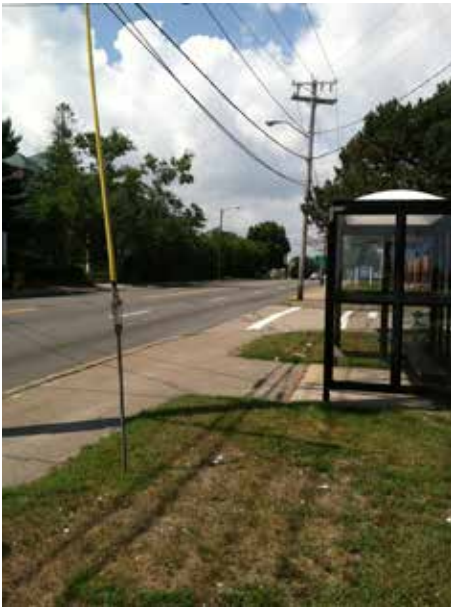
*No protected crosswalk near bus stop*

- Build a sidewalk along Bridge Street as it approaches Lowe's Plaza. The missing sidewalk poses a hazard for pedestrians to walk to the CVS at the far end of the Plaza.
- Review the signal timing at Green and Bridge Streets to consider changing from an all-way stop to a concurrent crossing which would reduce pedestrian wait times for a WALK signal
- Review the potential for adding protected crosswalks in close proximity to bus stops. Under the existing conditions there are bus stops on both sides of the street in several locations (near Blackstone Road and Lovell Street) without nearby crosswalks. Pedestrians are thus crossing Bridge Street without the protection of a crosswalk.

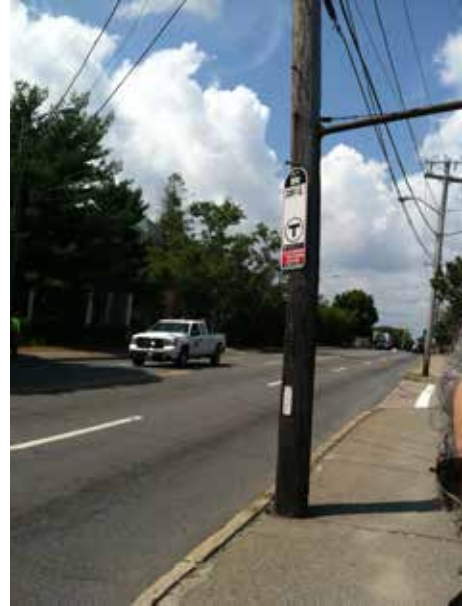
*Area near bus stop on Bridge Street that could benefit from street trees*

- If there is adequate room in the right-of-way consider the addition of street trees to enhance walking environment along Bridge Street.

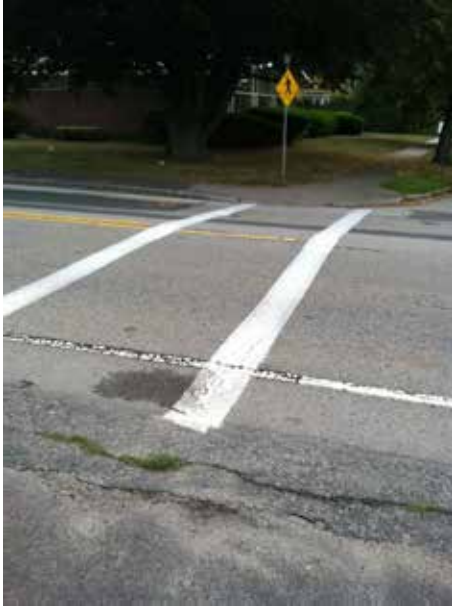
*Curb cut on Pearl Street in need of repair*

- Repair curb cut on Pearl Street to make it ADA compliant.

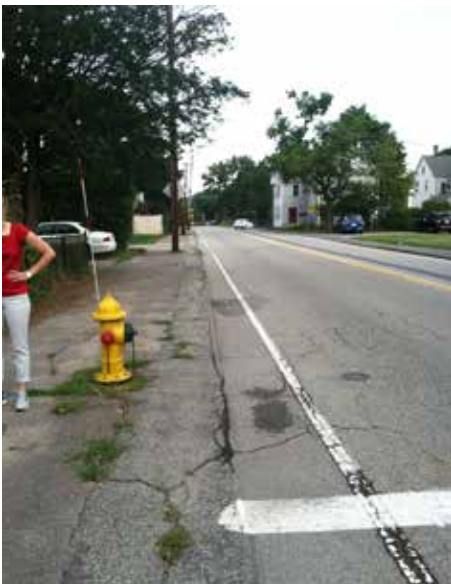
*Area on North Street in need of a curb*
