Walk and Bike Assessment Pittsfield, MA

January 20, 2015

Prepared for the Massachusetts Department of Transportation Bicycle and Pedestrian Safety Awareness and Enforcement Program in partnership with the Massachusetts Department of Public Health

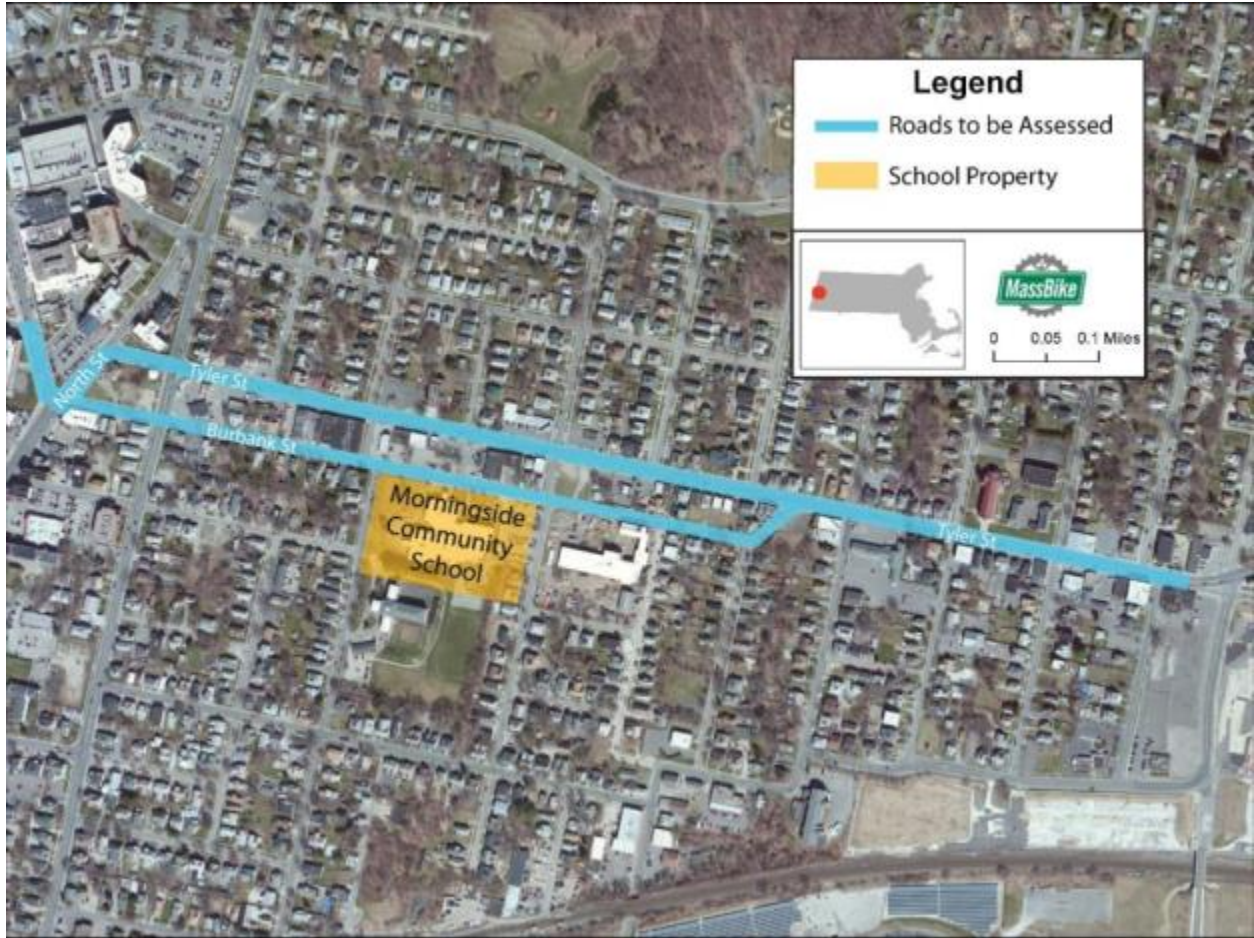
Figure 1 - Assessment Area Map

The assessment area is shown in **Figure 1**. The streets were selected to increase walking and bicycling safety, and to enhance the pedestrian and bicycle network. The roads and intersections in the study area do not have existing on- or off-street bicycle facilities.

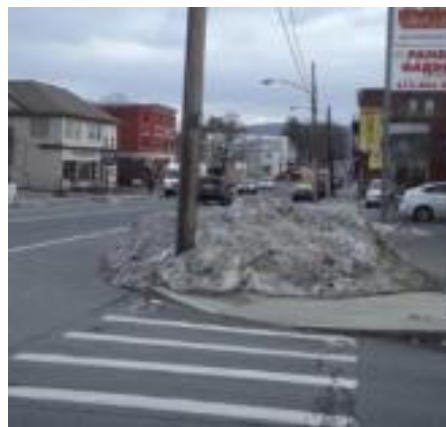
During the assessment, the team noted observations that are applicable throughout the City of Pittsfield. The assessment team observed several snow-covered sidewalks and discussed the importance of maintaining clear sidewalks and curb ramps especially during winter. The City of Pittsfield's policy is that abutters are responsible for snow clearance along sidewalks and will be ticketed if they have not cleared snow within approximately 24 hours after snow fall. It was also discussed that bicycle facilities should be clear of snow in the winter as well, as a growing percentage of the population depends on bicycling for transportation year-round.

Figure 1: Curb ramp and sidewalk with snow.

- Provide ADA-accessible curb ramps at all crosswalks and tactile warning panels at refuge islands 6 feet or wider.
- Maintain clear sidewalks and curb ramps, especially in snow.

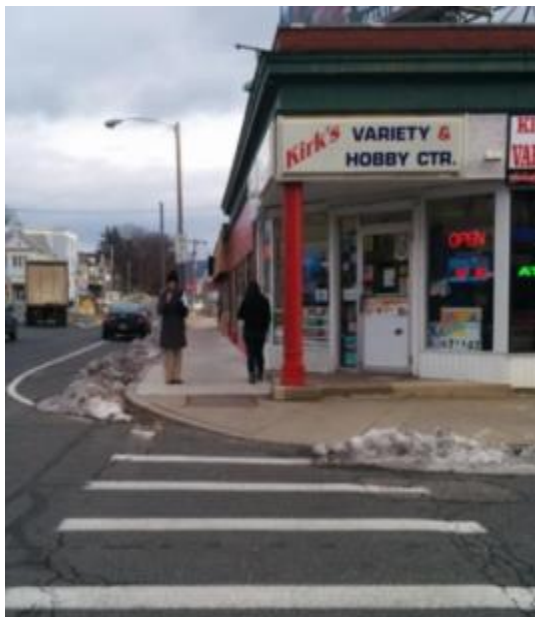
Figure 2: Typical continental crosswalk striping across Forest Place at Tyler Street facing eastbound.

Continental crosswalk striping is the standard pavement marking used in the City of Pittsfield. The team discussed the addition of transverse pavement markings to provide additional visual cues to motorists. In-street ‘YIELD TO PEDESTRIANS’ signs were noted as being used in warmer months and removed for plowing during the winter. Local team members commented that the in-street signs are often stolen or hit within the assessment area.

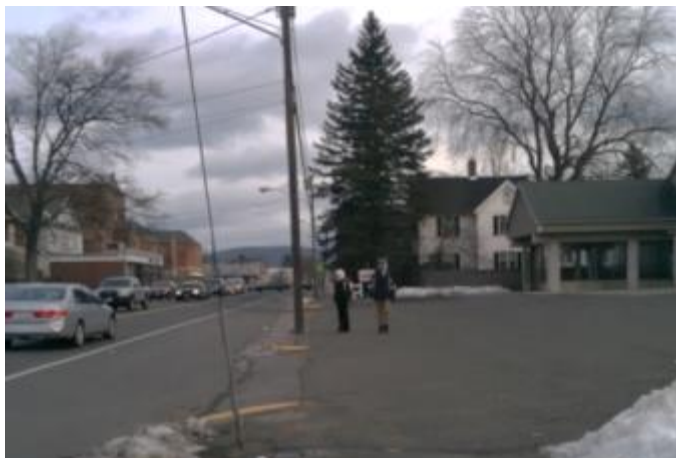
Throughout the assessment area, the assessment team observed that many businesses have multiple curb cuts with off-street parking located between storefronts and the sidewalk. The team discussed how potential zoning changes should consider encouraging buildings to front the sidewalk, and prohibit parking between building fronts and the sidewalk; this will help to reduce conflicts between vehicles entering and exiting parking spaces, provide a sense of enclosure to help calm traffic, and allow active uses along sidewalks such as sidewalk cafés.

Figure 3: Multiple curb cuts to access car wash on Tyler Street at Brown Street facing eastbound.

- Consolidate driveways by removing curb cuts along the corridor to reduce conflict points. Narrow driveway widths to reduce crossing distances.
- Install concrete sidewalks across driveways.

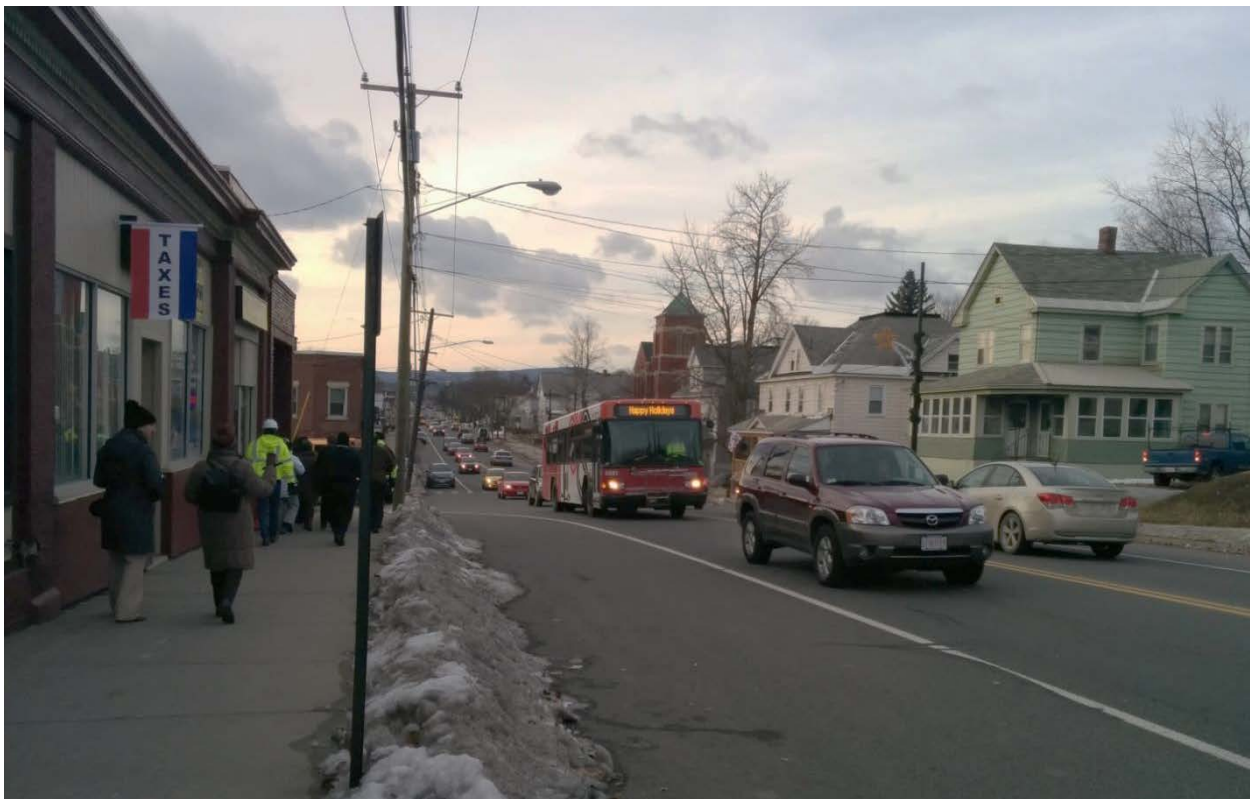
Tyler Street is a two lane roadway, with one lane in each direction and a marked shoulder with on-street parking permitted on both sides of the street. Tyler Street is outside of the downtown core with commercial and residential uses along the corridor. There are existing sidewalks on both sides of Tyler Street for the length of the assessment area, with a narrow sidewalk buffer varying in width west of Brown Street; there is no sidewalk buffer east of Brown Street. There are existing wayfinding signs for the Morning Side Loop walking route along Tyler Street.

Figure 4: Tyler Street typical cross section, approaching Burbank Street heading westbound.

The assessment team discussed narrowing travel and parking lanes to provide on-street bicycle lanes and as an effort to calm traffic. The assessment team also discussed conducting a parking utilization study along Tyler Street to consider removing parking on one side of the street to provide additional separation for bicycle facilities.

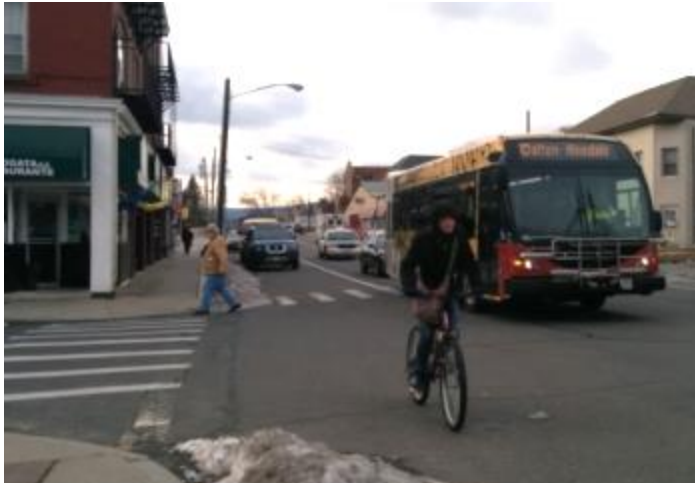
The team observed that Tyler Street is serviced by multiple bus routes by the Berkshire Regional Transit Authority. Service runs every day except Sundays between 5:45 pm and 7:20 pm Monday through Friday, and 7:15 am – 7:00pm on Saturdays at approximately hour-long headways. Bicycle racks are provided on the front of all the buses serving the assessment area. It was noted that there are no marked bus stops along Tyler Street, and the team did not observe any bus stop signs. The team

Figure 5: Tyler Street at Forest Place facing westbound.

observed passengers waiting for the bus and loading/unloading at different locations along Tyler Street. The team discussed the challenges of providing bicycle facilities on Tyler Street without designated bus stops such as anticipating when buses will be crossing a bicyclist's path.

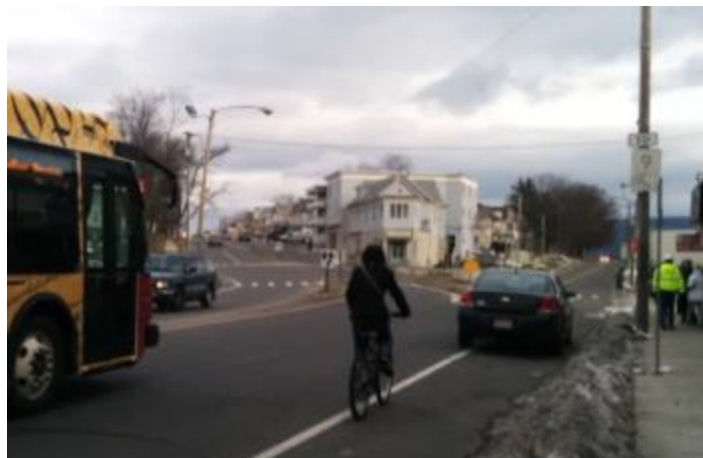
Figure 6: Tyler Street approaching Dalton Avenue/Woodlawn Avenue eastbound.

Team members also discussed the potential for a modern roundabout. A roundabout would help to slow speeds by channelizing traffic at the approach to the intersection, reduce conflict points, facilitate turning movements, and potentially eliminate the need for a traffic signal. Consideration should be given to accommodating larger vehicles by providing aprons or mountable curbs. Bicycle accommodations at modern roundabouts were also discussed. The team recommends providing bicycle ramps to allow bicyclists to transition off the roadway and use the sidewalk as a shared-use path. The team recommends high visibility crosswalks and additional pedestrian safety features such as median refuge islands. The assessment team also recommends the proposed development enhance the bicycle and pedestrian network within the project site and connect to the surrounding neighborhood.

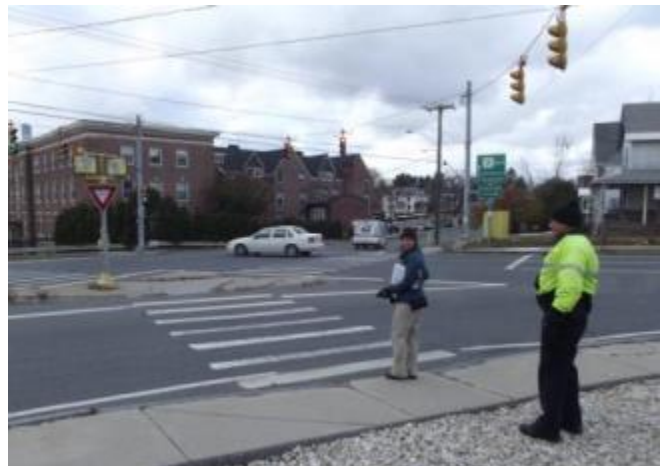
Navigating the slip lane can be difficult for pedestrians as experienced by the assessment team. There is a pushbutton in the pedestrian refuge island. The pedestrian signal timing did not provide adequate clearance time during the flashing don’t walk phase. The team discussed removing the slip lane and tightening the geometry of the intersection to reduce vehicle speeds and crossing distances for pedestrians. This intersection is a 2012 HSIP location and is also part of a larger 2012 HSIP Bicycle Cluster. The gas station at the corner of Tyler and First Streets has multiple,

Figure 7: Pedestrian approaching crosswalk to cross right turn slip lane at Tyler Street and First Street.

- For the right turn slip lane, install yield lines prior to the crosswalk to emphasize motorists must yield to pedestrians in the crosswalk (and vehicles on Tyler Street). Pedestrian warning signage is not recommended at this location due to the traffic signal and yield controls.

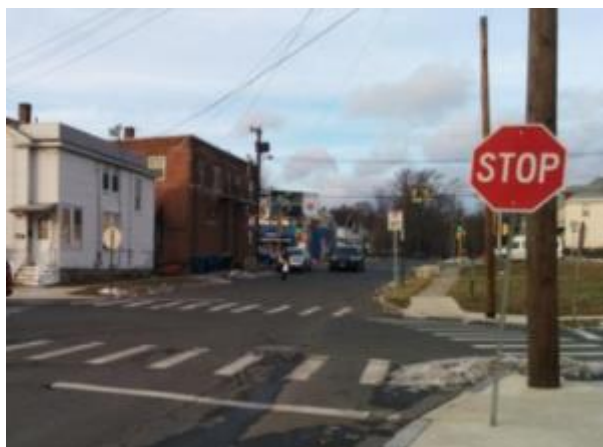
Figure 8: Intersection of Burbank Street/Cherry Street facing northbound.

Intersections are typically stop-controlled on the minor streets and Burbank Street is uncontrolled. The intersection of Burbank Street and Cherry Street is an all-way stop-controlled intersection at the approach to the school. The team noted that the marked crosswalks did not align with the curb ramps at this intersection. Also the team discussed removing the yield to pedestrian signs on the far-sides of the stop-controlled intersection as they are not appropriate for a stop-controlled intersection. It was also noted that the school warning signs were installed too low, and are not visible to motorists.

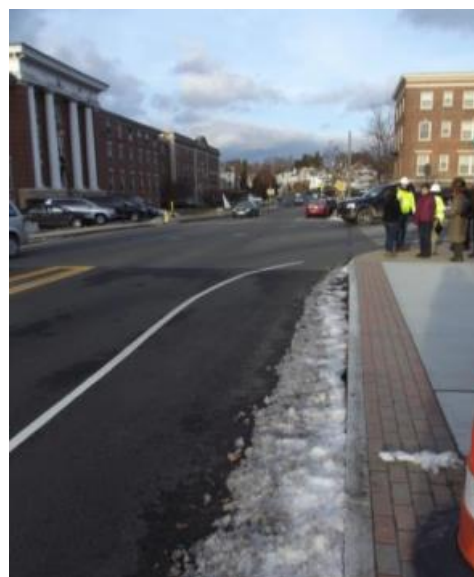
North Street was recently reconstructed to include bicycle lanes, new sidewalks, and turning lanes. There is no parking permitted along on this section of North Street. The team noted that at the intersection of North Street/Tyler Street the bicycle lane ends without warning signs or pavement markings to transition bicyclists to a shared roadway. Bicyclists continuing straight on North Street are directed into the on-street parking lane north of the intersection. The team discussed providing pavement markings and signage to alert bicyclists and motorists that the bicycle lane ends, and providing shared lane markings and signage to transition through bicyclists to a shared travel lane. Also, it was noted there are no bicycle lane pavement marking symbols provided in the southbound direction on North Street.

Figure 9: End of bike lane on North Street approaching Tyler Street northbound.

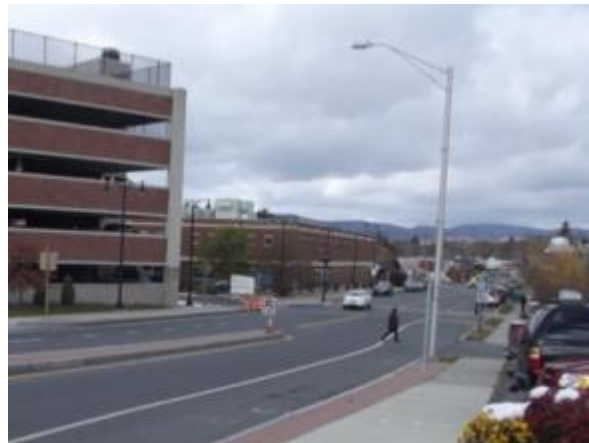
Park Street/Wahconah Street is an unsignalized T intersection. There is a parking lot for the Berkshire Medical Center encompassed by North Street and Wahconah Street. A new parking garage was constructed on the south west corner of Wahconah Street/Park Street. As a part of recent construction, a crosswalk on the south side of Wahconah Street/Park Street was relocated to the north side of the intersection with a flashing yellow beacon. The entrance to the garage is on the south west corner of the intersection or Wahconah Street/Park Street. There is also a sidewalk connecting the parking lot for the Medical Center on the south side of the intersection. It was noted that many pedestrians cross Wahconah Street on the south side of the intersection to access the parking garage entrance. The team discussed removing the flashing beacon at the north side crosswalk across Wahconah Street, and reinstalling the crosswalk on the south side of the intersection to connect the existing sidewalk and the parking garage entrance. The team also discussed installing a rectangular rapid flash beacon for the crosswalk on the south side of the intersection.

Figure 10: Pedestrian crossing intersection of Wahconah Street/Park Street on the south side of the intersection where the crosswalk was removed.

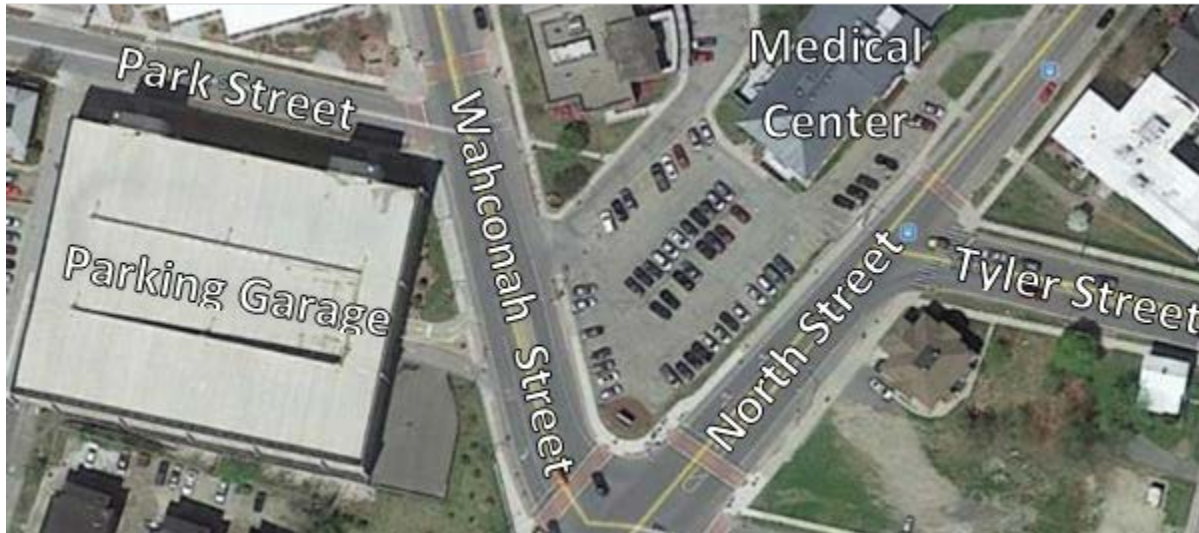
Figure 11 - Aerial view of intersection of Park Street, Wahconah Street, North Street, and Tyler Street.

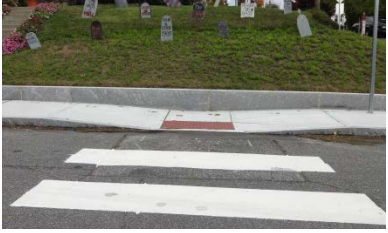
Facility Type	Description	Sample Photo
<p>Curb Ramps</p>	<p>ADA-compliant curb ramps provide ramped access and detectable warning for persons with disabilities. Curb ramps are typically at least 5 feet wide with a level landing pad. Detectable warning panels should be a contrasting color to the adjacent surface.</p>

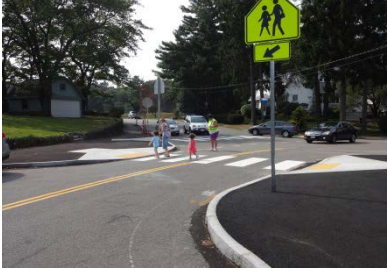
<p>Curb Extensions</p>	<p>A curb extension is an extension of the sidewalk at intersections or mid-block to reduce the pedestrian crossing distance and provide greater visibility for pedestrians waiting to cross a street. Curb extension should not impede on bicycle travel along the roadway.</p>

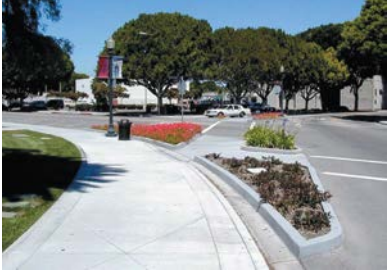
<p>Curb Radii Improvements</p>	<p>Curb radii improvements are modifications to existing curb lines or edges of the pavement at an intersection. These modifications typically are used to decrease crossing distances for pedestrians, increase pedestrian visibility, and/or to reduce vehicular speed by tightening the turning radii at the intersection corners.</p>

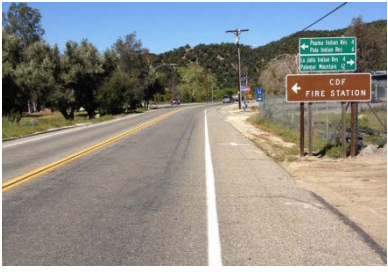
<p>Edge Lines</p>	<p>Edge lines are solid white lines painted along the roadside curb that defines the driving lane and visually narrows the travel lane.</p>

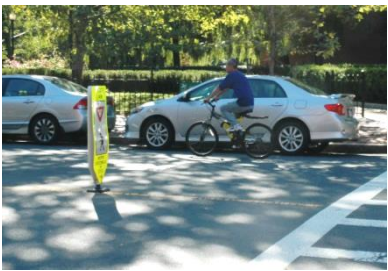
<p>In-Street Pedestrian Crossing Sign</p>	<p>A high-visibility sign placed on the centerline of a street prior to a crosswalk to alert motorists to yield when pedestrians are present in the crosswalk. When the sign is present, there tends to be an improved compliance of motorists yielding to pedestrians.</p>

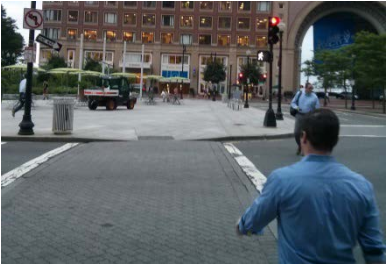
Facility Type	Description	Sample Photo
<p>Leading Pedestrian Interval (LPI)</p>	<p>A pedestrian crossing indication that permits pedestrians to move into the intersection 3-7 seconds before a green light is given to turning motorists that may cross the crosswalk. This increases visibility of pedestrians and reduces conflicts.</p>

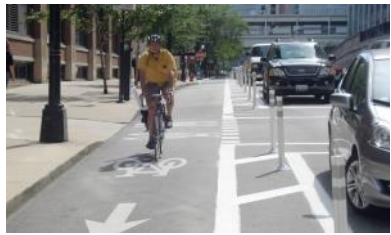
Facility Type	Description	Sample Photo
Separated Bike Lane	Separated bike lanes provide increased comfort and safety to cyclists. The lanes are separated from vehicle traffic by a vertical element, including flex posts, planters, parked cars, curbs, or raised medians.

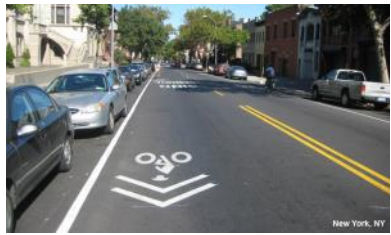
Shared Lane Markings	Shared Lane Markings designate positioning for cyclists within lanes shared by vehicles and bicyclists and alert drivers to the presence of cyclists. Shared lane markings should be considered in constrained corridors where installation of bicycle lanes is not feasible or as temporary until future improvements can provide full bicycle facilities.

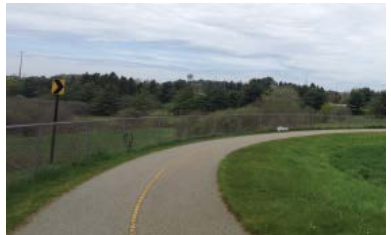
Shared-use Path	A shared use path is typically a paved path which may be located on an exclusive right-of-way or parallel to an existing roadway. Paths are typically two-way, open for bicyclists, pedestrians, and other non-motorized users. Shared use paths should be ADA-compliant and range between 10 to 14 feet wide.

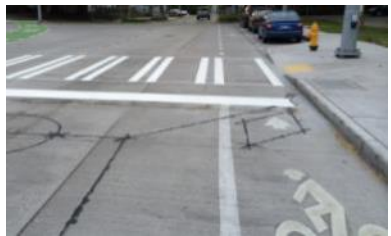
Traffic Signal Timing and Detection	Detection for bicycles should be provided at traffic signals where phases are not recalled during each cycle, in order to ensure that cyclists are able to legally cross an intersection. Traffic signal timing should be set to ensure that the total yellow and all-red time allows for a cyclist to clear the intersection.

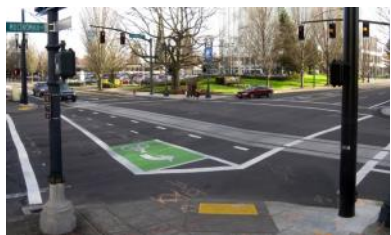
Two-Stage Turn Queue Box	A two-stage turn queue box is typically provided between the bike lane and the cross-street crosswalk, allowing cyclists to exit the bicycle lane and turn left after the traffic signal cycles to the side street phase. Note that two-stage turn queue boxes are considered experimental by FHWA; installation requires a request for experiment.
