Wollaston Walk Assessment Quincy, MA

August 5, 2014

Massachusetts Department of Transportation
Bicycle and Pedestrian Safety Program

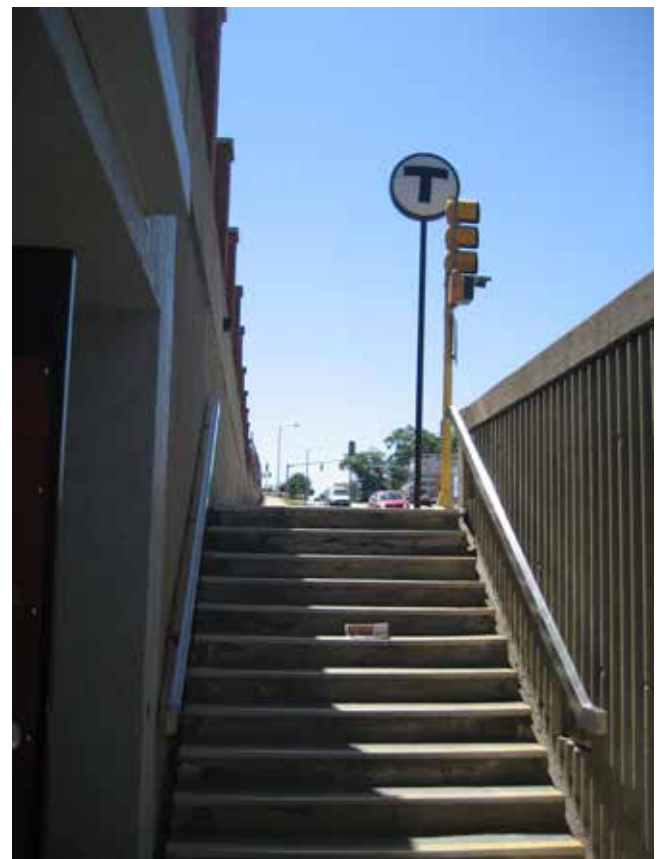
Accessibility is the focus of the MBTA effort to re-design Wollaston Station

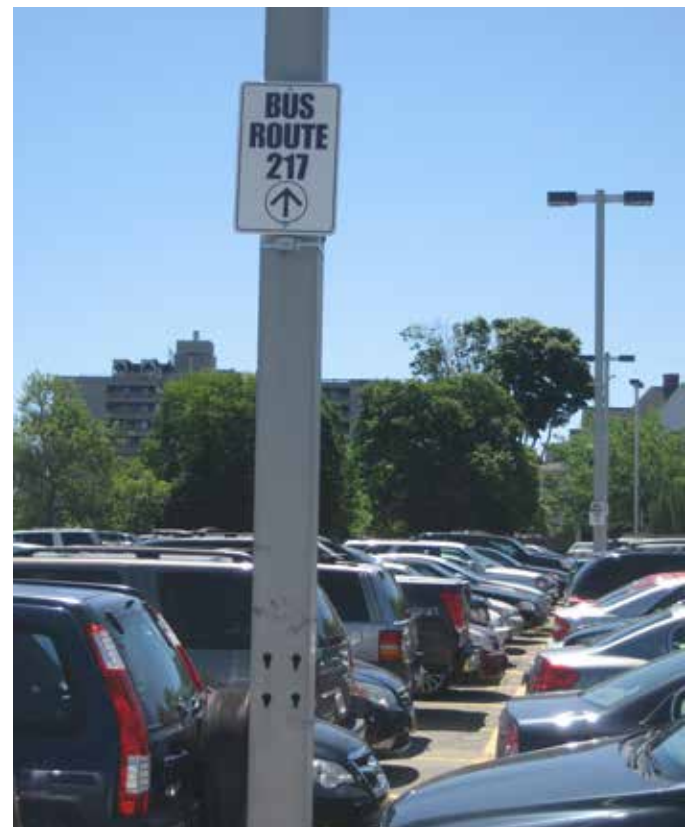
Bus stop signs lead pedestrians through the parking lot to the wrong location

- Relocate signs for bus stops – now at Beale/Hancock (210) and Beale/Newport (211/217)
- Improve light levels at night
 - » Short-term: assess light levels and determine if existing lighting can be supplemented
 - » Long-term: install new lighting as part of overall parking lot redesign

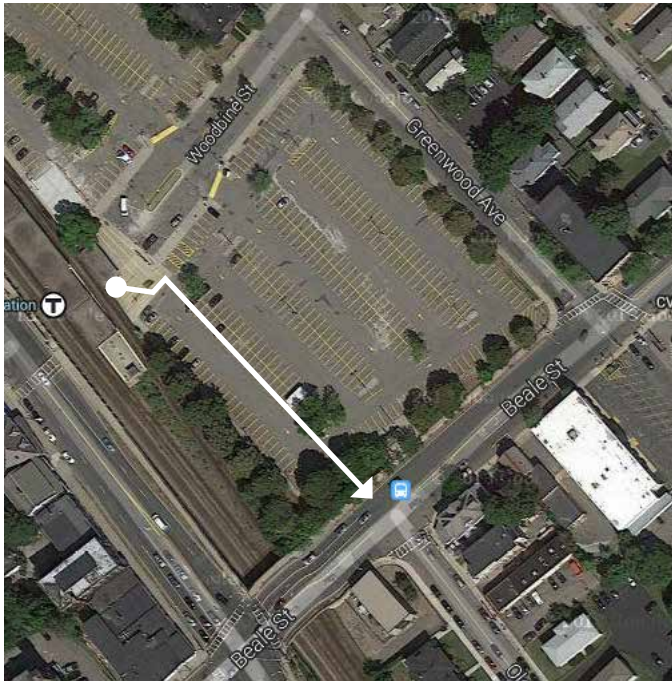
Proposed pedestrian connection to Beale Street

- » Long-term: Redesign parking lot with sidewalk connecting to the small gathering space along Beale Street (former bus stop). If parking space requirement is lowered, then consider additional space for pedestrian connections to Wollaston Center

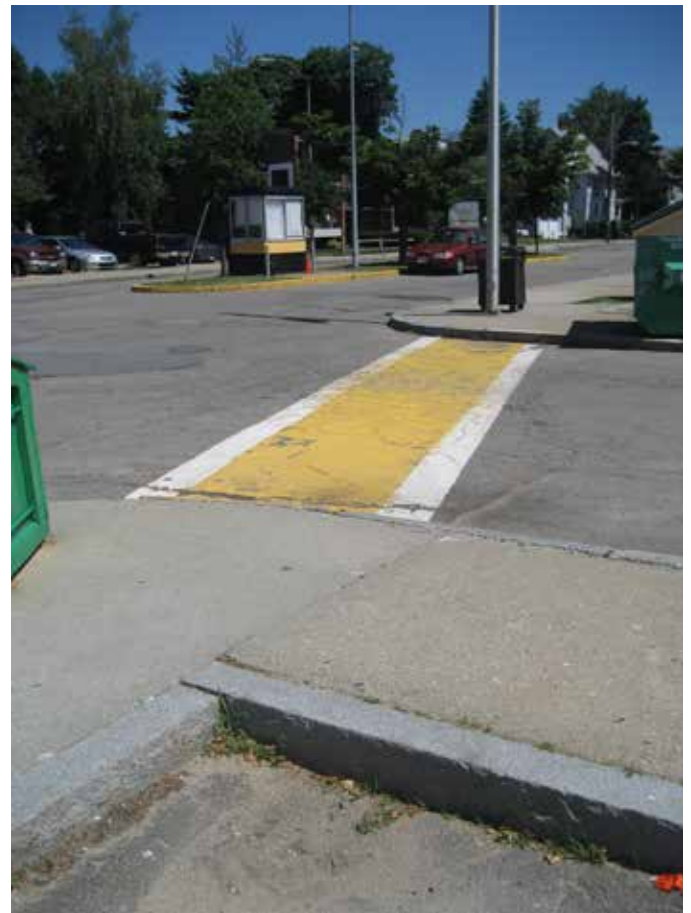
Sidewalks missing curb ramps at the parking lot entrance

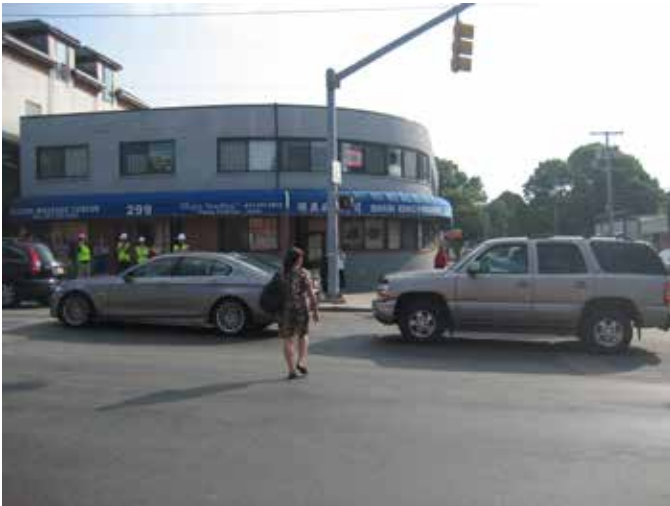
Pedestrian crossing Newport Avenue without waiting for the WALK signal

- Crosswalks are located outside the pedestrian desire line leading from the station exit/entrance to Brook Street; location in part due to traffic signal equipment and fire hydrants at the street corners
- Pedestrian phase of the traffic signal seems too short to allow adequate time to cross Newport Avenue
- Vehicles block crosswalks during pedestrian crossing phase – partially due to location of crosswalks, also due to driver behavior
- Traffic signals at Beale St/Newport Ave intersection and Brook St/Newport Ave intersection are not coordinated
- T Station sign is visible from Newport Avenue, but not from Brook Street; pedestrians presented with a blank wall with no indication of what is behind it
- T Station entrance is not accessible

- Evaluate location of crosswalks
 - » Short-term: repaint or expand crosswalks to reflect walking patterns
 - » Long-term: redesign entrance to the T station to align with Brook Street crossing; allow for adequate gathering space for pedestrians waiting for signal

- Evaluate the location of traffic signal heads; if placed over each lane, signal compliance by motorists may increase
- Assess traffic signal timing for compliance with Manual for Uniform Traffic Control Devices (MUTCD) standards; minimizing pedestrian wait times will increase compliance with signal

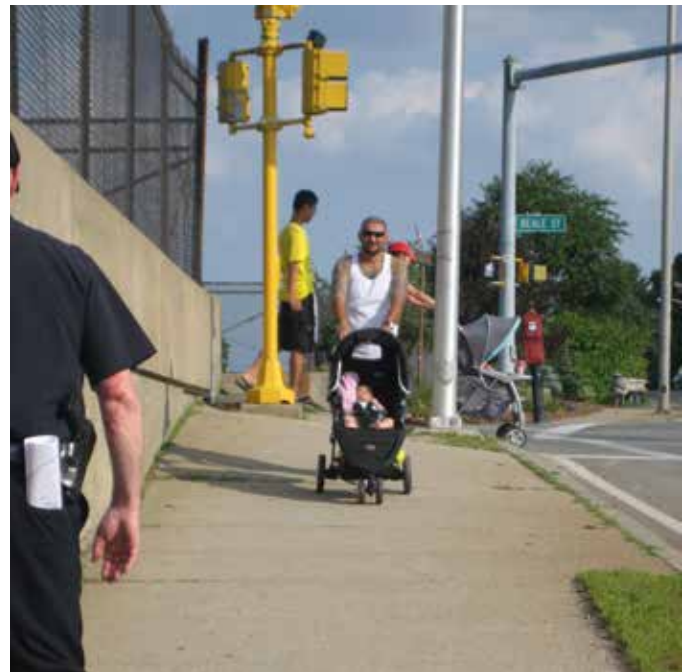
- Road widens near T Station entrance with a drop off area or bus stop; MBTA bus no longer uses this stop and drop off at this location competes with fast-moving traffic on Newport Avenue
- Lighting is insufficient according to local participants
- The steeply graded Newport street sidewalks from the station entrance to Beale Street are unattractive for walkers, are filled with obstructions, and may discourage pedestrians who might access the station from the southwest
 - » The east sidewalk runs along the blank wall which forms the MBTA rail embankment
 - » The west sidewalk has a blank concrete wall between the sidewalk and the street edge which gives the sidewalk a trench-like feel

Pedestrians navigating the steep slope on Newport Avenue

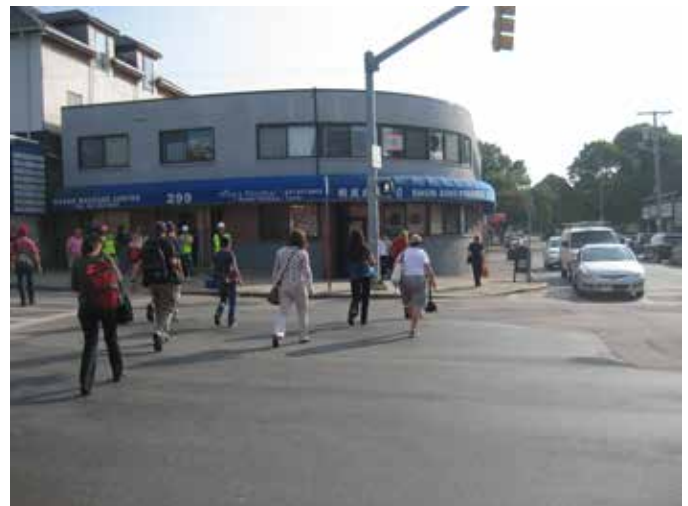
Pedestrians crossing outside of the crosswalk on Newport Avenue

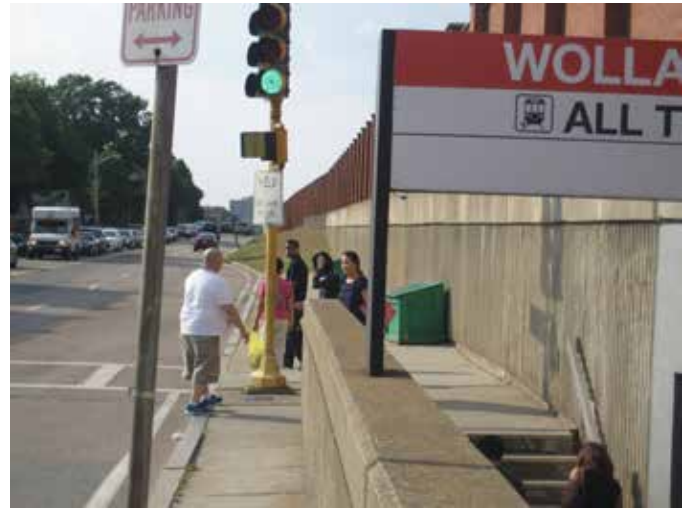
Gathering space for pedestrians is limited

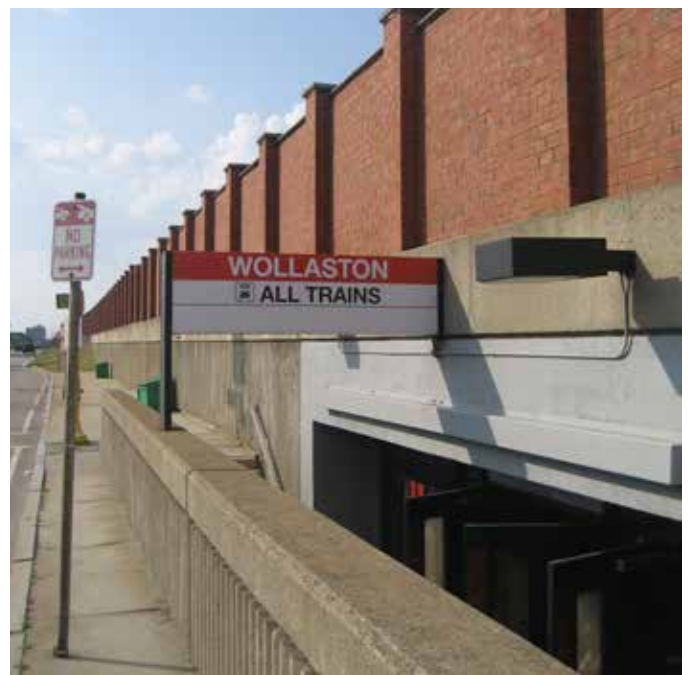
Wollaston signs face Newport Avenue, but there are none facing Brook Street. The sidewalk is narrow and has multiple obstructions which further limit its effective width. In the distance, the sidewalk ends providing no means of access for pedestrians.

- Clear obstructions from Newport Avenue sidewalks which may include sign posts, traffic signal equipment, etc.

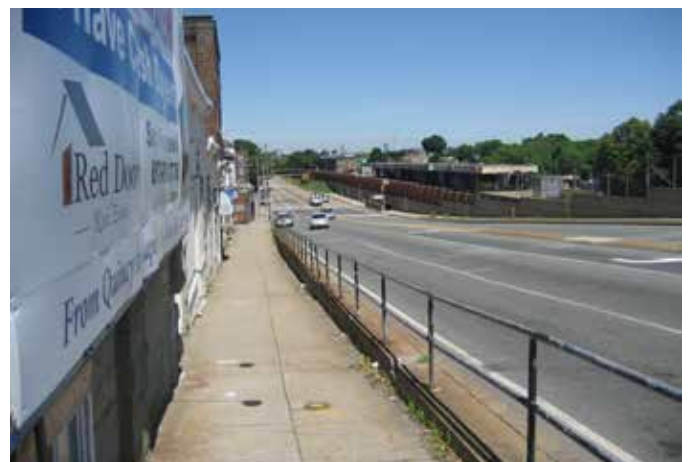
Blank concrete walk along Newport Avenue creates a stark pedestrian landscape

- Provide landscaping for Newport Avenue to improve streetscape quality
 - » Explore possibility of adding trees on the west sidewalk
 - » Explore addition of planters and benches on the east sidewalk and work with local merchants to help them add signs and façade treatments to enliven the sidewalk and draw customers to this portion of Newport Ave

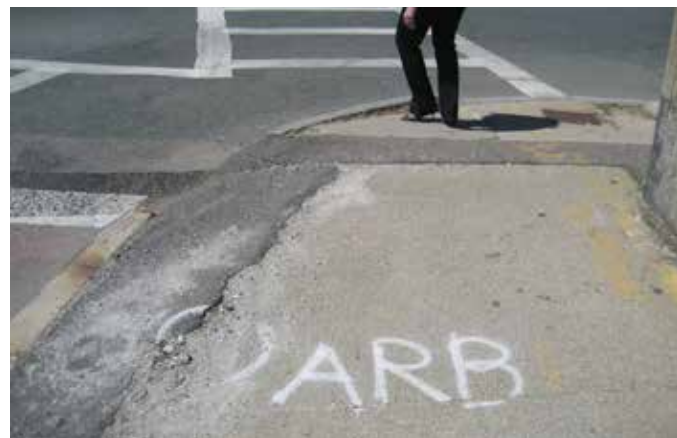
- Sidewalk surfaces are inconsistent and full of obstacles, and do not have ADA-compliant curb ramps or detectable warning strips
- Sidewalk on the east side of Newport Avenue is narrow and right up against the curb; there is very little space at the Beale/Newport intersection to wait at the corner for the signal

Patched sidewalk with no curb ramps at the corner of Newport and Beale

- Reconstruct/replace sidewalks on Newport Ave repairing cracks and pitfalls, and install curb ramps and detectable warning strips; recapture as much of the right-of-way from the travel lanes as possible to separate sidewalk from traffic and provide additional sidewalk space at the corners

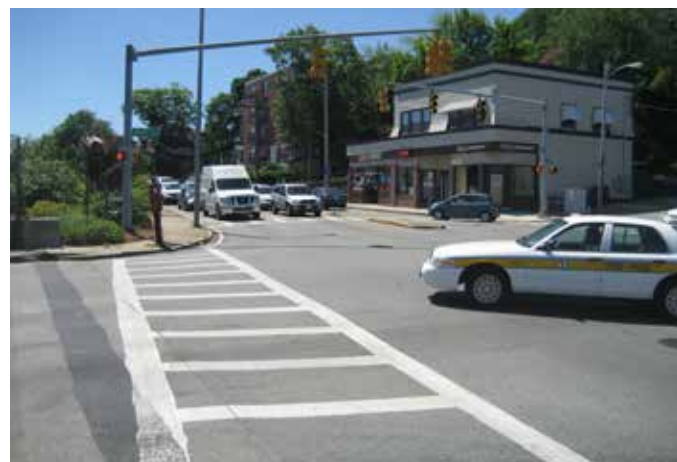
Traffic moving through the Newport Ave/Beale St intersection

- Traffic signal equipment and lamp posts are positioned at the corners where walkers would logically gather to cross the street; one traffic signal head is blocked by lamp post so pedestrians can not see the signal
- Medians on Newport Avenue and Beale Street end either mid-way into crosswalk or before the crosswalk and do not function as an adequate pedestrian refuge islands; medians are narrow
- Pedestrian signal does not give sufficient time for pedestrians to cross four lanes of traffic based on observation

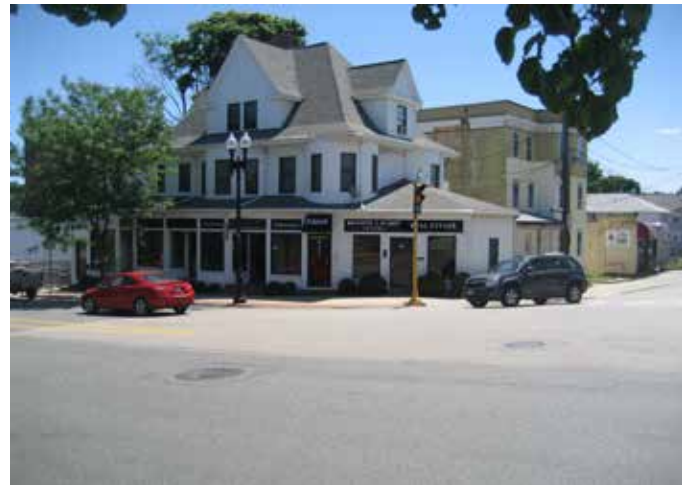
The Old Colony Avenue/Beale Street intersection has flashing yellow light beacons located on all three corners of the intersection, however these beacons do not stop traffic or assist pedestrians in crossing the street. The building located on the southwest corner of the intersection and the grade changes on both Beale Street and Old Colony compromise sight lines for drivers, forcing them to enter the crosswalk on Old Colony to see oncoming traffic and making it difficult to see pedestrians crossing Beale.

No crosswalk at the Old Colony/Beale intersection

Beale Street is four lanes wide at this intersection, and there is no crosswalk at Old Colony. There were many instances of quick acceleration out of Old Colony and through the Beale Street/Newport Avenue intersection in times of high traffic volumes. When combined with unexpected pedestrian crossings, the potential for crashes is high.

ISSUE	RECOMMENDATION	TIMEFRAME	RESPONSIBLE PARTY
Missing crosswalk across Beale Street – desire line for transit riders coming through MBTA surface parking lot and crossing to Old Colony Ave	Stripe a high visibility crosswalk (zebra, ladder or continental design) across Beale Street on the east side of Colony Avenue only; place an in-street pedestrian sign in the crosswalk on Beale Street	Short-term	City of Quincy
Wide travel lanes on Beale Street with few lane markers	Narrow travel lanes and tighten curb radii on Beale Street		
	» Paint pavement markings on Beale Street to define and narrow travel lanes	Short-term	City of Quincy

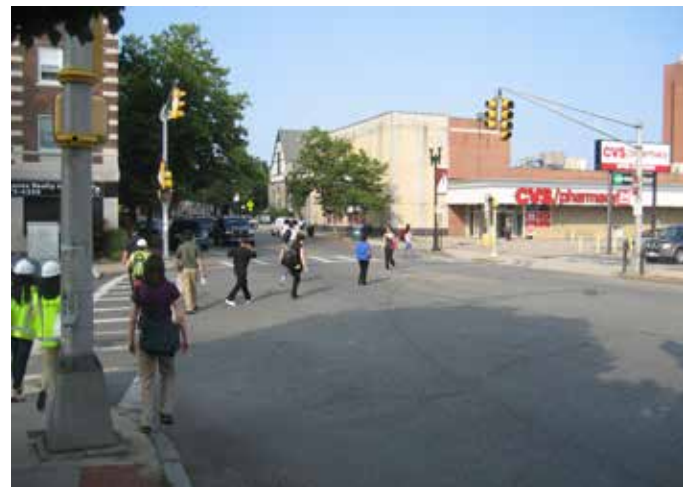
The Greenwood Avenue/Beale Street intersection sees a constant flow of transit riders during the evening surge as they cross through the MBTA surface lot and exit through a break in the wall near the intersection. Few use both crosswalks to cross the street, instead choosing to cut diagonally from the west side of the Greenwood/Beale Street intersection to the CVS pharmacy parking lot. Since the traffic signal has an

Pedestrians cross diagonally through the Greenwood/Beale Street intersection

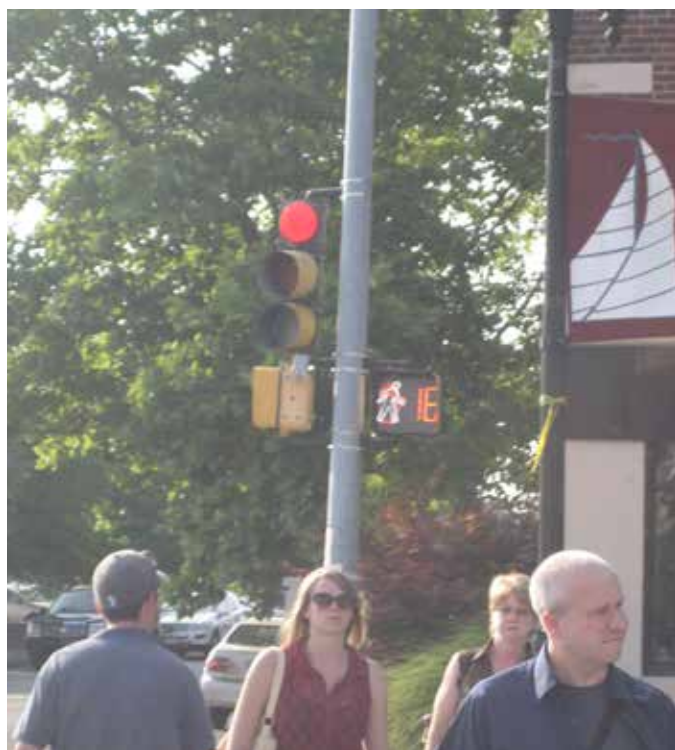
Malfunctioning pedestrian signal at Greenwood and Beale

- Fix the pedestrian countdown signal on northeast corner of Greenwood Ave/Beale Street (immediate need)
- Consider reducing the travel lane widths on Beale Street
 - » Short-term: Paint pavement markings on Beale Street to define and narrow travel lanes
 - » Long-term: Install curb bump-outs into parking lanes to shorten crossing distances and widen sidewalks
- Consider concurrent traffic signal phasing with a leading pedestrian indicator (LPI).
- Evaluate the location and number of access points to the retail strip (e.g., CVS) and surface parking lot on the south side of Beale Street and close as many of them as possible and provide narrow, tight turning radii driveways for access

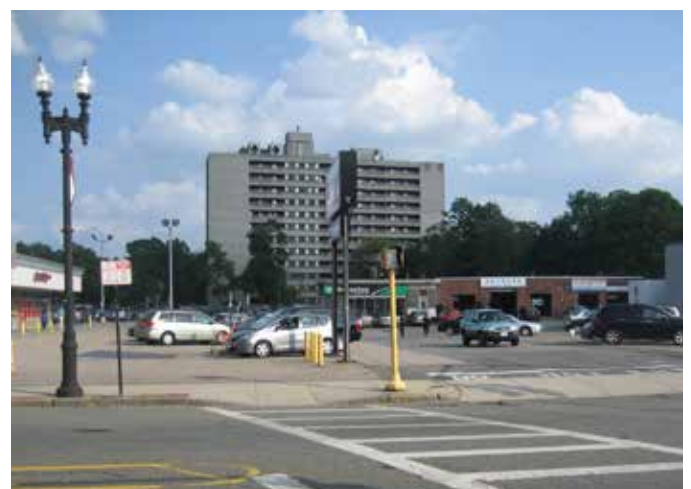
Multiple driveways and the surface parking lot near CVS

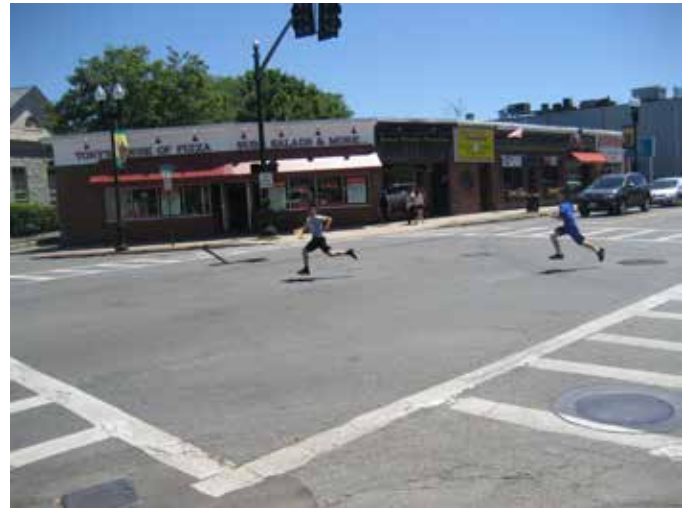
Children running through the exclusive pedestrian signal

ISSUE	RECOMMENDATION	TIMEFRAME	RESPONSIBLE PARTY
Traffic signals have exclusive pedestrian signal phase, which extends both pedestrian and vehicle wait times at the intersection	Consider concurrent traffic signal phasing with a leading pedestrian indicator (LPI)	Short-term	City of Quincy

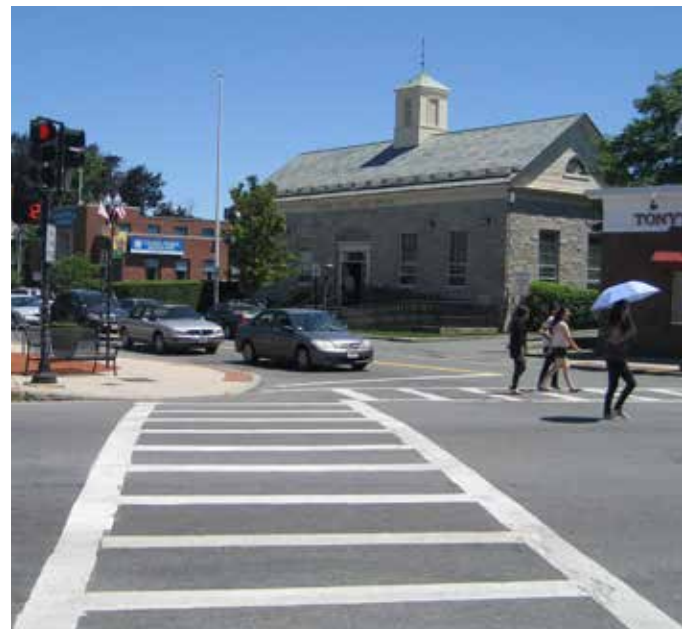
The Hancock/Beale Street intersection is at the core of Wollaston Center and has the best pedestrian infrastructure within the study area. Crosswalks are prominently painted, the sidewalks are wide, continuous and smooth, and have curb ramps. The travel lanes are well marked and parking stalls are painted. The traffic signals have an exclusive pedestrian phase. The bus stops are well marked at either side of the traffic signal, however the bus stop for buses traveling southeast on Hancock Street is on the nearside of the intersection rather than the farside, which is the preferred location.

Crosswalks, curb ramps and pedestrian signals on Hancock Street

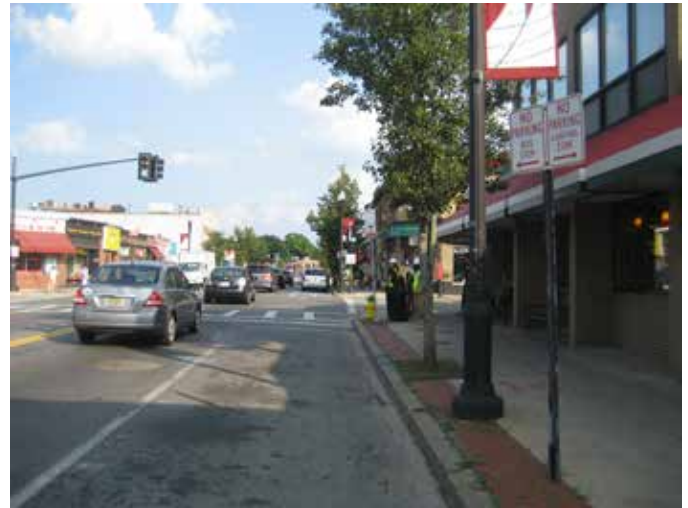
Nearside bus stop on Hancock Street

- Reevaluate the location of this stop and balance the need for parking with pedestrian safety concerns. Since a fully accessible bus stop has to be 70-100 feet long, up to five parking spaces can be affected. These spaces could be replaced at the current bus stop location if the bus stop is moved

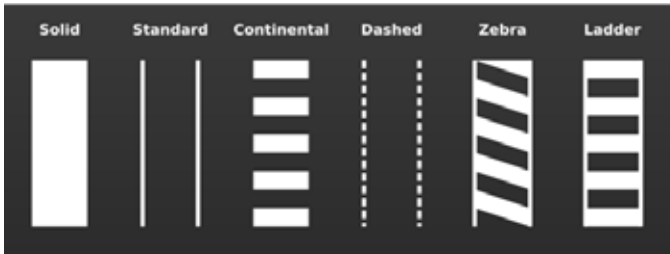
Crosswalks can be painted in a variety of ways, some of which are more effective in warning drivers of pedestrians. Crosswalks are usually accompanied with stop lines. These lines act as the legally mandated stopping point for vehicles, and discourage drivers from stopping in the middle of the crosswalk.

Crosswalk patterns
Source: USFHA

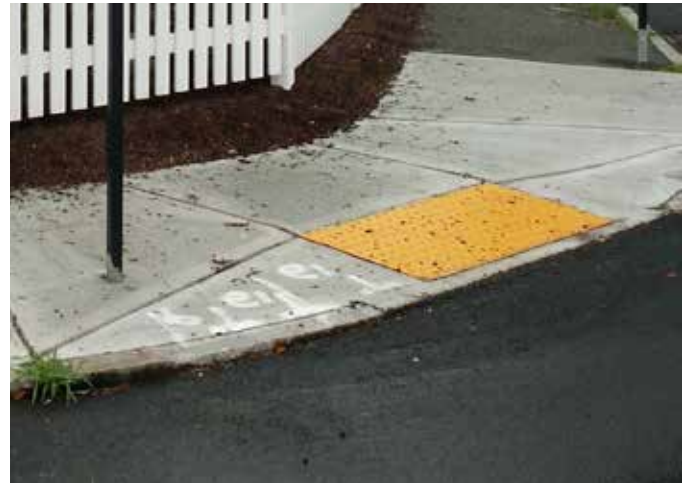
Curb ramps provide access from the sidewalk to the street for people using wheel chairs and strollers. They are most commonly found at intersections. While curb ramps have improved access for wheelchair-bound people, they are problematic for visually impaired people who use the curb as an indication of the side of the street. Detectable warning strips, a distinctive surface pattern of domes detectable by cane or underfoot, are now used to alert people with vision impairments of their approach to streets and hazardous drop-offs.

Curb ramp and detectable warning strip in Woburn, MA

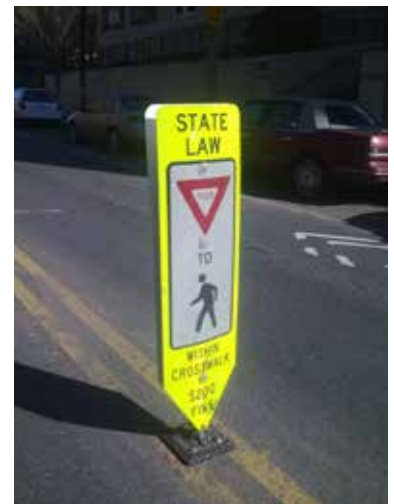
In-street pedestrian crossing signs are used at the road centerline within crosswalks to increase driver awareness of pedestrians in the area. These signs are a relatively low-cost, highly effective tool in slowing traffic by the narrowing travel lanes. They are popular with road maintenance departments since they can be easily moved for snow removal.

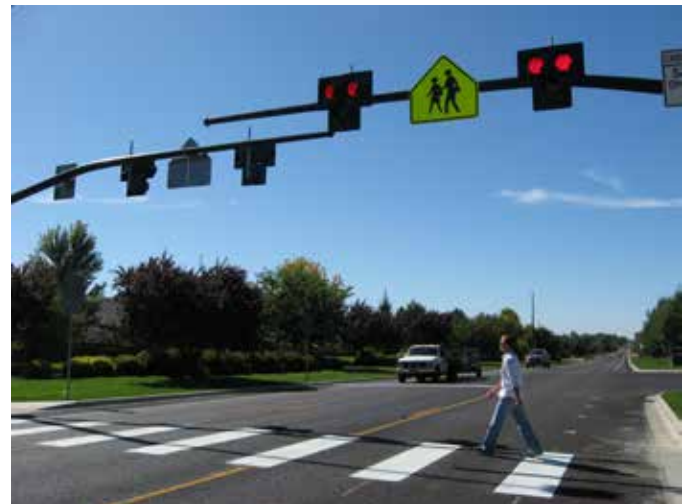
A HAWK beacon (High-Intensity Activated crossWalk beacon) is a traffic signal used to stop road traffic and allow pedestrians to cross safely. It is officially known as a Pedestrian Hybrid Beacon (PHB). The purpose of a HAWK beacon is to allow protected pedestrian crossings, stopping road traffic only as needed. Where standard traffic signal 'warrants' prevent the installation of standard three-color traffic signals, the HAWK beacon provides an alternative.
