**Route 132 Walk Audit
Hyannis, MA**

August 9, 2018

*Sponsored by the Massachusetts Executive Office of Public Safety and Security
Planning Initiative for High-Fatality Communities*

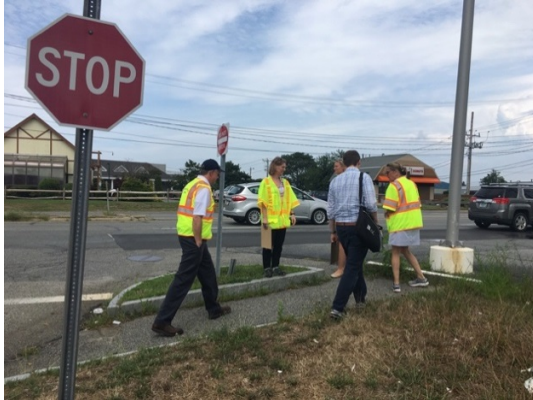
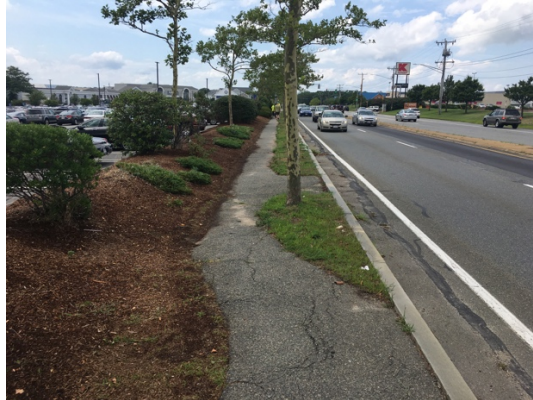
Sidewalk conditions along Route 132 are challenging.

Sidewalks in the study area vary in width and material. Sidewalks measure approximately 3' wide to 5' wide, with the newer sections being wider than the older sections. Asphalt sidewalks run along Route 132, and sidewalks leading to the Cape Cod Mall are concrete. There are no sidewalks leading to Capetown Plaza. Curb ramps either are not present or do not meet current ADA requirements at most driveways and intersections. The recent upgrade of the Independence Drive/Route 132 intersection includes ADA compliant ramps and a crosswalk across only the southern Independence Drive approach. As observed during the walk audit, people in wheelchairs have incredible difficulty navigating along Route 132 and are forced into the street to reach their destinations.

- Trim vegetation, clear litter and debris, and remove obstacles from existing sidewalks to improve current walking conditions until Route 132 can be rebuilt.

- Work with property owners to encourage them to maintain sidewalks and pedestrian pathways on their property.
- Design pathways that serve walkers and cyclists using the Route 132 corridor. Given the high volumes of fast-moving traffic, a multi-use, separated path on at least one side of the road could provide comfortable access for both walkers and cyclists. FHWA recommends multi-use paths be at least 10' wide.⁶ MassDOT's *Separated Bike Lane Planning & Design Guide* has more detailed recommendations regarding accommodating bikes that may also provide additional guidance on preferred dimensions.⁷

- Incorporate recommended dimensions for walking/biking paths when redesigning Route 132 corridor.
- Reserve adequate space for a sidewalk separated from vehicular traffic (approximately 10') on the north side of Route 132.

- Rebuild Route 132 with paved pathways on both sides of the roadway with at least one side of the roadway wide enough to accommodate both cyclists and walkers. Separated pathways (one for cyclists and one for pedestrians) are ideal, but given the Right of Way (ROW) limits and vehicle volumes, use-separated paths may not be feasible.
- All pathways should be separated from the curb with a verge (5'-10' wide) planted with trees to provide shade and help slow vehicle speeds.

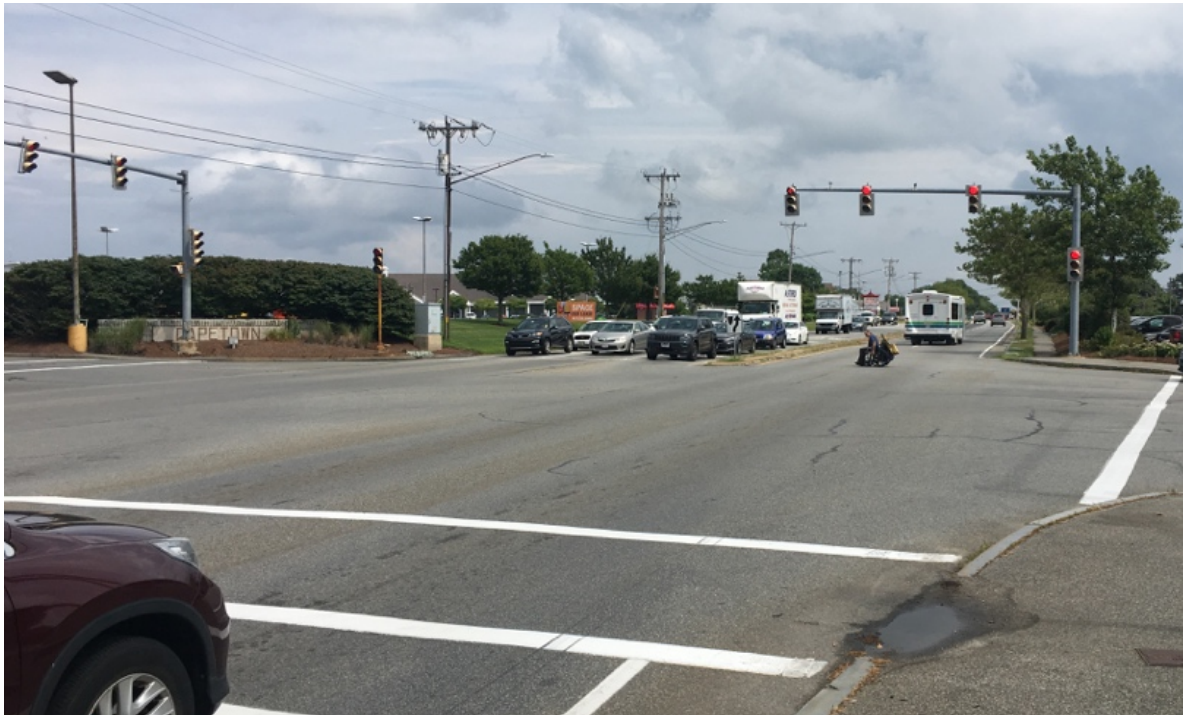
After navigating up the hill from the Cape Cod mall on the entrance road, this man in his wheelchair crossed Route 132 outside the crosswalk and proceeded up the Capetown Plaza entrance road within the travelway since no sidewalk was available.

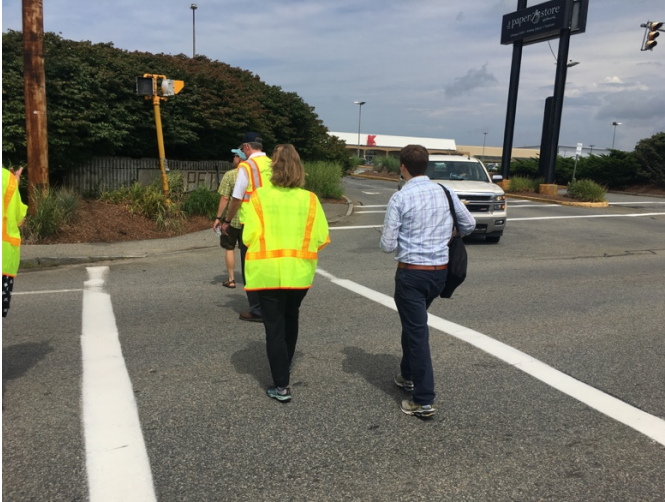
The “red hand” on the pedestrian walk signal on north side of the Cape Cod Mall/Capetown Plaza intersection of Route 132 on the Capetown Plaza side of the road is not functioning. Pedestrians see a WALK sign, but do not see a flashing red hand or solid red hand, and could interpret the lack of a signal as a safe time to cross.

In addition to the faulty pedestrian signal head, the signal phasing may give pedestrians a false sense of security that it is safe to cross when turning traffic is coming across their path. The pedestrian walk signal phasing is concurrent permitting drivers to turn left and right across pedestrian paths after yielding to pedestrians. Given the high turning volumes at the Cape Cod Mall/Capetown Plaza intersection and limited visibility, the Town should consider instituting an exclusive signal phase at this location. However, the current signal equipment may not support this phase change. As the town redesigns this corridor and conducts studies to determine traffic volumes, it is imperative that

The walk signal phasing and equipment at the Capetown Plaza entry drive put pedestrians at risk.

- Repair the “red hand” light on the pedestrian signal head at the Capetown Plaza entry drive intersection with Route 132
- Determine if the pedestrian traffic signal equipment can be changed from a concurrent phase to an exclusive phase. If the existing signal equipment can accommodate it, then reprogram the signal to an exclusive phase.
- Consider posting No Right Turn on Red signs at the intersection to decrease the danger of pedestrians being struck while crossing Route 132 and the Capetown Plaza entry drive.
- Trim or remove vegetation and any other obstacles (e.g., gateway features) that block visibility.
- Install paved walkway on grassy slope (although grades will not meet ADA Accessibility requirements).

- Upgrade traffic signal equipment to include accessible countdown pedestrian signals.
- Redesign gateway features and Capetown Plaza entry drive to include accessible sidewalks and vegetation that does not limit visibility.

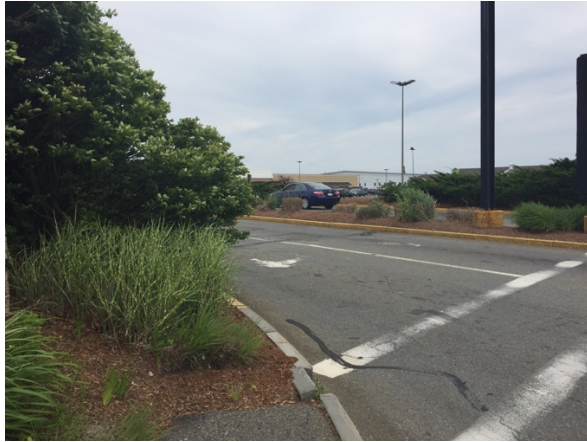
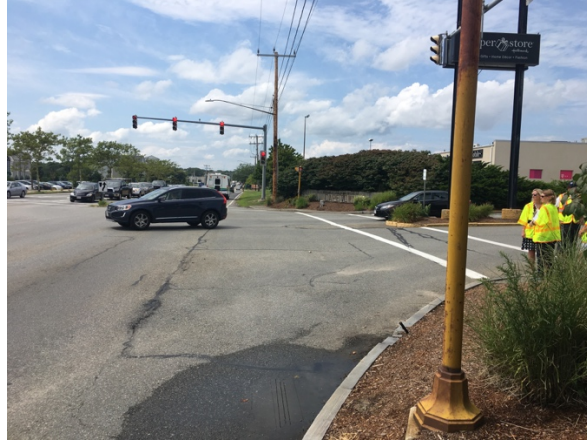
The dense, tall vegetation at the entrance to Capetown Plaza blocks drivers' visibility of pedestrians crossing both Route 132 and the Capetown Plaza access road. Drivers turning right out of Capetown Plaza cannot see people walking in the crosswalks on Route 132. While one of only a few areas with mature trees and shrubs along the Route 132 corridor, the removal of this vegetation would significantly increase pedestrian visibility and improve safety for all road users.

Pedestrians are hidden from drivers' view when leaving Capetown Plaza.

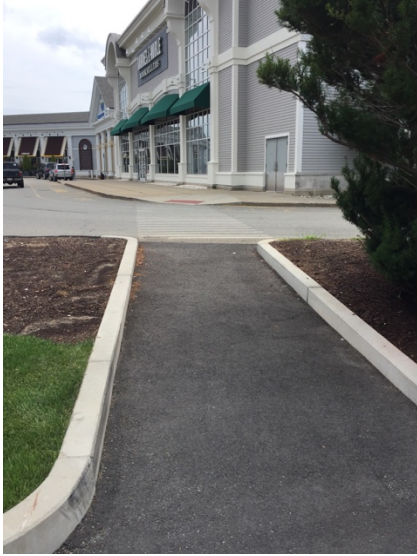
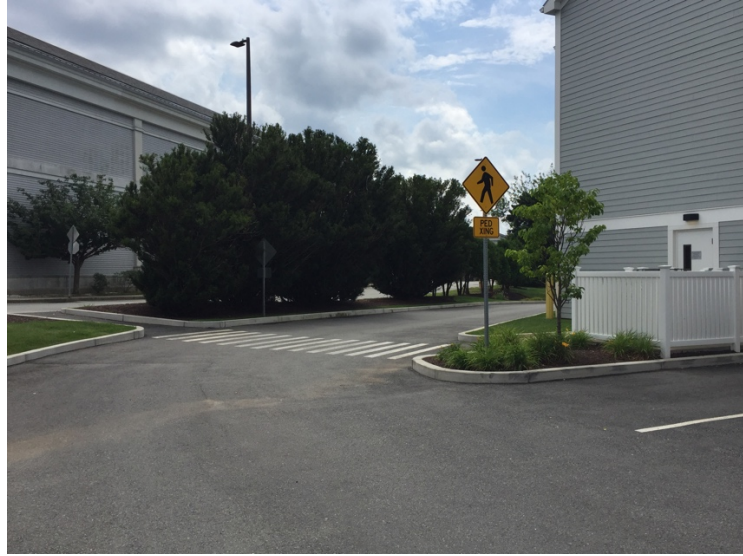
Pedestrian access to the Cape Cod Mall from the Fairfield Inn.

In addition to promoting internal vehicular circulation, pedestrians and business owners would benefit from a network of connected walkways. People now walk through parking lots and service drives to reach their destinations. Marked, signed pathways – which could include the amount of time it takes to walk from one place to another – would help people shop, dine and move between destinations after parking their car once and walking. The pedestrian connection between the Fairfield Inn and the Cape Cod Mall parking lot is a good example of providing safe access between properties.

- Reach out to property owners to determine interest in cooperative planning for both vehicular and pedestrian circulation, including a district-wide wayfinding signage system.
- Analyze current zoning codes, design standards and site plan review procedures to determine if mechanisms exist to incentivize cooperative circulation planning.

- Amend Town zoning codes, design standards, or site plan review procedures to require the consideration of internal circulation strategies and pedestrian networks.
