**Dennison Crossing Walk Audit
Framingham, MA**

September 13, 2018

*Sponsored by the Massachusetts Executive Office of Public Safety and Security
Planning Initiative for High-Fatality Communities*

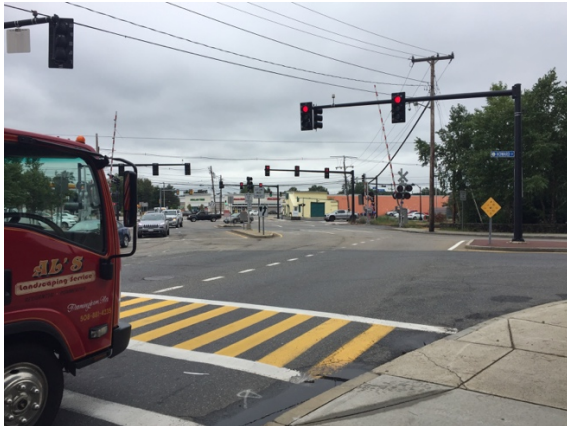
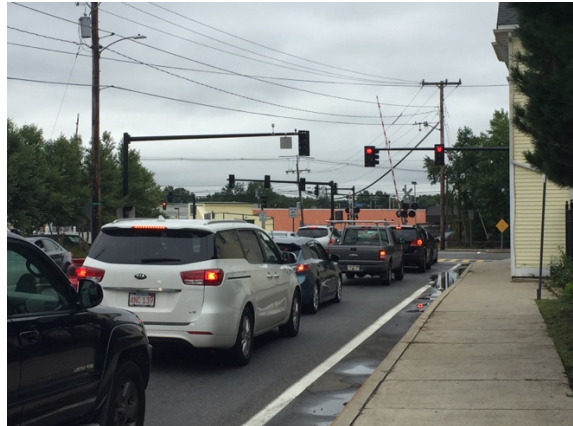
The location of social services on either side of Waverly Street poses an additional challenge to pedestrian safety in Dennison Crossing. A SMOC staff member who participated in the walk audit commented that many people cross Bishop Street between the SMOC-owned buildings and the social services located at 300 Howard Street. Many clients with substance abuse disorders or other ailments

that affect their judgment must navigate through the high volumes of fast-moving vehicular traffic and cross these streets. Long waits for WALK signals frustrate all of us, but for those dealing with other issues, it can be too much. While infrastructure can provide opportunities for safer environments, it is impossible to dictate good behavior by people walking, biking or driving. It is prudent, however, knowing that this vulnerable population frequently visits Dennison Crossing to do as much as possible to limit the chances for serious injuries.

Views from Bishop Street looking toward the Howard Street intersection.

- Complete a comprehensive assessment of actual signal cycle lengths at each intersection in Dennison Crossing to verify the times collected during the walk audit.
- Reprogram traffic signals to minimize pedestrian wait times (less than 90 seconds). Consider an automatic walk signal if concurrent phasing is employed.
- Consider typical walker destinations and program signals so that people can cross to their destination in a single WALK cycle.
- Evaluate the location and safety of crosswalks across Bishop Street at both the Clinton and Howard intersections to better serve the vulnerable populations using this busy corridor.

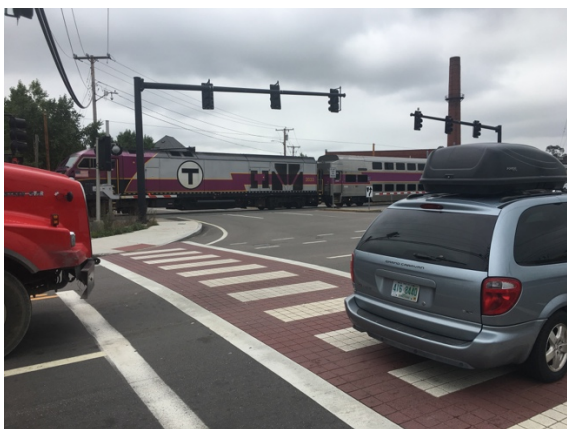
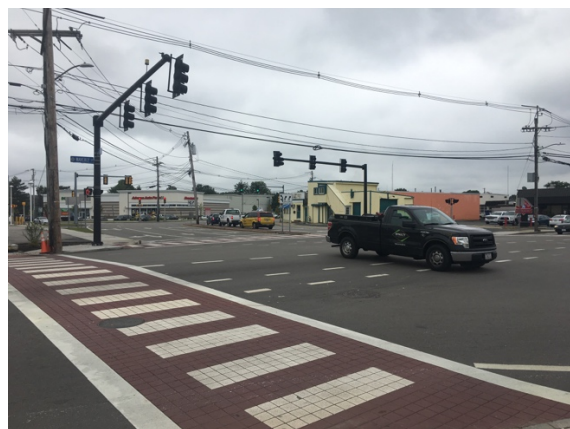
The railroad (RR) crossing also adds complexity to programming signal cycle lengths and also has preemption over the typical signal sequence. The train came through the intersection while we walked and lengthened the pedestrian WAIT time. It was unclear whether the RR crossing reset the signal cycle length or just added time to our wait as the train passed.

The commuter train crossing preempted the traffic signal lengthening wait times for everyone.

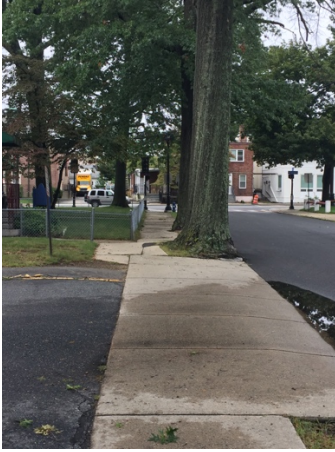
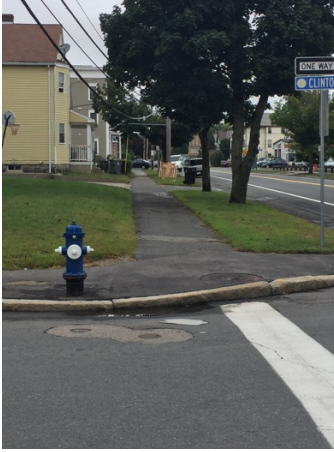
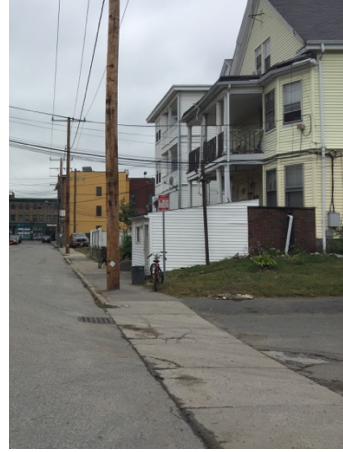
The smaller, residential streets on the walk audit route have relatively narrow sidewalks with cracks in concrete panels and tripping hazards. Lovely mature trees interrupt the sidewalk on Clinton Street requiring wheelchair users to choose a different, potentially less safe route. The level of maintenance on Clinton, Frederick, and Kendall Streets is not as high as along some of the major thoroughfares in downtown. (Clinton Street is privately owned between Grant Street and Bishop Street). People with disabilities would have a harder time using these streets because some sidewalks and crosswalks do not have curb ramps or detectable warning panels. Many of the driveways have cross-slopes that are also too steep to move comfortably across in a wheelchair.

There are opportunities to improve sidewalk accessibility and maintenance in the Dennison Crossing area.

- Determine whether there are low cost, quick fixes to improving sidewalk accessibility (e.g., paving details to accommodate mature trees, replacement of individual concrete panels rather than replacing the entire length of sidewalk).
- Identify funding stream to install accessible sidewalks where they are missing throughout Dennison Crossing.
- Trim trees along south side of Howard Street.

- Make comprehensive accessibility improvements to sidewalks in the Dennison Crossing residential districts.

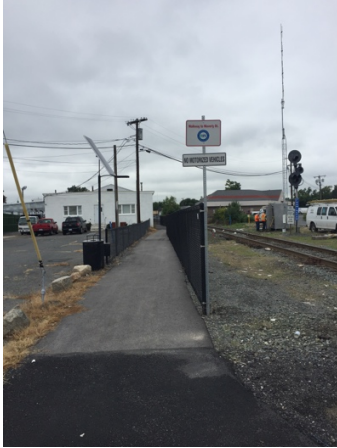
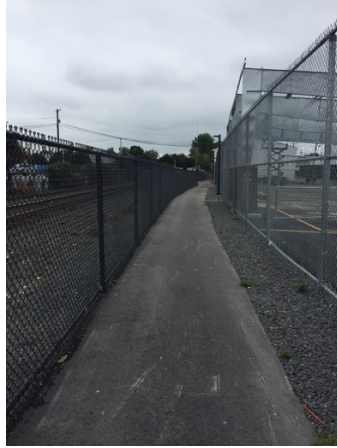
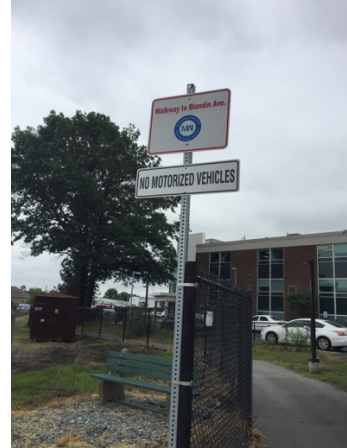
MWRTA has a multi-modal plan to better connect their riders to other transit options once disembarking at their transit center along Blandin Avenue. The completion of the multi-use trail connecting Blandin Avenue with Waverly Street provides a faster, off-street connection to downtown Framingham. Wayfinding signs indicate the trail destinations. The signs, however, do not indicate that the pathway is public, and some may assume that it is for MWRTA personnel only given the MWRTA logo affixed to the signs. The signs would be more effective for non-English speakers if they also used a pedestrian graphic. Furthermore, the signs are mounted high on the poles and not at eye level for many people walking.

MWRTA recently installed lights and security cameras to improve trail safety and maintains the trail with regular trash pick-up and vegetation maintenance. As more people ride transit and move to the neighborhood, additional opportunities to make safe, off-road connections to downtown and other services should be pursued.

Multi-use trail along the RR tracks leading from Blandin Avenue to Waverly Street.

- Improve wayfinding signs to better identify the trail as a public, safe, enjoyable alternative to walking along Blandin Avenue and Waverly Street

- Link this pathway to others to form a network of safe walking and biking connections through downtown Framingham
- Consider the multi-use pathway as an opportunity to display public art to improve the aesthetics of the industrial setting and fence-line. A relevant example is the “May This Never End” art piece formerly on the Rose Kennedy Greenway and now in Allston, MA.
