WalkBoston

## Walking Audit Summary Davis Thayer Elementary & Oak Street Elementary, Franklin November 22, 2011

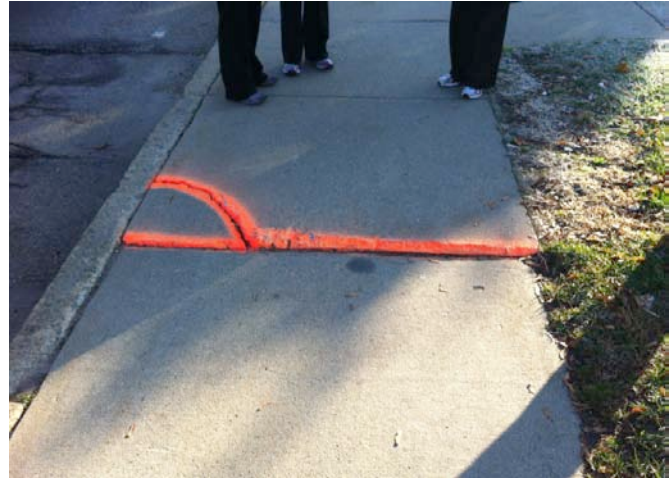
### 1. Observation: Cracked, highlighted sidewalks along West Central Street

The sidewalk along the south side of West Central Street is badly cracked and uneven. It appears someone is paying attention to this as the cracks have been highlighted with neon pink spray paint. Whether this is to identify areas in need of repair or if the paint serves to call attention to tripping hazards is unknown.

Large cracks in the sidewalk on West Central Street have been highlighted with paint, but not fixed.

- Repair or replace the broken sections of sidewalk.

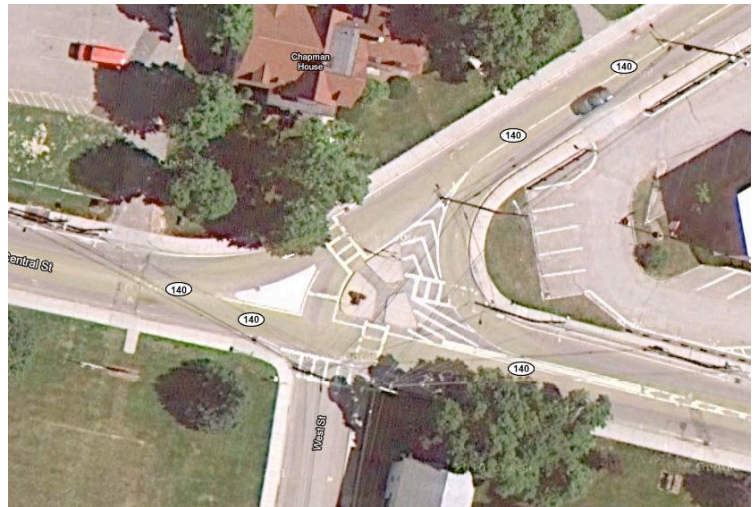
### 2. Observation: Complicated intersection at West Central/Emmons/West

The intersection of West Central and Emmons is complicated. Westbound traffic is forced to turn right onto Emmons, and southbound traffic on Emmons is forced to turn right onto West Central. The existing crosswalks do not reflect desire lines. It features a “porkchop” island and another refuge island trisected by a trio of crosswalks. In order to walk north at this intersection from the south side of West Central using crosswalks, the audit team would have to cross West, then West Central and then cross Emmons. A similar, complicated path would need to be taken to cross from the same spot to the northeastern corner of Emmons and West Central.

The intersection at West Central and Emmons requires pedestrians to cross multiple travel lanes and doesn't adequately slow traffic entering the school zone near Davis Thayer Elementary.

Also, the wide, gradual turn from Emmons southwest onto West Central has only a YIELD sign. This arrangement does not adequately slow vehicles entering a school zone.

- Short-term/small-investment: Add crosswalks on West Central on the eastern and western edges of the intersection and also north of the intersection on Emmons.
- Short-term/small-investment: Replace the YIELD sign at Emmons and West Central with a STOP sign.
- Mid-term/moderate-investment: Add button-activated pedestrian crossing signals at this intersection
- Long-term/large-investment: Convert all streets to two-way and re-engineer the intersection into a) a more traditional signalized 4-way intersection or b) a roundabout.

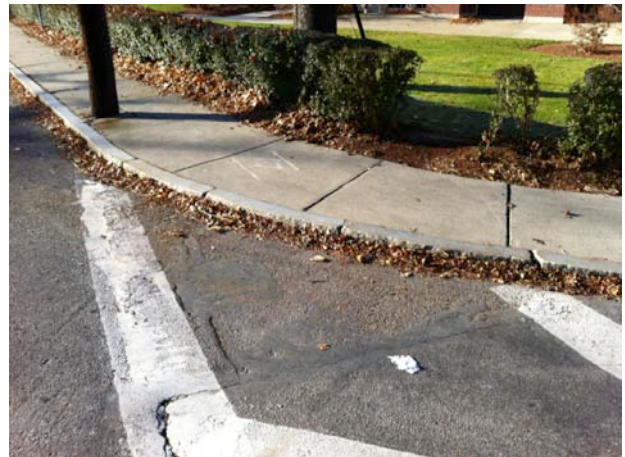
### **3. Observation: Some crosswalks are missing curb ramps**

The crosswalk that crosses Church Street where it intersects with Main Street connects two solid curbs with no accessible ramps. This is especially problematic, not only because it's within Davis Thayer's walk zone, but also because of its proximity to a church and the Benjamin Franklin Charter School.

The crosswalk at Main and Church lacks accessible curb ramps.

- Short-term/Small-investment: Create curb ramps by building a ramp with asphalt to provide access from the street to the sidewalk.
- Mid-term/moderate-investment: Remove the granite curb at the corners and build ADA compliant access ramps.

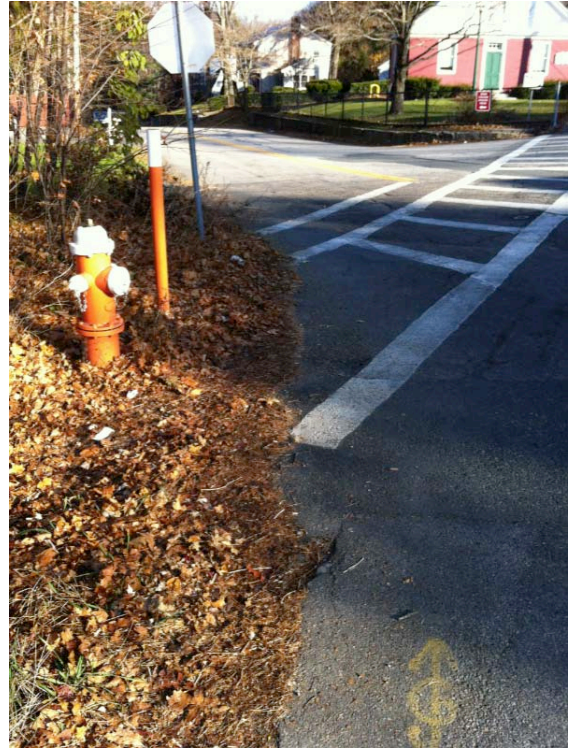
#### 4. Sidewalk along northern section of Main Street is damaged and ends suddenly

The sidewalk along the west side of Main Street north of Highland Street has a large hole and also ends suddenly. There is also a crosswalk at the intersection of Main Street and Maple Street that leads not to a sidewalk, but instead into a fire hydrant and an unpaved shoulder. Also, the sidewalk is narrow, missing curbs, and is flush with the street surface for much of its length from Church Street to Maple Street.

The crosswalk at Main and Maple leads into a hydrant and an unpaved shoulder.

- Short-term/small-investment: Fill in the hole with asphalt and extend the sidewalk using asphalt from its terminus to Maple Street.
- Mid-term/moderate-investment: Replace the damaged concrete slab and extend the sidewalk to Maple Street with concrete (the existing sidewalk is concrete), which lasts longer and provides a better walking surface.
- Long-term/large-investment: Rebuild a wider sidewalk with solid curbs from Church Street to Maple Street.
