Green Hill Neighborhood Walk Audit Worcester, MA

November 2, 2019

On November 2, 2019, WalkBoston conducted a walk audit in the Green Hill Neighborhood of Worcester, MA. The Green Hill Neighborhood association was awarded a Transportation Justice grant from Transportation for Massachusetts (T4MA) to “reimagine” Lincoln Street from Brittan Square to the Nativity School. As a part of this grant project, Green Hill residents hope to improve the safety and comfort of the walking environment in their neighborhood. The neighborhood association has been working with students from Worcester Polytechnic Institute (WPI) to develop a re-design of Lincoln Street corridor that makes this street a better place for all road users with enhancements that support people walking, biking, and using transit.

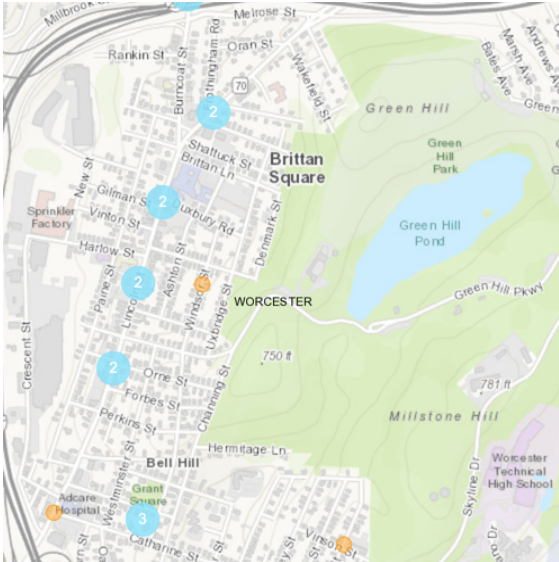
MassDOT’s crash data indicate 14 pedestrian-involved crashes in the Lincoln Street study area since 2016. In September 2019, there was a pedestrian fatality on Lincoln Street near the Catharine Street intersection. A map of the pedestrian-involved crashes along the walk audit route for the last three years is shown to the right.

Dates: 01/01/2016-11/01/2019
-Blue circles with numbers indicate multiple pedestrian crashes have occurred at the location.
-Orange circles indicate one pedestrian crash has occurred at the location.

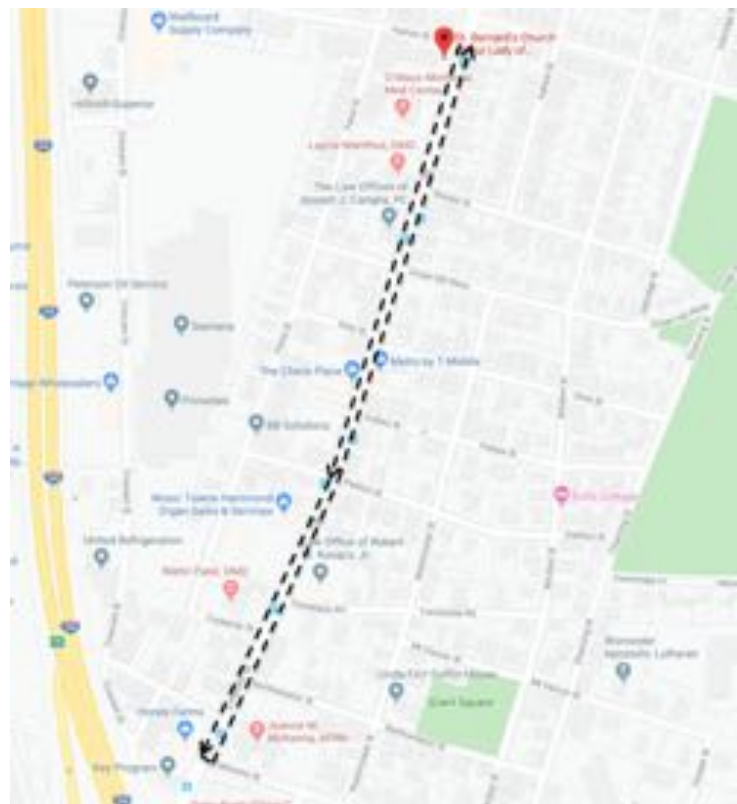
The walk audit started at the intersection of Lincoln Street and Harlow Street. The group traveled south on Lincoln Street to the Catharine Street intersection along the west-side sidewalk and then traveled back north on Lincoln Street on the east-side sidewalk to return to the church. Along the route, audit participants made observations and suggested recommendations to enhance the walkability of their neighborhood.

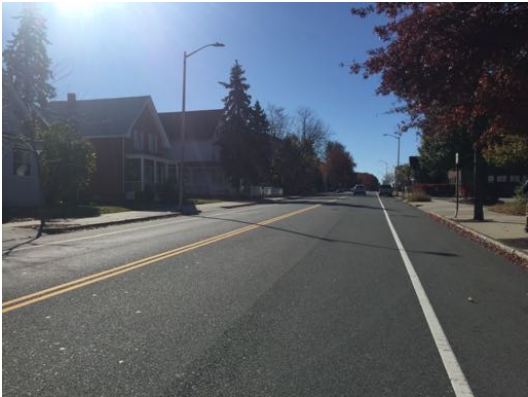
Walk audit participants recorded high vehicle speeds with radar detection devices

1. Slow speeds:
 - Consider narrowing the width of the travel lanes - this could be accomplished by installing bike lanes, adding a dedicated bus lane, or moving the existing sharrow to a mid-lane position and repainting the fog line to tighten the travel lane.
 - Post 30 MPH speed limit signs along Lincoln Street and consider using speed feedback signs to slow vehicle speeds.

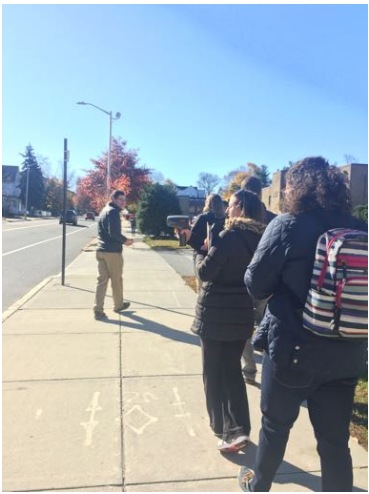
For most of the corridor, Lincoln Street is a two-lane minor arterial with one travel lane in each direction. Near the Catharine Street intersection and I-290, the street widens to two travel lanes in each direction. Lincoln Street has heavy traffic congestion during peak commuting times. Drivers often choose to cut through the residential streets in the Green Hill neighborhood to avoid this congestion. Residents expressed concern that vehicles travel at high speeds along this corridor during off-peak hours. On the day of the walk audit, participants used radar speed detection devices and recorded vehicle speeds in the range of 40-50 MPH, despite a 30 MPH speed limit on Lincoln Street. There are no speed limit signs posted anywhere within the study area. Wide lane widths, coupled with additional pavement to accommodate a bike sharrow and under-utilized on-street parking spaces, contribute to high vehicle travel speeds. On the morning of the walk audit, most on-street parking spaces were empty, leaving 20 feet of pavement for the vehicle travel lane.

Lincoln Street has wide lane widths that contribute to high vehicle speeds

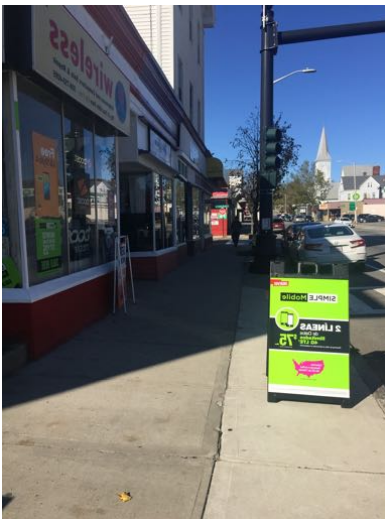
Sandwich board signs are placed in front of business along Lincoln Street

- Enhance features of the verge to further separate pedestrians from vehicle traffic, especially in low parking utilization areas where street trees have not been planted. This could be done through planting more street trees or adding a protected bike lane.
- Work with the City Public Works Department to address the uneven east-side sidewalk.
- Add elements that make it feel like Lincoln Street is a place for walking for people of all ages. Age-Friendly features could include: benches for resting, pedestrian-scale lighting, and wayfinding signage.
- Evaluate city ordinances to reduce sidewalk obstructions (sandwich boards at businesses, fallen leaves, and vegetation overgrowth).
- Consider adding trash receptacles to manage littering along Lincoln Street

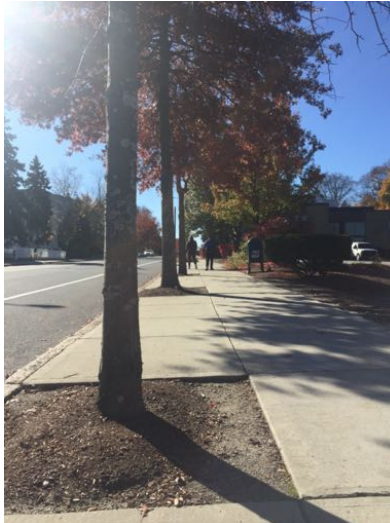
Both the east and west sides of the Lincoln Street sidewalk have a number of street trees with tree pits in varying states of maintenance. Some tree pits have little mulch remaining and the depth of the exposed pits has created tripping hazards. A few of the tree pits also have overgrown weeds and vegetation. There are other sidewalk obstructions along the Lincoln Street corridor that include: overgrown vegetation at some residential properties, sandwich board marketing signs in front of businesses, fallen leaves, and litter.

Street trees separate people walking from moving vehicles. Additional mulch could minimize tripping hazard

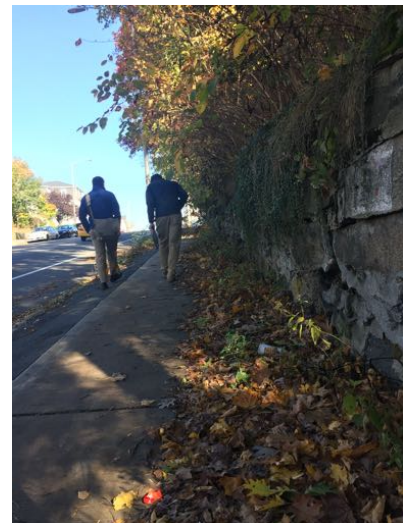
Lincoln street has wide, well-maintained sidewalks on the west side of the corridor and many young street trees that will help separate people walking from moving vehicles once they reach full growth. The east side sidewalk is uneven in places and lacks a verge to separate people walking from moving vehicles. Lincoln Street has on-street parking along the length of the study area, with some time-limited parking spaces near the local businesses. Despite the presence of trees and on-street parking to separate people walking from vehicles, the sheer volume and speed of traffic make the walking environment feel uncomfortable.

The east side sidewalk of Lincoln Street is sloped in sections and is obstructed by overgrown vegetation and fallen leaves

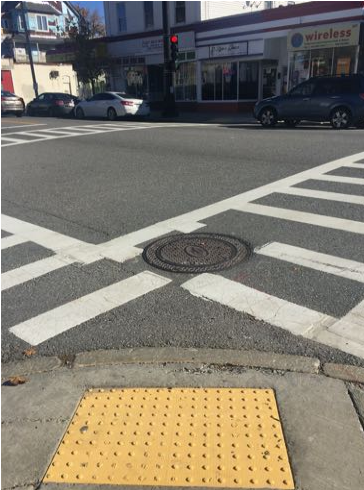
Walk audit participants observed misalignment of tactile warning panels within curb ramps at many locations along Lincoln Street. The tactile warning panels were not aligned with the crosswalks, and instead led into vehicle travel lanes, posing a risk to persons with low-vision who utilize these panels for directional guidance when accessing crosswalks

Misaligned tactile warning panel at Harlow Street intersection

- Evaluate the placement of additional enhanced mid-block crosswalks along Lincoln Street in high utilization areas, such as Green Hill Parkway, at bus stops, and at businesses.
- Increase the visibility of existing crosswalks with pedestrian scale lighting, raised crosswalks, in-crosswalk pedestrian signage, advanced pedestrian crossing signage, curb bump-outs to shorten the crossing distance, and rectangular rapid flashing beacons (RRFBs).
- Consider parking regulations to enhance pedestrian visibility, such as a no parking zone within 20 feet of a marked crosswalk.
- Ensure that tactile warning panels of curb ramps are ADA-compliant and appropriately aligned with marked crosswalks.

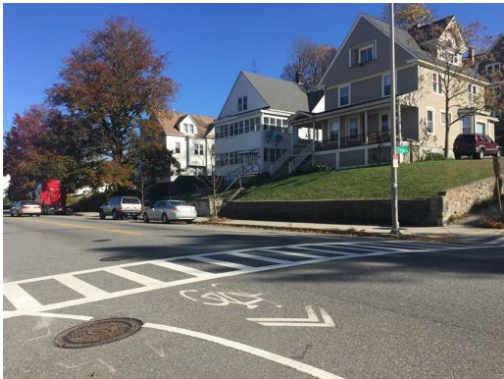
There are three crosswalks across Lincoln Street between Harlow Street and Catharine Street, which is a distance of 0.5 miles (2640 feet). Two of the three crosswalks are at signalized intersections (Harlow Street and Catharine Street) and one crosswalk is at the unsignalized intersection of Orne Street. The distance between the Harlow Street and Orne Street crosswalks is 0.2 miles (1056 feet) and the distance from the Orne Street to Catharine Street intersection is 0.3 miles (1584 feet). These distances exceed the National Association of City Transportation Officials (NACTO) recommended distance of 200 feet in highly utilized walking areas. The Orne Street crosswalk lacks advanced crosswalk signage and in-street signage, reducing the visibility of this crosswalk. Residents shared that there is poor visibility of pedestrians at these crosswalks in the evening due to dim street lighting. There are on-street parking

spaces that abut the Orne Street crosswalk, which also decreases visibility of people crossing Lincoln Street in this location.

On-street parking is allowed to the edge of crosswalks on Lincoln Street, which limits the visibility of pedestrians

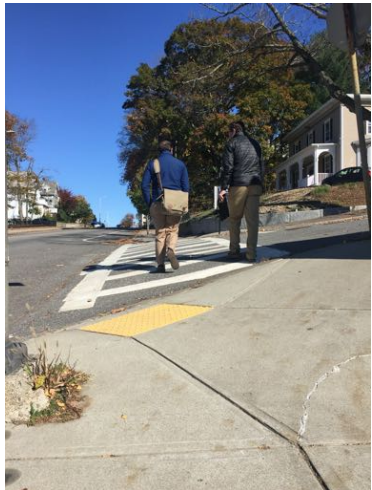
The north-south crosswalks that allow pedestrians to cross over residential streets when moving in the north-south direction on Lincoln street have accessibility issues due to the hilly terrain of the Green Hill neighborhood. The steep slope to the east and west of Lincoln Street leads to severely slanted crosswalks in places, making it difficult to navigate for people walking with wheeled devices (wheelchairs, walkers, strollers, etc.)

Crosswalks are steeply sloped on the hilly Lincoln Street terrain

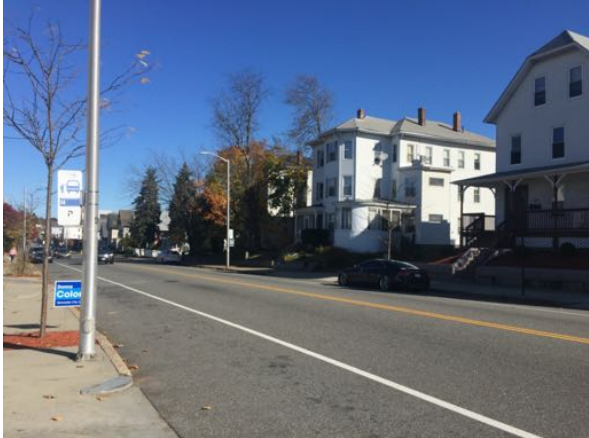
There are three WRTA buses (Rt 14,23 and 26) that service Lincoln Street. In the study area, there is only one bus shelter at the stop near the Adcare Hospital campus. The other stops in the study area are signified by a metal post sign alone, with no places to sit and no shelter from weather. There are other bus stops along Lincoln Street that do have shelters (one near Northampton St and 2 in front of the UMass facilities at the north and south ends of the corridor). Many of the Green Hill bus stops do not have crosswalks, and transit users must navigate unsafe crossing of multiple vehicle travel lanes if they wish to cross Lincoln Street at a bus stop. Cars do not always stop for transit users who are attempting to cross the traffic lanes, creating a dangerous scenario for those walking to and from the bus on Lincoln Street.

Most Lincoln Street bus stops lack crosswalks, benches, and shelters

5. Bus access:
- Enhance the pedestrian accommodations at bus stops along Lincoln Street. For the comfort of transit users of all ages, benches and weather protection could be considered at the bus stops of this corridor. Evaluate the addition of unsignalized, marked crosswalks at the marked bus stops on Lincoln Street. These crosswalks should include features that enhance visibility and safety (pedestrian scale lighting, raised crosswalks, in-crosswalk pedestrian signage, advanced pedestrian crossing signage, curb bump-outs, and rectangular rapid flashing beacons (RRFBs)).

- At bus stops with shelters: consider including system maps and bus route information/schedules. At bus stops without shelters: consider installing new bus signs to replace those that are faded or in poor condition.

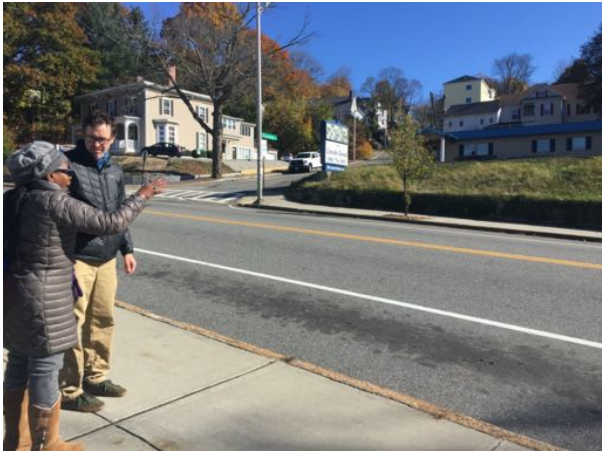
There is also school bus service on Lincoln Street with pickup locations that do not have marked crosswalks (at Henchman Street and Northampton Street). There is concern amongst residents for the visibility of students at bus stops and for cars that ignore the school bus STOP signs. The school bus depot is located on Crescent Street, which is to the west of Lincoln Street, leading to a high volume of school bus movement in the mornings and afternoons.

A Green Hill resident describes safety concerns for her grandchildren, who must cross Lincoln Street where this no crosswalk to get to the school bus stop

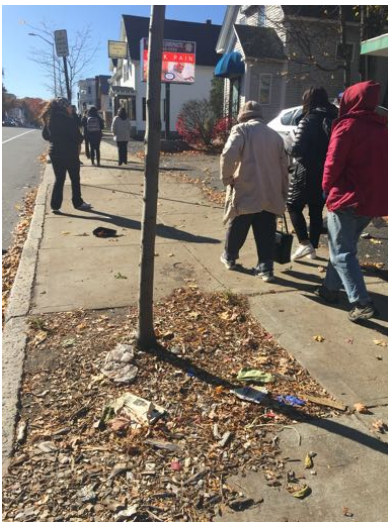
Reducing litter is a top concern for Green Hill residents

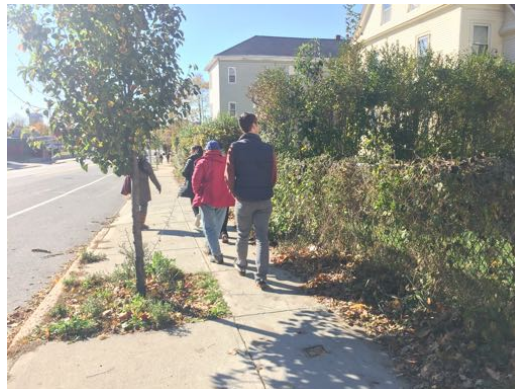
Vegetation overgrowth obstructs portions of the Lincoln Street sidewalk

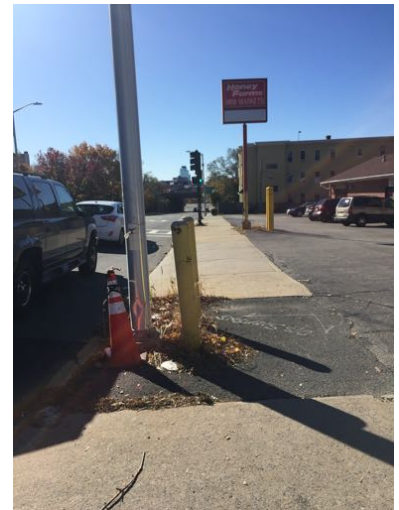
A lighting pole and parking bollards obstruct the sidewalk at Honey Farms

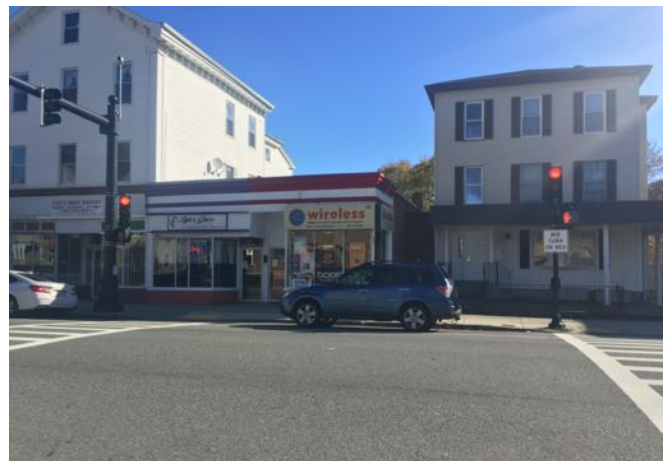
On-street parking within the Harlow Street intersection blocks visibility of pedestrians

The crosswalk at this intersection has high visibility continental striped crosswalk markings; however, visibility of this crosswalk is limited because parking is allowed up to the crosswalk marking. Parking is also allowed within the intersection itself, with one on-street parking spot located between the north

and south crosswalks of this intersection. The only lighting at this crosswalk, as with the rest of the corridor, is tall highway-scale street-lighting. The curb ramps had a lot of built up dirt, which led participants to infer that puddling occurs after rain or snow to block the ramp.

- 1. Upgrade the pedestrian signals to current APS standards.
- 2. Increase the WALK signal time to give people more time to cross at this intersection.
- 3. Adopt a parking ordinance that prohibits parking within 20 feet of a crosswalk and add features that prevent parking in this area such as flex posts or cement bollards.
- 4. Add additional pedestrian scale lighting, curb bump-outs, and a raised crosswalk at this intersection to improve the visibility of people walking.

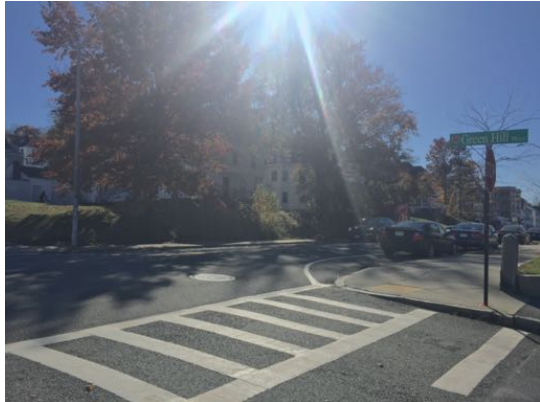
The intersection of Lincoln Street and Green Hill Parkway is one of the main access points to Green Hill Park. There is no crosswalk at this intersection across Lincoln Street, and there is little signage to indicate the presence of the park.

Residents would like a midblock crossing at Green Hill Parkway

- 1. Add an unsignalized, marked crosswalk at the intersection of Green Hill Parkway and Lincoln Street across Lincoln. This crosswalk should include features that enhance visibility and safety (pedestrian scale lighting, raised crosswalks, in-crosswalk pedestrian signage, advanced pedestrian crossing signage, curb bump-outs, and rectangular rapid flashing beacons (RRFBs)).
- 2. Consider placemaking features that signalize the entrance to the park such as pavement art, landscaping, and wayfinding signage.

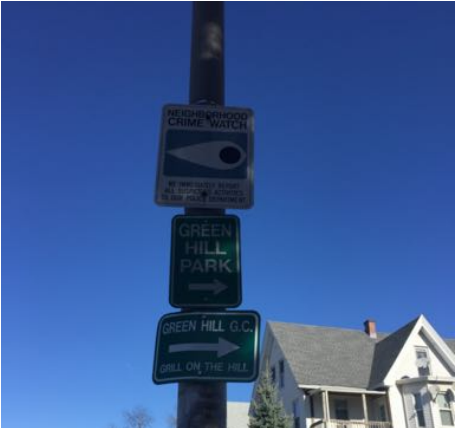
Residents want more visible signage to signify the entrance to Green Hill Park

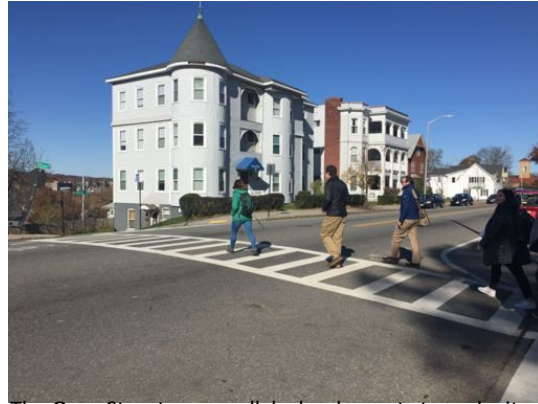
The intersection of Orne Street and Lincoln Street has a marked crosswalk for people to cross Lincoln Street in the east-west direction at this location. Orne Street is in close proximity to one of the retail corridors of Lincoln Street. On-street parking is allowed to the edge of the crosswalk, which decreases the visibility of people crossing Lincoln Street at this location. There is no pedestrian crossing signage at this crosswalk.

The Orne Street crosswalk lacks elements to make it visible to drivers

1. This crosswalk needs features to enhance visibility and safety (pedestrian scale lighting, raised crosswalks, in-crosswalk pedestrian signage, advanced pedestrian crossing signage, curb bump-outs, and/or rectangular rapid flashing beacons (RRFBs)).

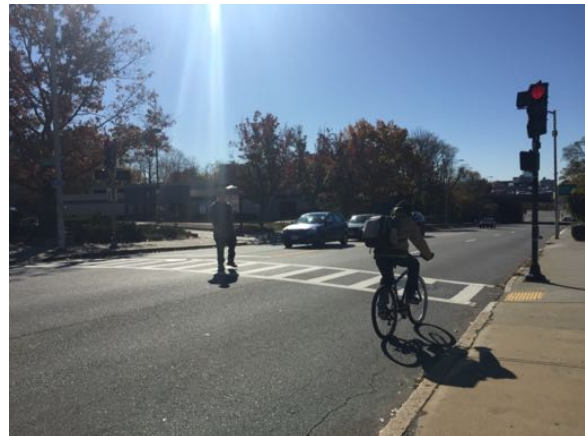
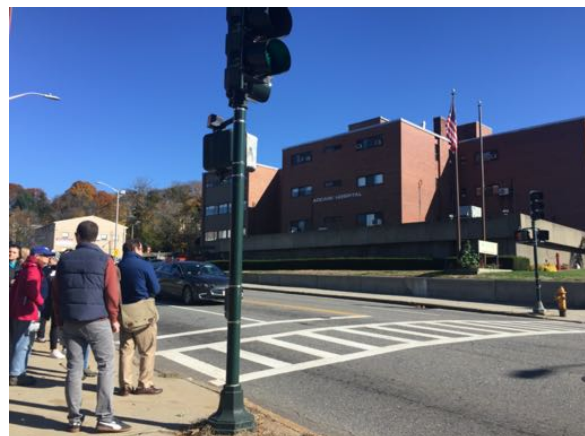
The Catharine Street intersection has marked crosswalks at all approaches and four pedestrian pushbuttons. This is an exclusive phase signalized intersection that permits right turns on red from Catharine Street to Lincoln Street. The crossing signals at this intersection are not accessible pedestrian signals (APS). On the day of the audit, participants attempted to use the two west-side pedestrian pushbuttons, and neither were operable. One walk audit participant crossed the intersection to attempt use of the east-side pushbutton, which did work. By the time this individual had unsafely crossed the intersection to use a functional pushbutton, the

The Catharine Street intersection is a high-volume pedestrian crossing

group had waited 4 minutes and 40 seconds before we were given a WALK signal. Audit participants shared that drivers travel at high speeds down Catharine Street to catch a green light at the Lincoln Street intersection. Audit participants also shared that visibility in this intersection is very poor at night due to a lack of pedestrian scale lighting, which was a contributing factor on the night of the September 2019 pedestrian fatality.

This intersection has steep curb ramps (may not be ADA compliant) and WalkBoston staff observed an individual in a wheelchair trying to navigate the ramp when planning the walk audit. Due to the inaccessible slope of the curb ramp at the intersection's north crosswalk, the individual had to use the travel lane (after crossing four travel lanes) to access the curb ramp of the intersection's south crosswalk. Once at the curb ramp of the south crosswalk, the individual had to turn their wheelchair around in the crosswalk and reverse direction to get the leverage they needed to get up the ramp slope.

1. Upgrade the pedestrian signals to APS standards and allow 3.5 feet/second WALK times.
2. Evaluate signal timing and phasing of the traffic signal on Catharine Street to determine feasibility of prohibiting right turns on red.
3. Add pedestrian scale lighting to improve visibility of people walking at this intersection.
4. Evaluate the condition of the curb ramps to ensure ADA compliance.
5. Add additional features to enhance visibility and safety such as curb bump-outs.
6. Consider speed reduction strategies for Catharine Street, such as speed feedback signs

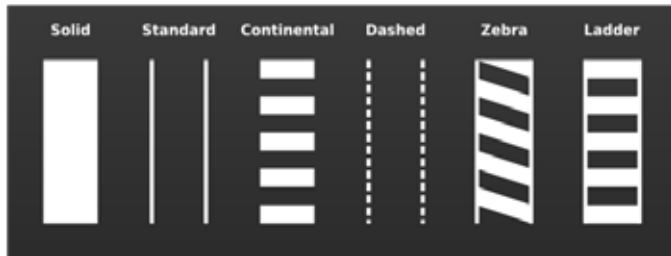
Crosswalks can be painted in a variety of ways, some of which are more effective in warning drivers of pedestrians. Crosswalks are usually accompanied with stop lines. These lines act as the legally mandated stopping point for vehicles, and discourage drivers from stopping in the middle of the crosswalk.

Crosswalk patterns
Source: USFHA

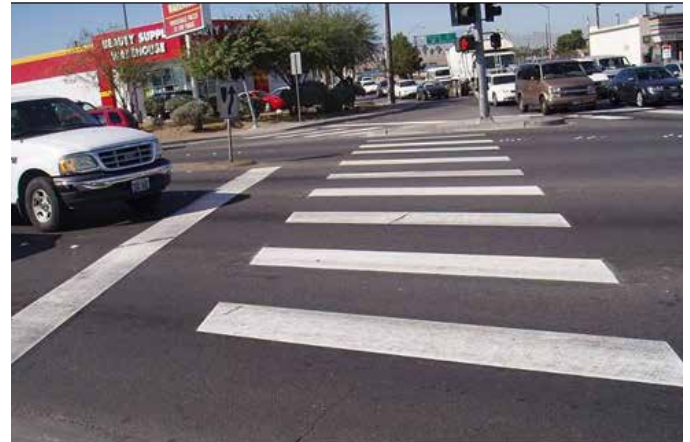
Crosswalk and stop line
Source: http://safety.fhwa.dot.gov/ped_bike/tools_solve/ped_scdproj/sys_impact_rpt/images/fig16.jpg

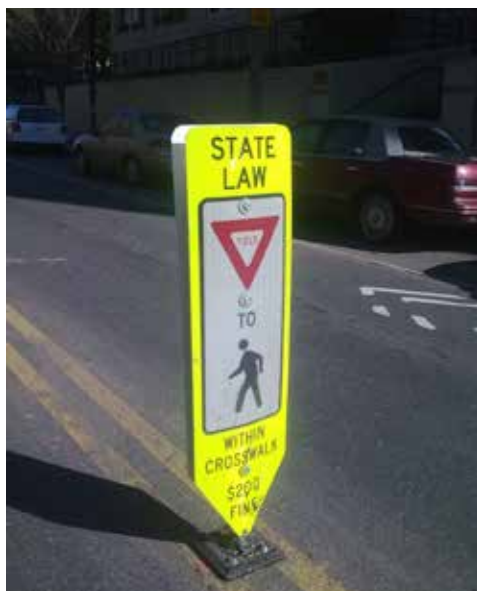
In-street Pedestrian Crossing Sign

In-street pedestrian crossing signs are used at the road centerline within crosswalks to increase driver awareness of pedestrians in the area. These signs are a relatively low-cost, highly effective tool in slowing traffic by the narrowing travel lanes. They are popular with road maintenance departments since they can be easily moved for snow removal.

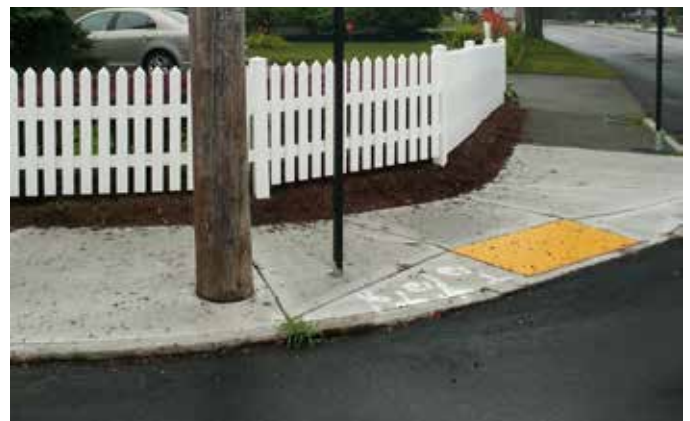
Curb ramps provide access from the sidewalk to the street for people using wheel chairs and strollers. They are most commonly found at intersections. While curb ramps have improved access for wheelchair-bound people, they are problematic for visually impaired people who use the curb as an indication of the side of the street. Detectable warning strips, a distinctive surface pattern of domes detectable by cane or underfoot, are now used to alert people with vision impairments of their approach to streets and hazardous drop-offs.

Curb ramp and detectable warning strip

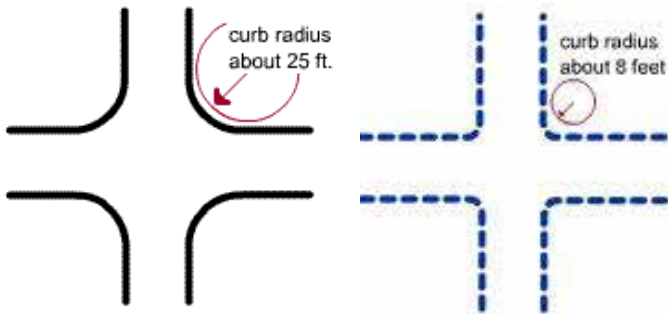
A longer curb radius (on the left in figure below) allows vehicles to turn more quickly and creates longer crossing distance for pedestrians. A shorter curb radius (on the right in the figure below) slows turning speeds and provides pedestrians shorter crossing distances.

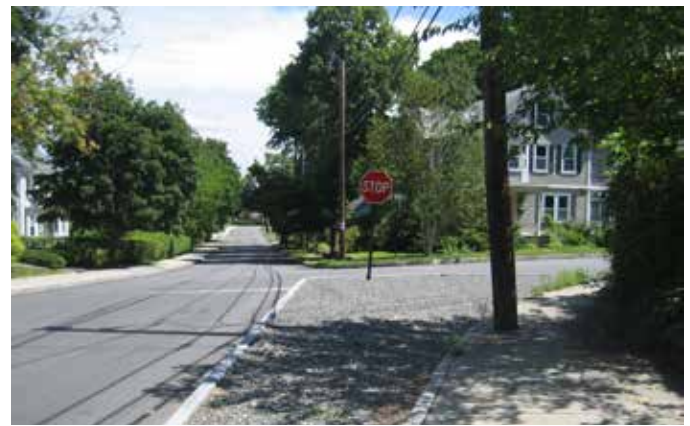
There are two excellent examples of the shortening of curb radii in Woburn, MA. The first (A) is a low-cost solution using a gravel-filled zone between the original curb line and the newly established road edge. The second is a higher-cost solution using grass and trees and extending the sidewalks to the new curb. Both work to slow traffic.

(A) Gravel-filled curb extension

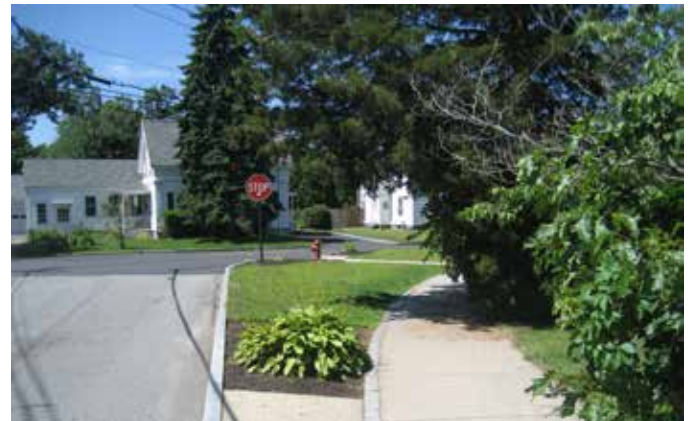
(B) Grass, trees and extended sidewalk in curb extension

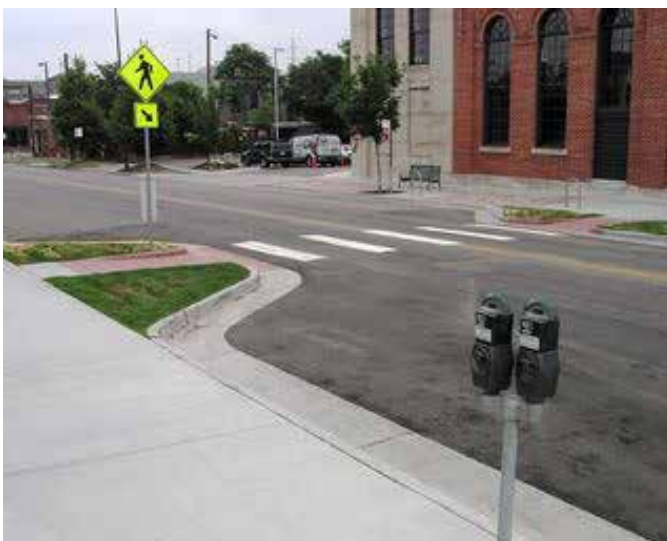
A sidewalk extension into the street (into the parking lane) shortens crossing distance, increases visibility for walkers and encourages eye contact between drivers and walkers.

Curb extensions are often associated with mid-block crossings

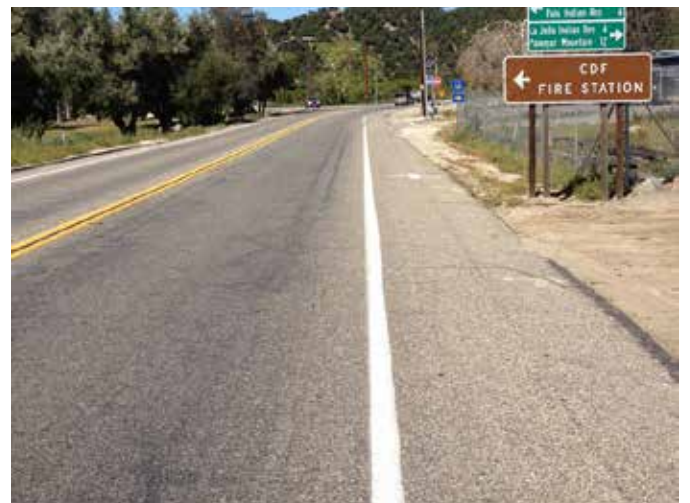
A fog line is a solid white line painted along the roadside curb that defines the travel lane. It narrows a driver's perspective and helps to slow traffic speeds. Fog lines are used in urban, suburban and rural locations.

Fog lines delineate the vehicular driving zone on wide roadways.
