Lenox Town Center Walk Audit

Lenox, MA

July 28, 2016

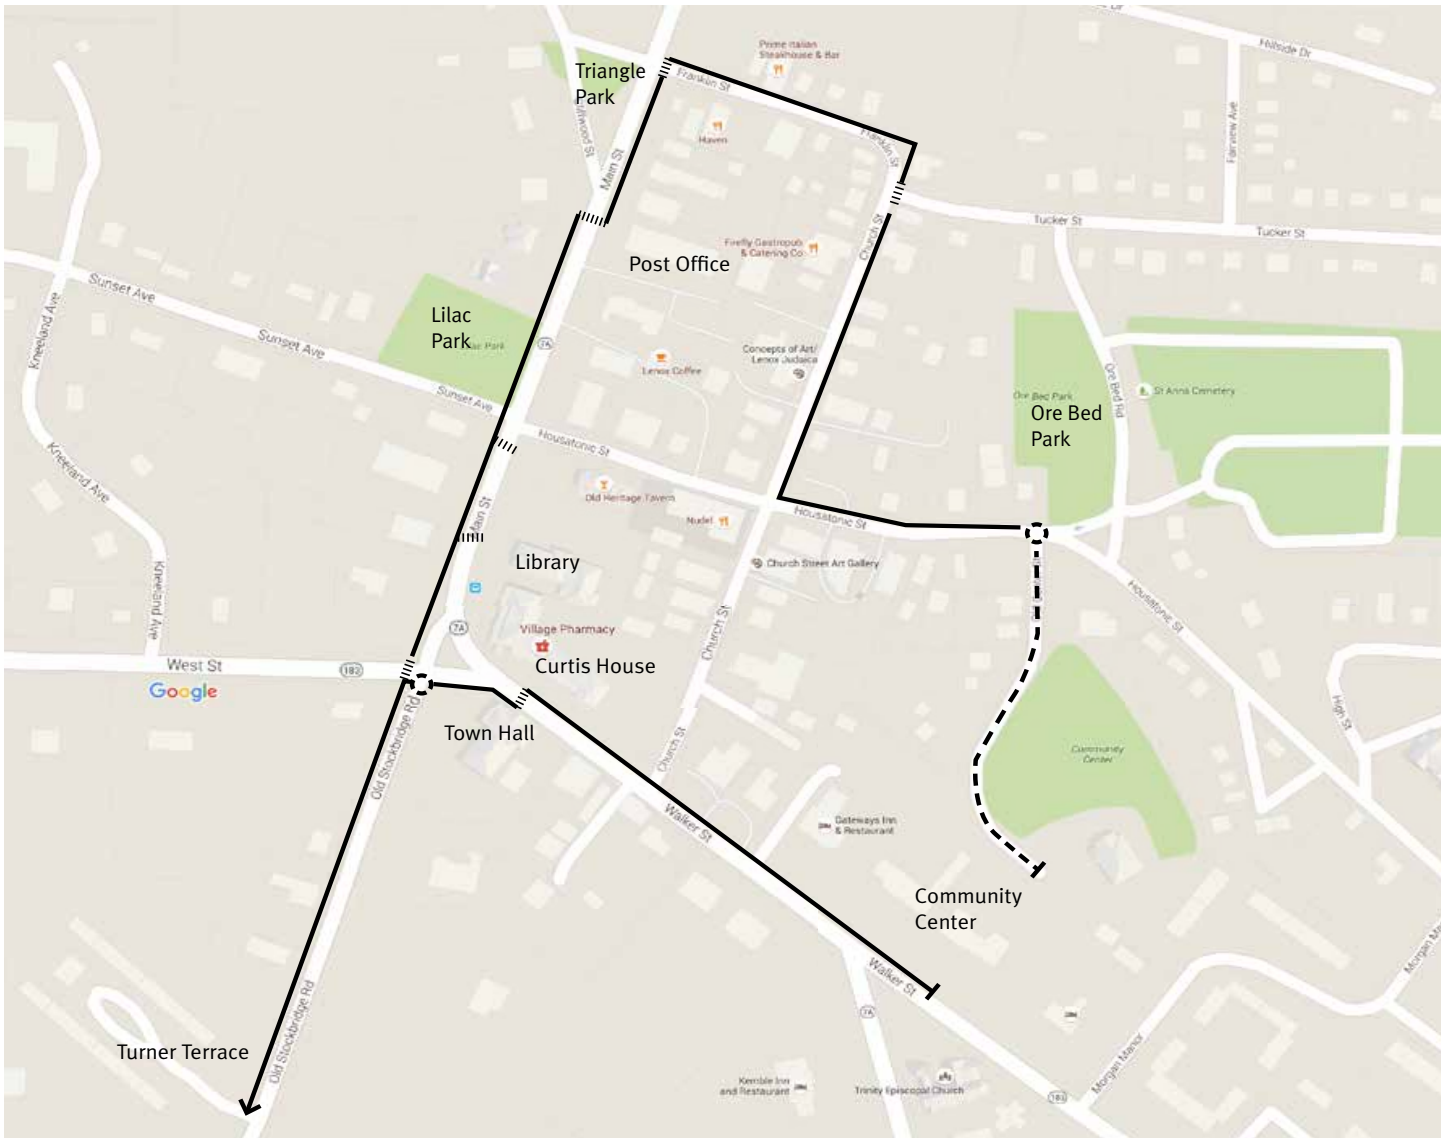
Walk audit route to and from the Community Center

Overall, the walking conditions within the town center are excellent when compared to many other rural Massachusetts communities. However, walk audit participants witnessed dangerous intersections, missing crosswalks, confusing paving treatments, and uneven sidewalks. The following sections detail the key issues that affect walkability and pedestrian safety in Lenox town center and make recommendations for improvement.

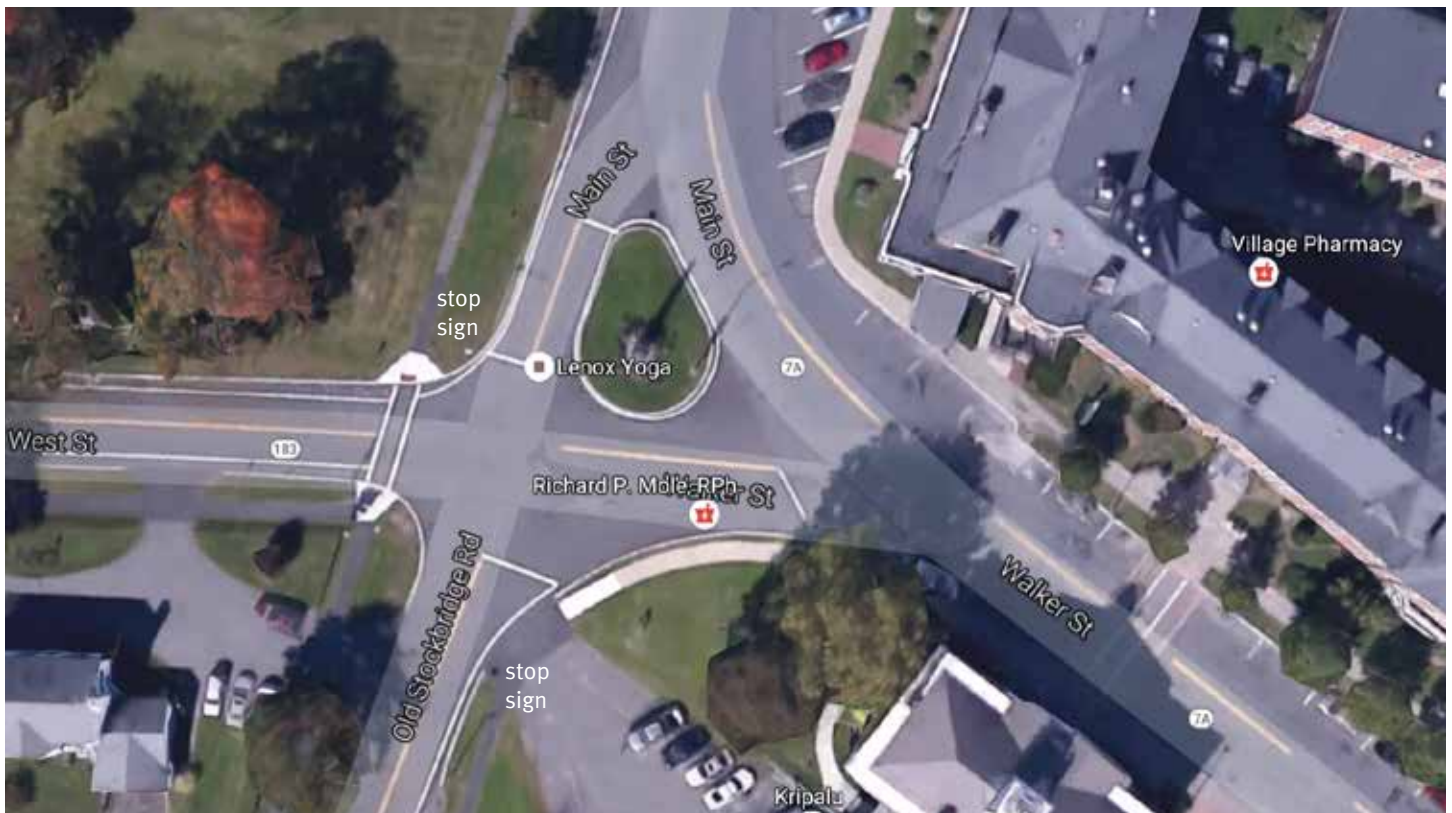
Aerial view of Route 138/7A intersection

There is no crosswalk across Old Stockbridge Road at the intersection of Rt 183/7A.

The Walker Street/West Street/Main Street/Old Stockbridge Road intersection (183/7A) in front of town hall and the Curtis House sees high volumes of vehicular and pedestrian traffic. People walking do not have a complete marked route across the intersection from any direction and must walk a significant distance out of their way to use crosswalks. There are only two crosswalks at the intersection – one across West Street and one located just east of the intersection between the Curtis House and Town Hall. There is a third crosswalk across Main Street connecting the Library and the Summer White House Inn. It is unreasonable to expect people to walk to the Library and back to West Street to cross this intersection.

The intersection is not signalized, but the northbound Old Stockbridge Road approach and the Main Street southbound approach are controlled with stop signs. Drivers familiar with the intersection move quickly through it, while visitors hesitate as they determine who has the right of way. The Paterson –Egleston

Monument sits in the center of the junction of 7A and Route 183. When approaching the intersection from the south on Old Stockbridge Road, people must go up a considerable hill which compromises sight lines and pedestrian visibility.

Walk audit participants observed people walking from town hall across Old Stockbridge Road to reach destinations on West Street and Main Street, including passengers arriving by regional bus. Boston University Technical Institute students (BUTI) walk between BUTI and the town center in the summer to take the bus into Boston.

This intersection has been studied in the past (*Downtown Transportation Management Study, 2003; Lenox Village Center Improvement Plan, 2008*) and some recommendations included moving the Monument. Participants in the walk audit felt strongly that immediate, short-term improvements to this intersection must be a priority and not depend on moving the monument to enhance safety. Given the grade change, the angles of each approaching road, and the location of some driveway access points, the improvements are more complicated than simply painting a crosswalk across Old Stockbridge Road.

- Explore the following short-term options for installing a marked crosswalk across Old Stockbridge Road
 - » Mark a crosswalk and install accessible ramps and sidewalk connections between the municipal parking lots on the east side of Old Stockbridge connecting to the sidewalk on the west side just south of the residential driveway
 - » Relocate and/or close the municipal and private residence driveways on Old Stockbridge Road just south of the West Street intersection to make room for a marked crosswalk and accessible ramp
 - » Install roadside crosswalk signs to make the crossing more visible
- Review location of stop sign and stop line where Old Stockbridge meets West Street
- Move existing crosswalk sign closer to edge of the road; consider installing advance crosswalk signs

- Tighten curb radius where Walker Street meets Old Stockbridge Road on the west side of town hall
 - » Install curb ramps and a crosswalk at the Walker St/Old Stockbridge Rd intersection
 - » Install roadside crosswalk signs to make crossing more visible
- Rethink location of angled parking in front of the Curtis House
 - » Redesign to accommodate marked crosswalk between Adams Community Bank and the Curtis House – could include curb bump-out or complete curb realignment to mirror curve and convert to parallel parking
 - » Remove parking entirely to maximize pedestrian visibility
