Age-Friendly Walk Audit - Ware Ware, MA

November 15, 2019

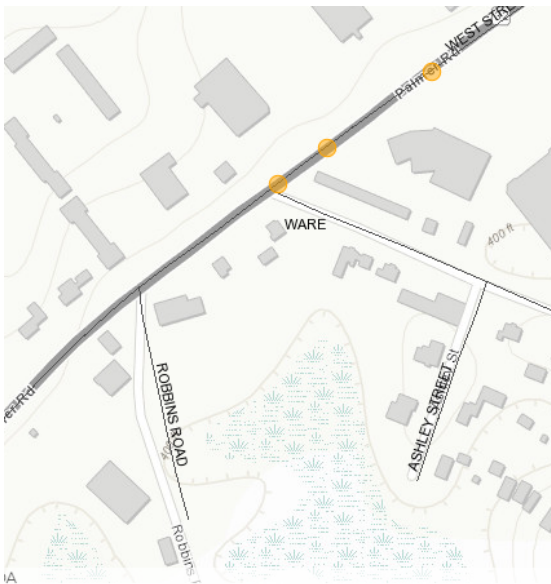
Figure 1: Pedestrian Crash Map – Town Center

MassDOT’s crash data indicates 10 pedestrian-involved crashes in the walk audit study area since 2009. One of these crashes resulted in a fatality and nine resulted in non-fatal injuries of the involved pedestrian.
