Bicycle and Pedestrian Infrastructure Assessments Brookline, MA

Harvard Street Corridor: Longwood Avenue to Shailer Street

Walk/Bike Assessment

September 14, 2016

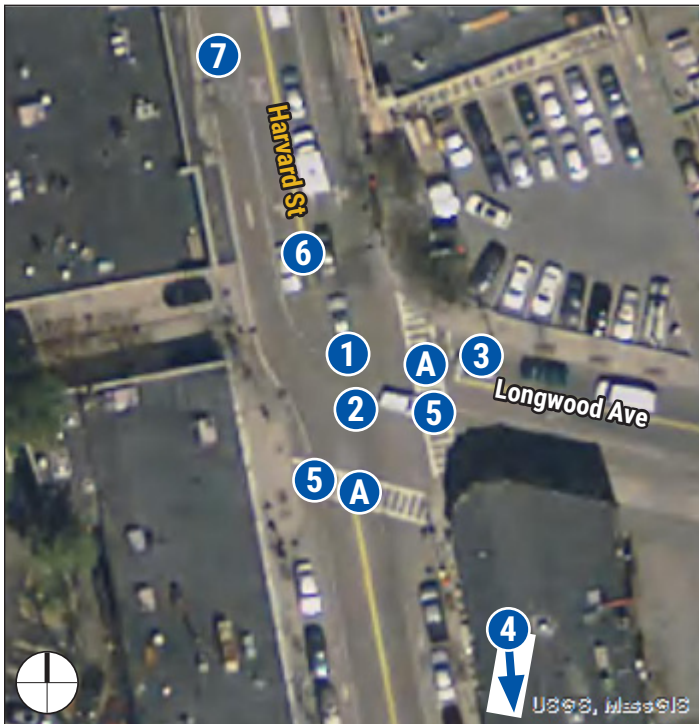
Harvard St at Longwood Ave

1. Further study the potential to signalize the intersection and coordinate with the intersection of Beacon Street.
2. Add 'Don't Block the Box' markings and signs that conform to the latest version of the MUTCD.
3. Restrict left turns from Longwood Avenue onto Harvard Street southbound.
4. Further evaluate the intersection of Harvard Street/Sewall Avenue for an increase in left turning vehicles.
5. Install in-street warning signs on the Harvard Street and Longwood Avenue crosswalks.
6. Widen bicycle lane by reducing width of travel lanes and install flexposts.
7. Remove warning signs and replace with a bike lane sign.

- A. Shorten crosswalks with curb extensions or pedestrian crossing islands where such treatments would not interfere with current or future bicycle facilities.

- Further study the potential to signalize the intersection and coordinate with the intersection of Beacon Street;
- Add 'Don't Block the Box' markings and signs that conform to the latest version of the MUTCD ;
- Restrict left turns from Longwood Avenue onto Harvard Street southbound;
- Further evaluate the intersection of Harvard Street/Sewall Avenue for an increase in left turning vehicles;
- Install in-street warning signs on the Harvard Street and Longwood Avenue crosswalks;
- Widen bicycle lane by reducing width of travel lanes and install flexposts;
- Remove warning signs and replace with a bike lane sign; and
Install wayfinding signage on southbound Harvard Street north of Beacon Street to inform drivers of the need to position for a left turn onto Longwood Avenue prior to Beacon Street.

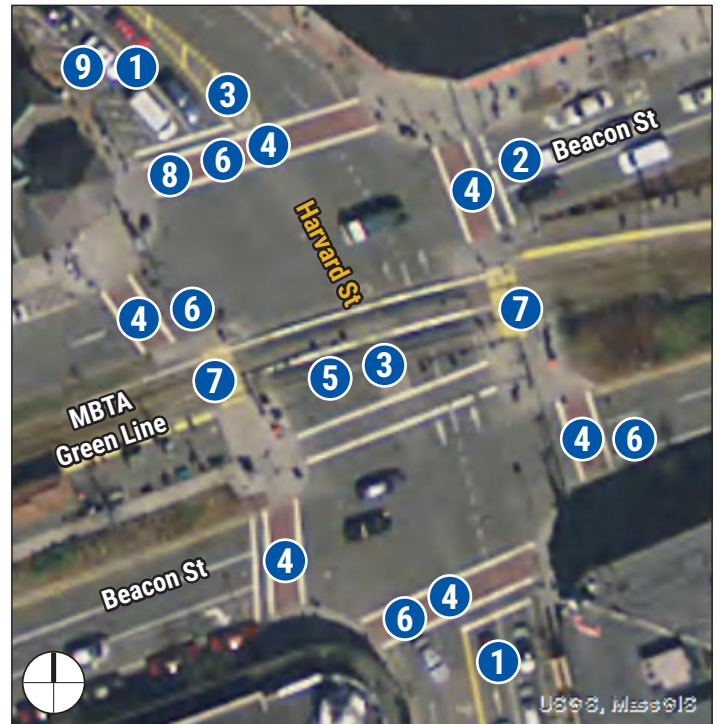
Harvard St at Beacon St

1. Reduce width of travel lanes to provide continuous bike lanes.
2. Reallocate the space for bicycle facilities for the Beacon Street westbound approach.
3. Remove the two existing small medians and reallocate space to other users.
4. Replace the existing crosswalks with high visibility ladder style crosswalks.
5. Further study the feasibility of providing one stage crossings across Beacon Street.
6. Extend leading pedestrian intervals.
7. Maximize pedestrian crossing times for all approaches.
8. Install bicycle box for the Harvard Street southbound approach to Beacon Street.
9. Install wayfinding signage on southbound Harvard Street north of Beacon Street to inform drivers of the need to position for a left turn onto Longwood Avenue prior to Beacon Street.

- Replace the existing crosswalks with high visibility ladder style crosswalks;
- Study providing one stage pedestrian crossings across Beacon Street; and
- Extend leading pedestrian intervals;
- Maximize pedestrian crossing times for all approaches; and
- Install bicycle box for the Harvard Street southbound approach to Beacon Street.

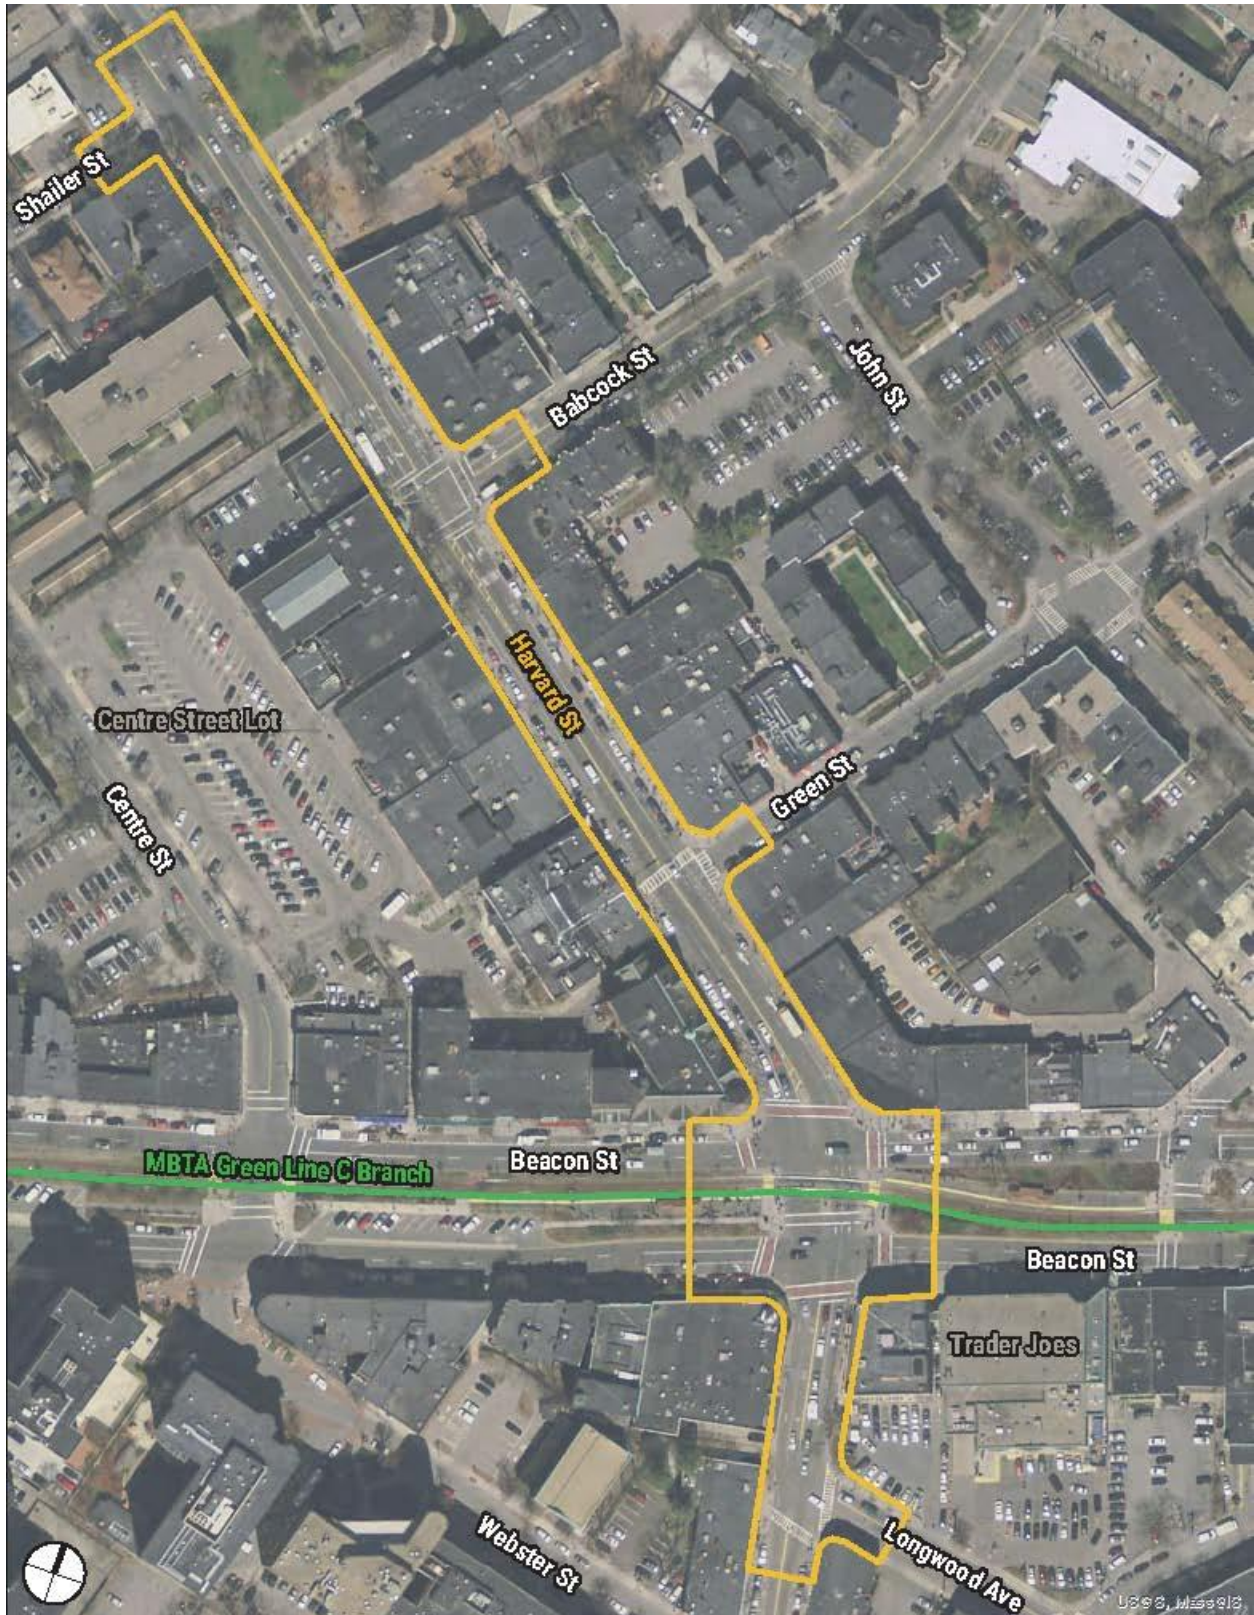
Figure 1: Assessment Study Area

The study area is illustrated in **Figure 1**. In addition, MassDOT provided crash data and collision diagrams which are provided in **Appendix D**.

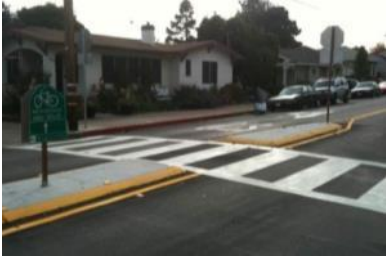
<p>Pedestrian-Scale Lighting</p>	<p>Light fixtures used to illuminate a sidewalk or pathway typically closer to the ground and placed closer together than roadway lighting.</p>

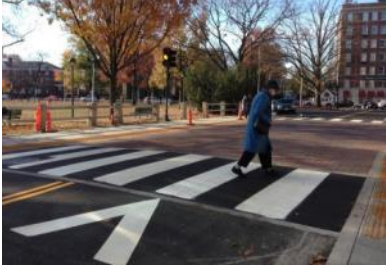
<p>Rectangular Rapid Flash Beacon</p>	<p>An on-demand activated flashing beacon with a “wig-wag” pattern that alerts motorists to pedestrians in the crosswalk. Typically used on lower volume and lower speed streets.</p>

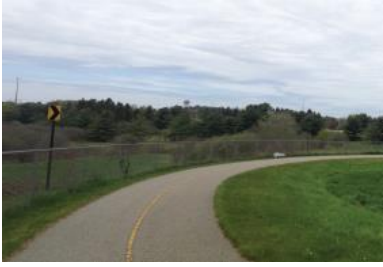
Sidewalk	A concrete pathway adjacent to the roadway. Sidewalks must meet minimum dimensions and smoothness for ADA-compliance. They may have decorative paving or plantings and should be wider where high pedestrian volumes are present or desired.

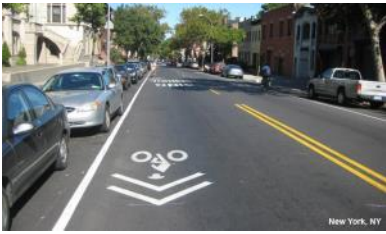
Facility Type	Description	Sample Photo
<p>Shared Lane Markings</p>	<p>Designate positioning for cyclists within shared travel lanes and alert drivers to the presence of cyclists. Shared lane markings should be considered temporary measures until future improvements can provide full bicycle facilities.</p>

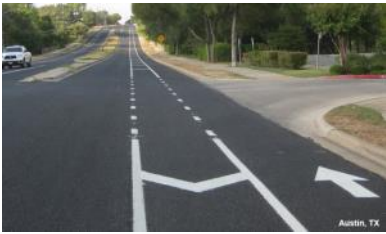
<p>Separated Bicycle Lane</p>	<p>Bicycle lane protected from vehicle traffic by adjacent vertical elements, including flex posts, planters, parked cars, curbs, or raised medians.</p>
