Philip G. Coburn Elementary Walk Audit **West Springfield, MA**

April 25, 2016

Key Issues and Recommendations

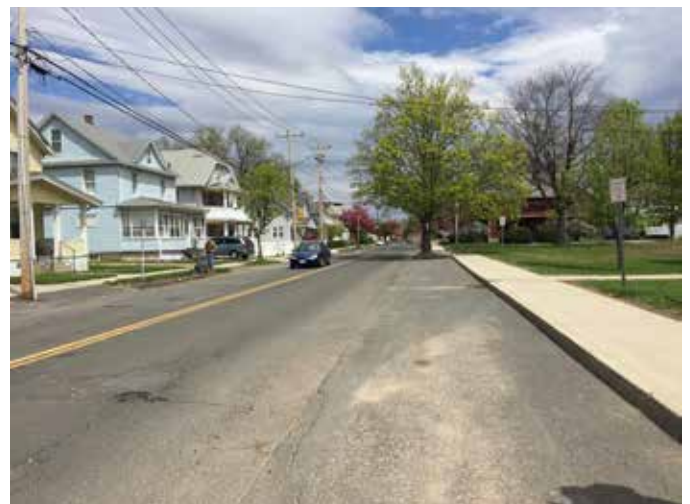
Parent car drop off and pick up is on Southworth Street. The recent construction (within the last 5 years) of drop-off lane on Southworth Street has improved traffic flow for cars throughout neighborhood, according to the West Springfield engineering department. There have been far fewer complaints from neighborhood residents and parents. The Coburn Principal voiced no concerns about arrival and dismissal procedures, and stated that there have been no incidents reported.

Drop off and pick up zone along Southworth Street

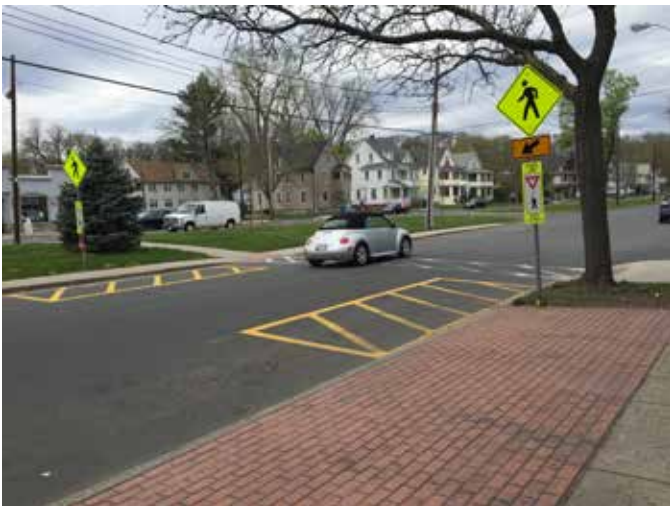
Elm Street/Garden Street crossing

Students walking from the west side of Elm Street to the Coburn School use the crosswalk just south of the Elm Street/Garden Street intersection. This intersection was the site of a pedestrian fatality in December 2014. Elm Street was recently converted from a four lane, median-separated road to a two lane, median-separated road with parking lanes on both sides. The crosswalks are well marked. Parking is prohibited within 20' of the crosswalk which improves the visibility of walkers to oncoming traffic. Pedestrian crossing signs are also present.

The crosswalk at Elm Street and Garden Street is a popular crossing point for Coburn students. A crossing guard monitors this area.

- Install curb bump-outs at the crosswalk locations to reduce the crossing distances for pedestrians and further discourage drivers from parking near the crosswalks.
- Consider installing Rectangular Rapid Flashing Beacons similar to those found at the US Post Office crossing.
- Work with the police department and engineering department to monitor driving speeds and volumes at this crossing. If traffic speeds are an issue, then prioritize this area for traffic enforcement. If traffic volumes are low enough, continue to implement road diet strategies to reduce the width of the travel lanes and roadway.

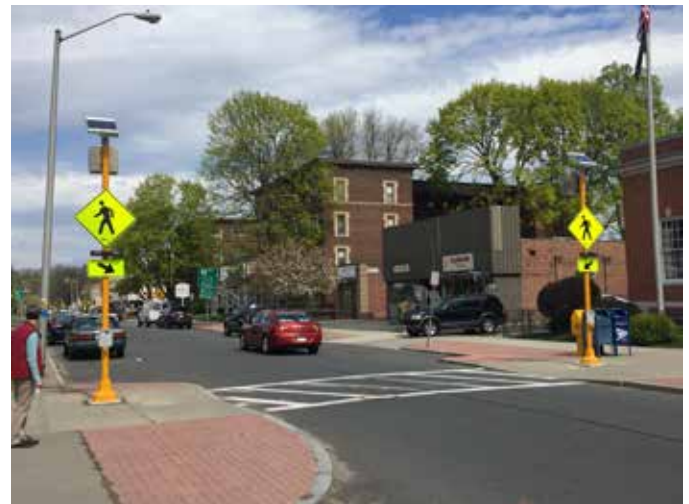
The crosswalk in front of the US Post Office on Elm Street has a Rectangular Rapid Flash Beacon and curb bump-outs.

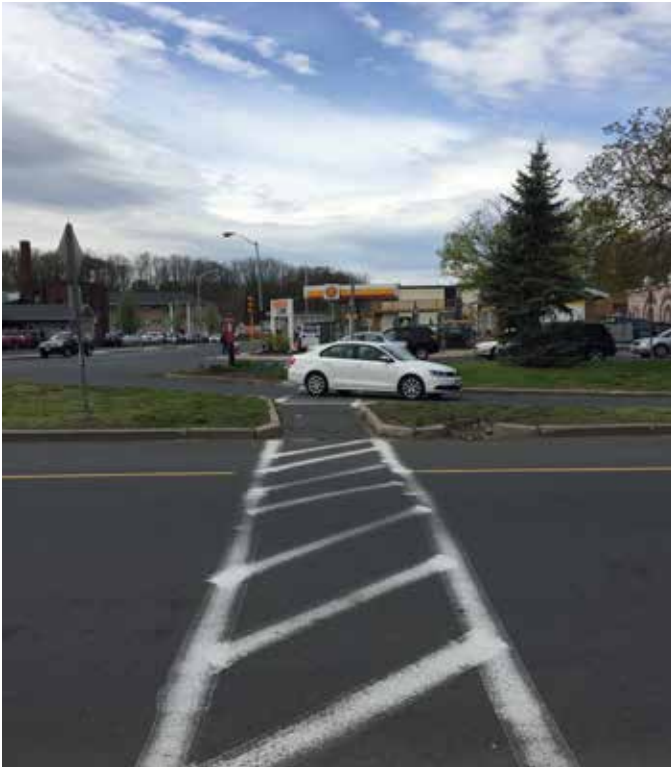
The Elm Street/Westfield intersection poses danger to pedestrians, particularly those new to the area who do not understand the phasing of the traffic signal. Most students attending the Coburn School do not use this intersection to reach the school, but they may use it to reach other destinations before or after school. There are no pedestrian signals and it is difficult to anticipate when drivers will be given a green light. The City engineer mentioned that this intersection is under study and traffic counts are in process. This section of Elm Street has two travel lanes and two parking lanes on each side of the median. There is one marked crosswalk on the north side of Elm Street, and one marked crosswalk across Westfield Street.

View of the Elm Street crosswalk looking west toward Westfield Street

- Institute “no right turn on red” for drivers turning right from Westfield Street onto Elm Street. Limiting these turns would allow walkers to feel more comfortable walking across Westfield when traffic is stopped at a red signal.
- Upgrade traffic signal equipment to include pedestrian countdown signals. (*Acknowledge that underground drainage pipes may make installation difficult).

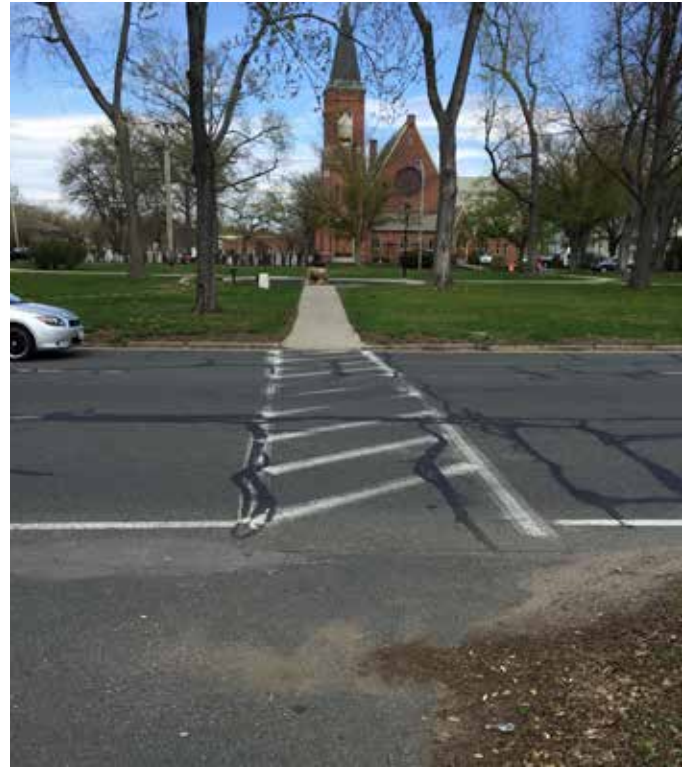
View of the mid-block crossing on Park Avenue leading to another mid-block crossing in front of the church on Park Street.

There are three un-signalized crossings on Park Street: (1) at the senior center and (2) in front of the First Congregational Church, and (3) on the north side of the Main Street/Park Street intersection. PVTa has bus stops at the first two crosswalk locations. The crossings have crosswalk signs and arrows pointing to the crosswalk on both sides of the road. The crosswalks are painted with a zebra pattern. There is one mid-block crossing on Park Avenue with no crosswalk signs.

- Install crosswalk signs and advance crosswalk signs on Park Street and Park Avenue to warn drivers of the presence of pedestrians in the crosswalks.
- Study the feasibility and safety of consolidating the un-signalized crosswalks on Park Street. Consider the path network in the park as it sets up desire lines for people to cross the street.
- Monitor traffic speeds on Park Street and Park Avenue to ensure drivers are not driving at excessive speeds. Traffic speed is the number one threat to pedestrians.

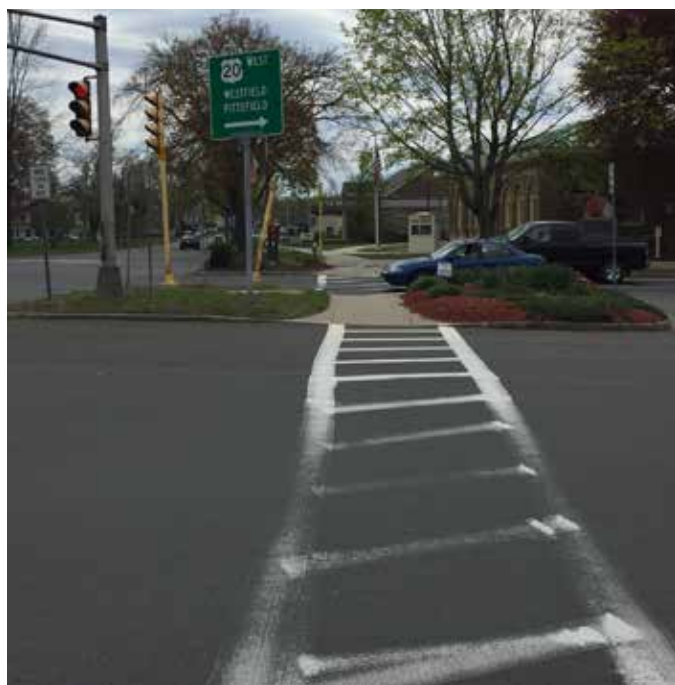
The Elm Street/Park Street intersection is identified as a 2011-2013 HSIP crash cluster (31 crashes; no fatalities; 8 injuries), which means that this intersection is in the top 5% of crash clusters in the region between the years of 2011-2013 (as reported to the Pioneer Valley Planning Commission). Crossing Elm Street is a three-stage crosswalk where people walking must cross 5 lanes of oncoming traffic. Crossing Park Street involves one long crosswalk across three lanes of traffic. These long crossing distances can discourage people from walking to the park and the Merrick-Memorial Neighborhood.

Elm Street/Park Street intersection is a HSIP crash cluster zone

- Consider narrowing or eliminating travel lanes to tighten curb radii, construct curb bump-outs and slow traffic at both intersections
- Upgrade traffic signals at both intersections to include countdown pedestrian signals across both sides of the intersection.

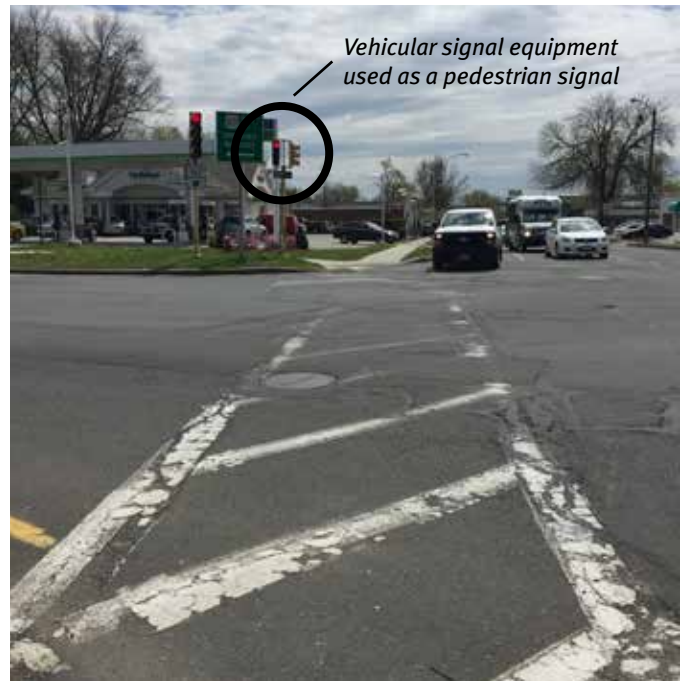
The pedestrian signal equipment at the Elm Street/Park Avenue/Union Street intersection is a smaller version of a standard vehicular traffic signal. It is mounted at a pedestrian scale, but is confusing to drivers and pedestrians alike.

Park Avenue and Union Street intersection with long crossing distances and confusing pedestrian signal equipment

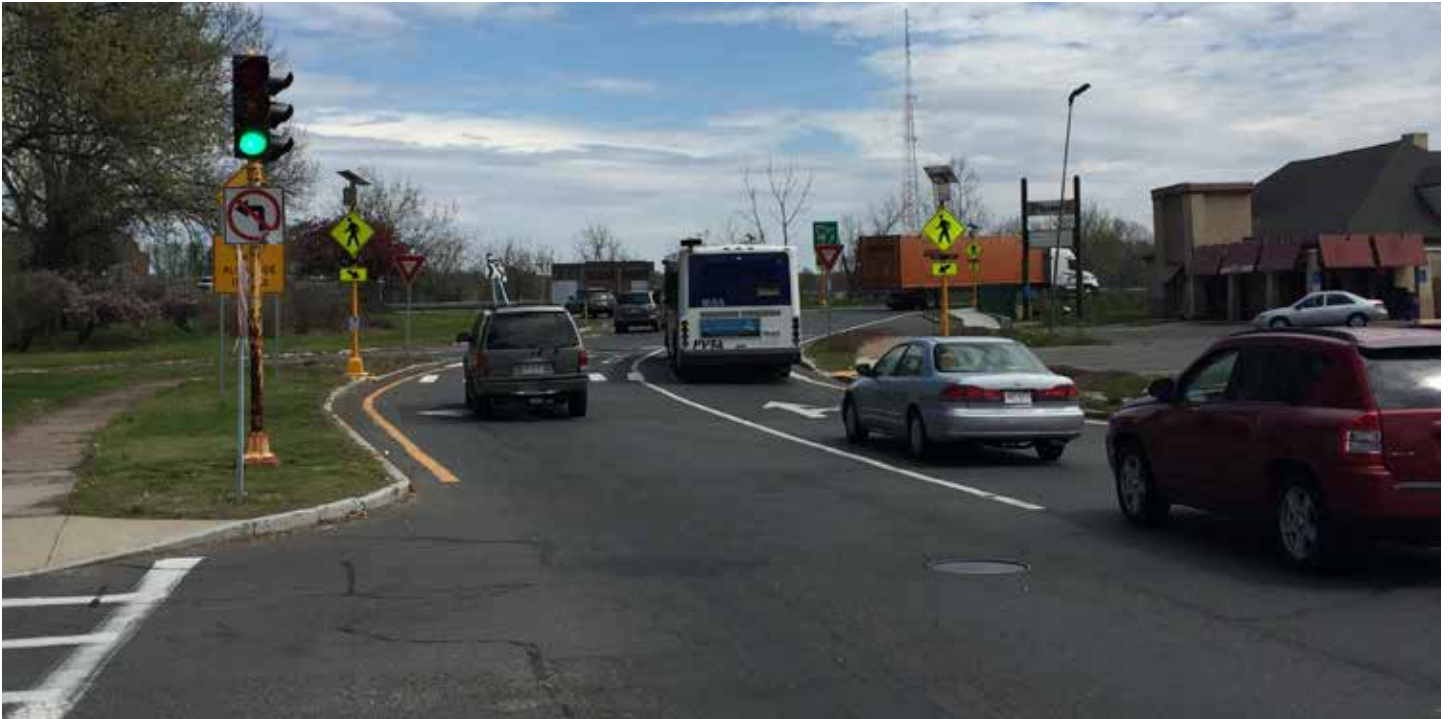
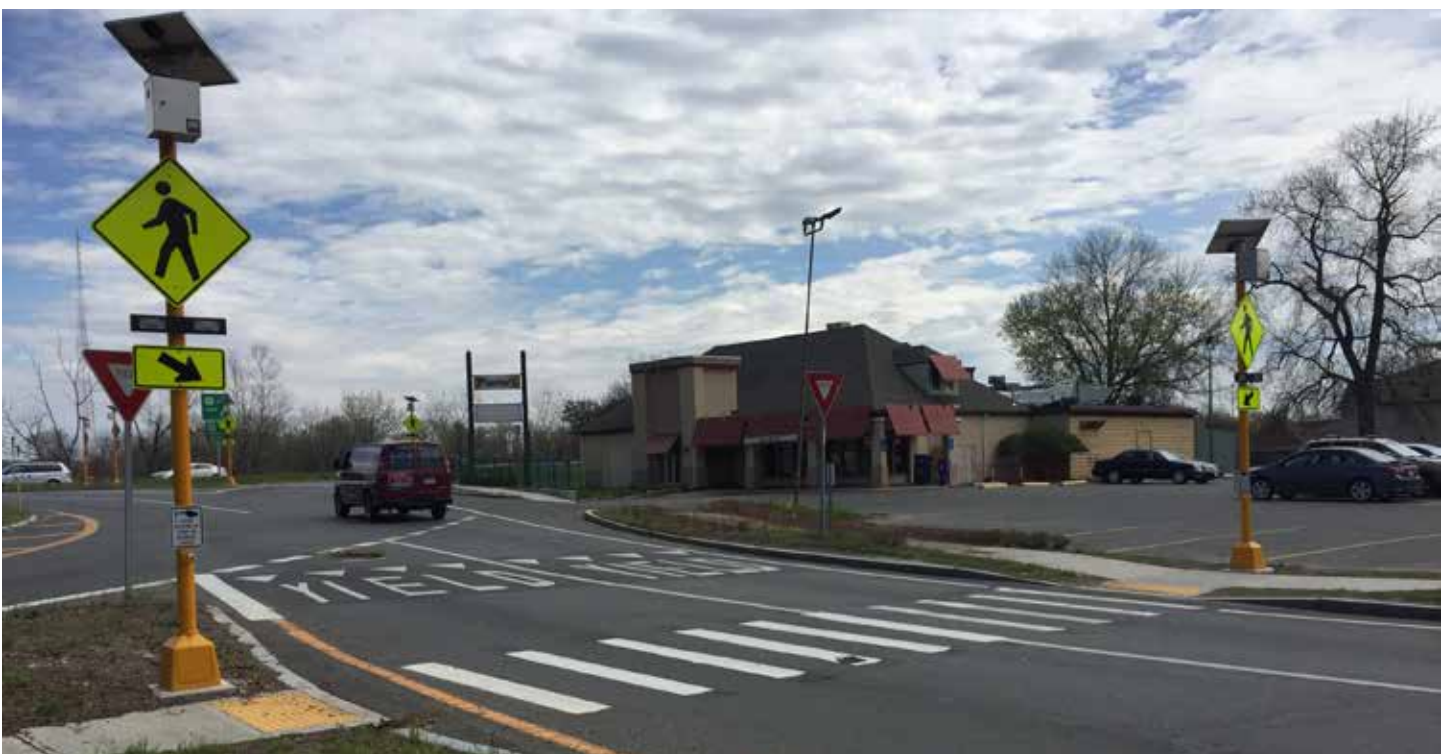
Similar to the Elm Street/Park Avenue intersection, the lane widths and crossing distances at this intersection are long. There is a crossing guard at this location during school arrival and dismissal. There are marked crosswalks, but no pedestrian signals. Furthermore, there is a second crosswalk at the rotary entrance with a Rectangular Rapid Flash Beacon (RRFB) less than 100 feet from the traffic signal. The proximity of the RRFB to the traffic signal is potentially dangerous for pedestrians. Those walking would push the RRFB button and begin crossing, while drivers who just began to accelerate would have to hit their brakes. Drivers may not anticipate or see pedestrians at this location. If the RRFB is tied into phasing of traffic light, it would extend the wait time for pedestrians and the RRFB would not function as designed.

The mismatch of traffic signal equipment could be due to different jurisdictions. MassDOT designed and implemented the rotary improvements, while the traffic signal equipment is owned and operated by the City of West Springfield.

Rectangular Rapid Flash Beacons installed at the rotary are within 100' of the traffic signal and may pose a danger to pedestrians.

- Install pedestrian countdown signals at the intersection
- Study the possibility of re-routing pedestrian traffic away from the rotary. Changes could include removal of RRFB, crosswalk and sidewalk network leading to the rotary. Any improvements done at this intersection should be coordinated with modifications to the Main Street/Park Street intersection as well (e.g., removal of RRFB, crosswalk, and sidewalk network).

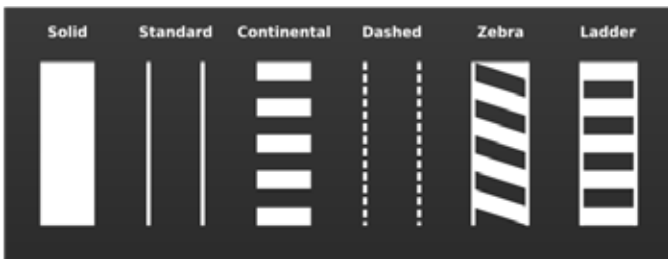
Crosswalks can be painted in a variety of ways, some of which are more effective in warning drivers of pedestrians. Crosswalks are usually accompanied with stop lines. These lines act as the legally mandated stopping point for vehicles, and discourage drivers from stopping in the middle of the crosswalk.

Crosswalk patterns
Source: USFHA

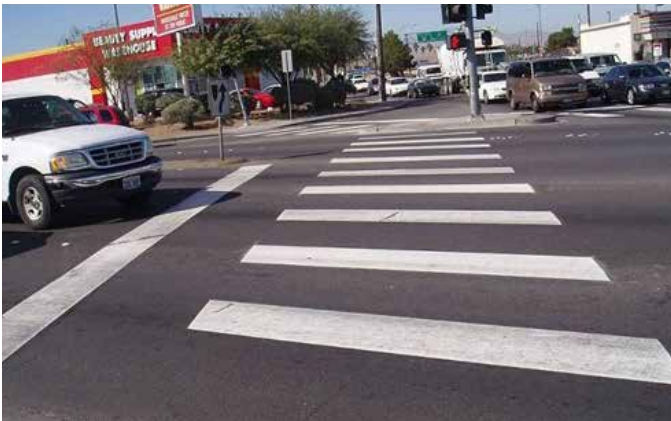
Crosswalk and stop line
Source: http://safety.fhwa.dot.gov/ped_bike/tools_solve/ped_scdproj//images/fig16.jpg

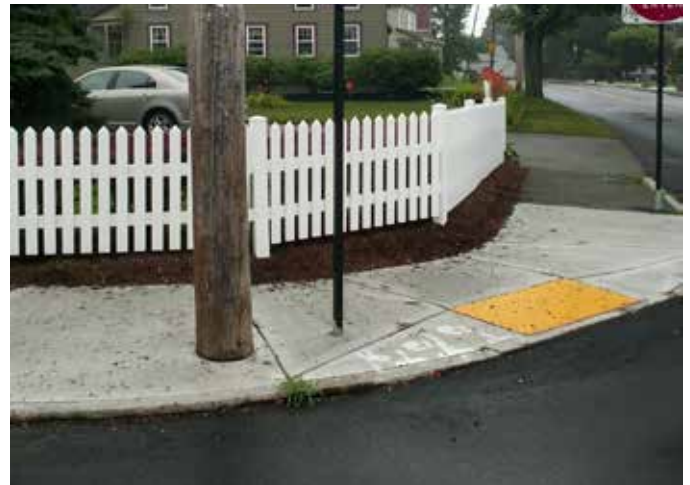
Curb ramps provide access from the sidewalk to the street for people using wheel chairs and strollers. They are most commonly found at intersections. While curb ramps have improved access for wheelchair-bound people, they are problematic for visually impaired people who use the curb as an indication of the side of the street. Detectable warning strips, a distinctive surface pattern of domes detectable by cane or underfoot, are now used to alert people with vision impairments of their approach to streets and hazardous drop-offs.

Curb ramp and detectable warning strip in Woburn, MA

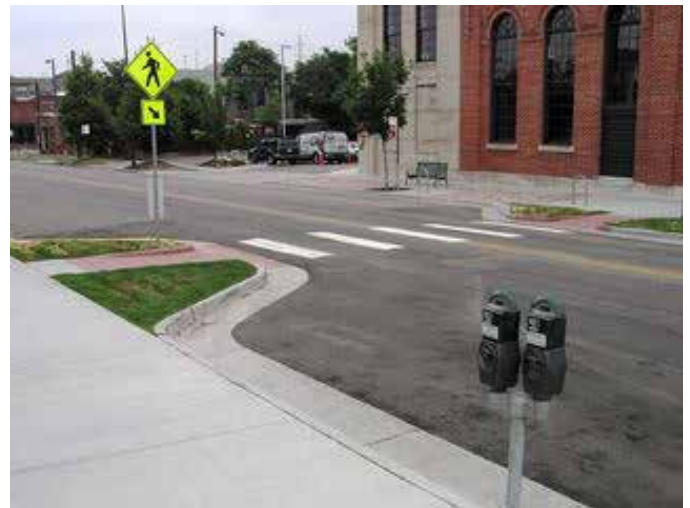
A sidewalk extension into the street (into the parking lane) shortens crossing distance, increases visibility for walkers and encourages eye contact between drivers and walkers.

Curb extensions are often associated with mid-block crossings

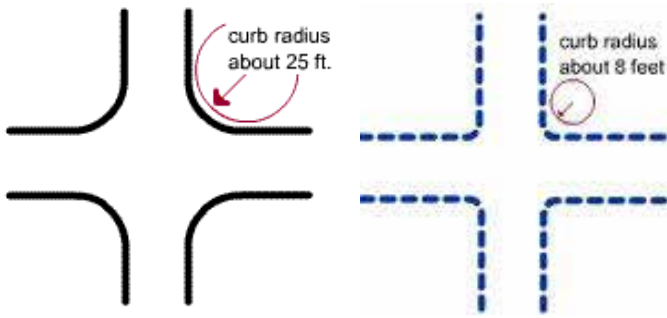
A longer curb radius (on the left in figure below) allows vehicles to turn more quickly and creates longer crossing distance for pedestrians. A shorter curb radius (on the right in the figure below) slows turning speeds and provides pedestrians shorter crossing distances.

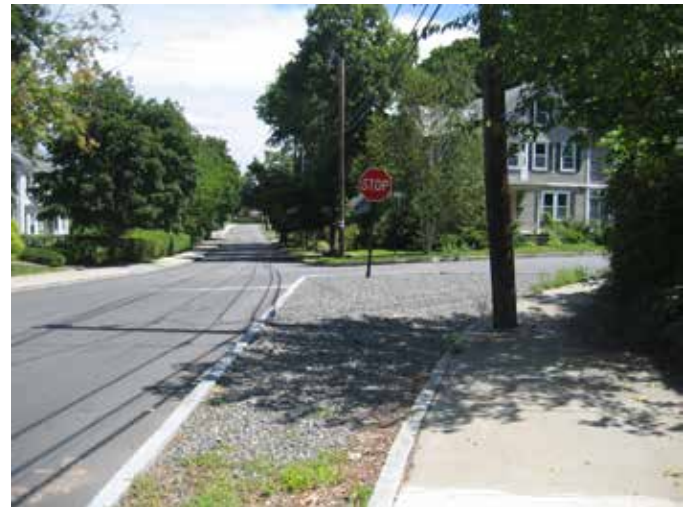
There are two excellent examples of the shortening of curb radii in Woburn, MA. The first (A) is a low-cost solution using a gravel-filled zone between the original curb line and the newly established road edge. The second is a higher-cost solution using grass and trees and extending the sidewalks to the new curb. Both work to slow traffic.

(A) Gravel-filled curb extension

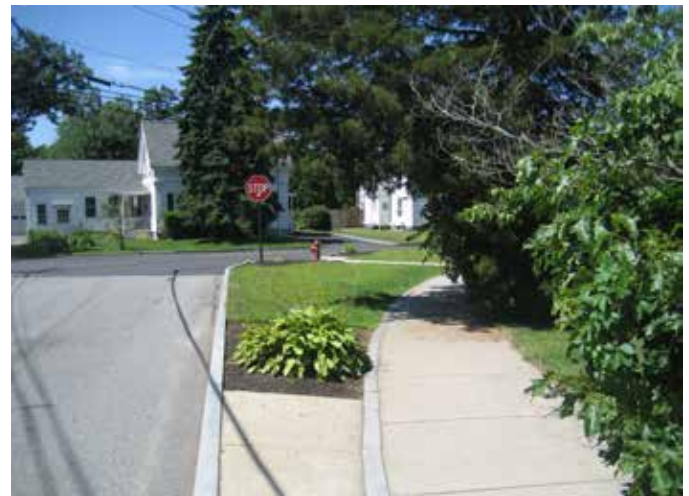
(B) Grass, trees and extended sidewalk in curb extension

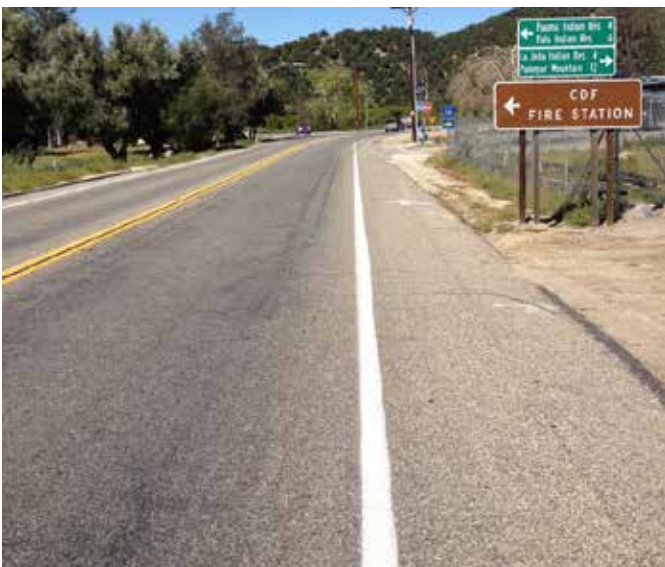
A fog line is a solid white line painted along the roadside curb that defines the driving lane and narrows the driver's perspective. Fog lines are most often used in suburban and rural locations, but may be appropriate in some urban conditions.

Fog lines delineate the vehicular driving zone on wide roadways.

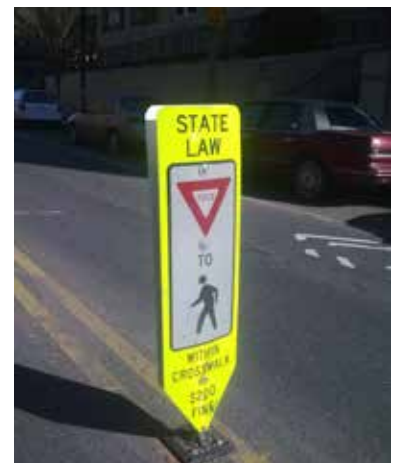
In-street Pedestrian Crossing Sign

In-street pedestrian crossing signs are used at the road centerline within crosswalks to increase driver awareness of pedestrians in the area. These signs are a relatively low-cost, highly effective tool in slowing traffic by the narrowing travel lanes. They are popular with road maintenance departments since they can be easily moved for snow removal.

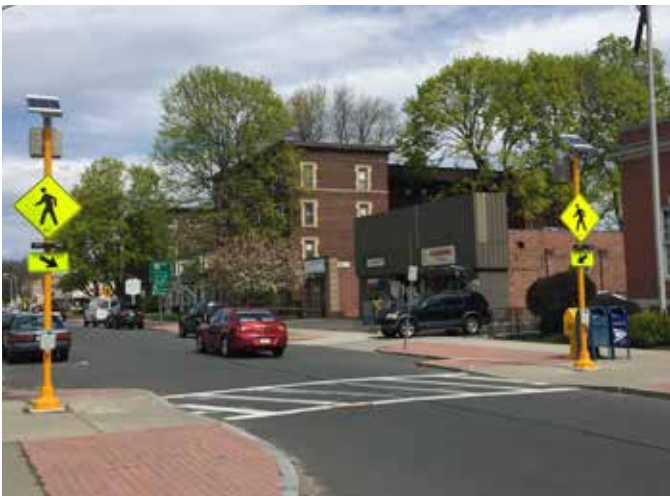
RRFBs are user-actuated flashing lights (amber LEDs) that supplement pedestrian warning signs at unsignalized intersections or mid-block crosswalks. They can be activated by pedestrians manually by a push button or passively by a pedestrian detection system. RRFBs use an irregular flash pattern that is similar to emergency flashers on police vehicles. RRFBs may be installed on either two-lane or multi-lane roadways.

Rectangular Rapid Flash Beacon (RRFB) in West Springfield
