**Beachmont – Cummings Square (Crescent Avenue and Winthrop Avenue)
Revere, MA**

April 25, 2019

Funded by the Cummings Foundation – 100K for 100 Grant Program

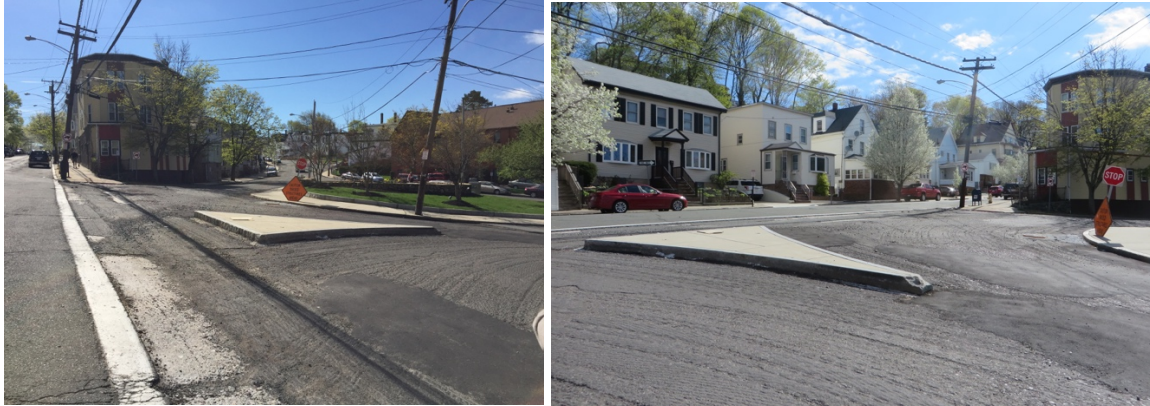
Crosswalk and traffic island parallel to Winthrop Avenue along the north side of Cummings Square

The crosswalk that spans Crescent Avenue along the north side of Cummings Square is approximately 120' long with no protected refuge island. The traffic island in the center of Crescent Avenue is used as a pedestrian refuge island; but, it was not designed as a refuge, is not ADA compliant, and does not provide sufficient protection. Visibility within crosswalks is compromised by cars parked too close to intersections and crosswalks. It is understood that parking is a premium in this neighborhood, but the strategic removal of a few spaces could significantly improve the safety of everyone walking around Cummings Square.

The average width (from curb to curb as measured on Google Maps) of Winthrop Avenue and Crescent Avenue is 30 feet. With the two parking lanes along Winthrop Avenue (each 8' wide), the travel lane remains wide at 14 feet. Painted parking lanes or "Ts and L" could reduce lane width and help to slow traffic. While the 30' width of Crescent Avenue is reasonable with 2-way traffic and parking lanes, there are wide expanses of pavement at the intersections that surround Cummings Square. The wide turning radii could be narrowed with paint and flex-posts, which would help reduce traffic speeds as vehicles turn around the corners.

Short-term recommendations:

- Paint parking lanes or "Ts and Ls" along Winthrop Avenue to narrow travel lane and delineate parking zones
- Paint high visibility crosswalks (continental or ladder) across Crescent Avenue at Belle Isle Avenue on the west side of the intersection, and a crosswalk at the stop sign at the intersection of Crescent Avenue and Winthrop Avenue. Vehicular traffic must stop at this location already and are more likely to see pedestrians crossing here than at a mid-block, uncontrolled crossing across Winthrop at the east side of Cummings Square.

- Repaint all crosswalks in the area with high visibility crosswalks (continental or ladder).
- Where possible given current street projects, install curb ramps and/or replace non-compliant curb ramps Crescent Avenue and Winthrop Avenue corners. Install detectable warning panels.

- Paint stop lines where they are missing and refresh existing stop lines.
- Use Ts and Ls to delineate parking spaces around Cummings Square. Ensure spaces are marked a sufficient distance away from crosswalks (approx. 20'-25').

- Investigate the history of the highway scale safety barrier. Its presence conveys danger.
- Observe quality of street light levels at night around Cummings Square and at major crossing points.

- Install curb ramps and/or replace non-compliant curb ramps at any remaining Crescent Avenue and Winthrop Avenue corners that are not repaired as part of current road repair project. Install detectable warning panels.
- Consider re-routing traffic around Cummings Square in a one-way loop. This strategy could remove some of the confusion drivers now experience when driving in this area. It could also provide opportunities to reclaim some of the pavement with expanded curb bump-outs that would shorten crossing distances for people walking and reduce traffic speeds. It would require the reallocation of some parking spaces.
- Conduct parking utilization study to determine need and desired location of parking around Cummings Square
- If needed, conduct a study of light levels around Cummings Square to inform a pedestrian scale lighting strategy.

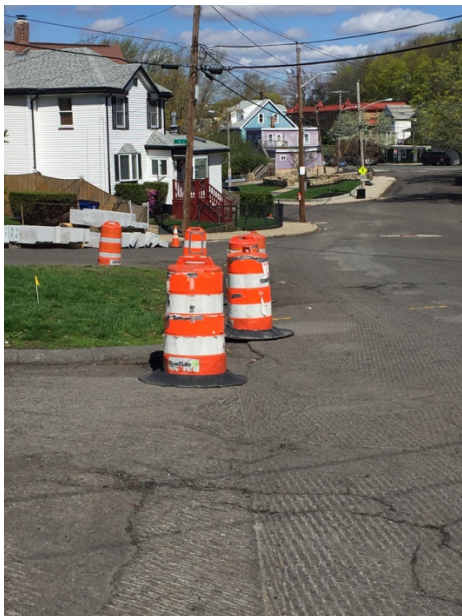
In addition to Cummings Square, walk audit participants discussed potential improvements to the Crescent Avenue/Orchard Street intersection. There are no crosswalks painted across Orchard Street or Crescent Avenue at this intersection and no functional curb ramps. The City has agreed to install a sidewalk along the northeast side of the existing traffic island. However, the alignment of the sidewalk in this location sets up a long-term conflict with an existing driveway and parking area, which could be remedied if the sidewalk is placed within the traffic island.

New sidewalk is proposed where the construction barrels are now (Photo1).

The City plans to build a curb extension at the southeastern corner of Orchard Street and Crescent Street with a curb ramp that leads to a crosswalk and corresponding curb ramp on the new sidewalk. However, no crosswalk or curb ramp will be installed on the north side of the traffic island at this time. While constructing a sidewalk is a welcome improvement in the short term, the sidewalk will most likely need to be reconstructed to adequately complete the crosswalk network in this area.

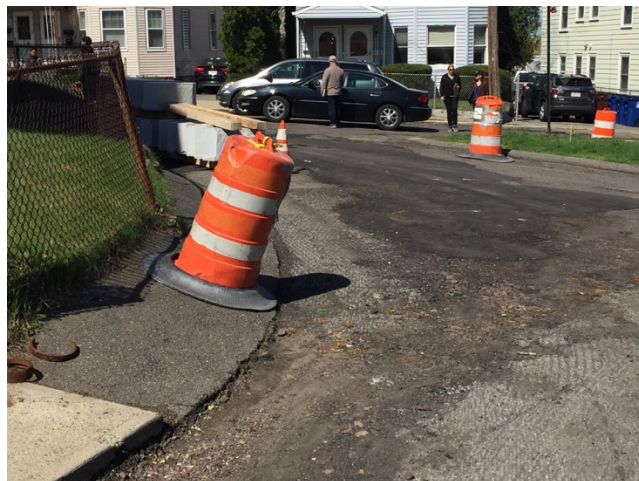
Curb bump-out is proposed at corner shown above (Photo 2).
